Phase I Environmental Due Diligence Audit (EDDA)

Environmental Impact Statement for the Proposed Airfield Safety Enhancement Project and Land Transactions for the Tucson International Airport Tucson, Arizona

January 23, 2018
AAI Date: December 27, 2016
File No. 01216132.01

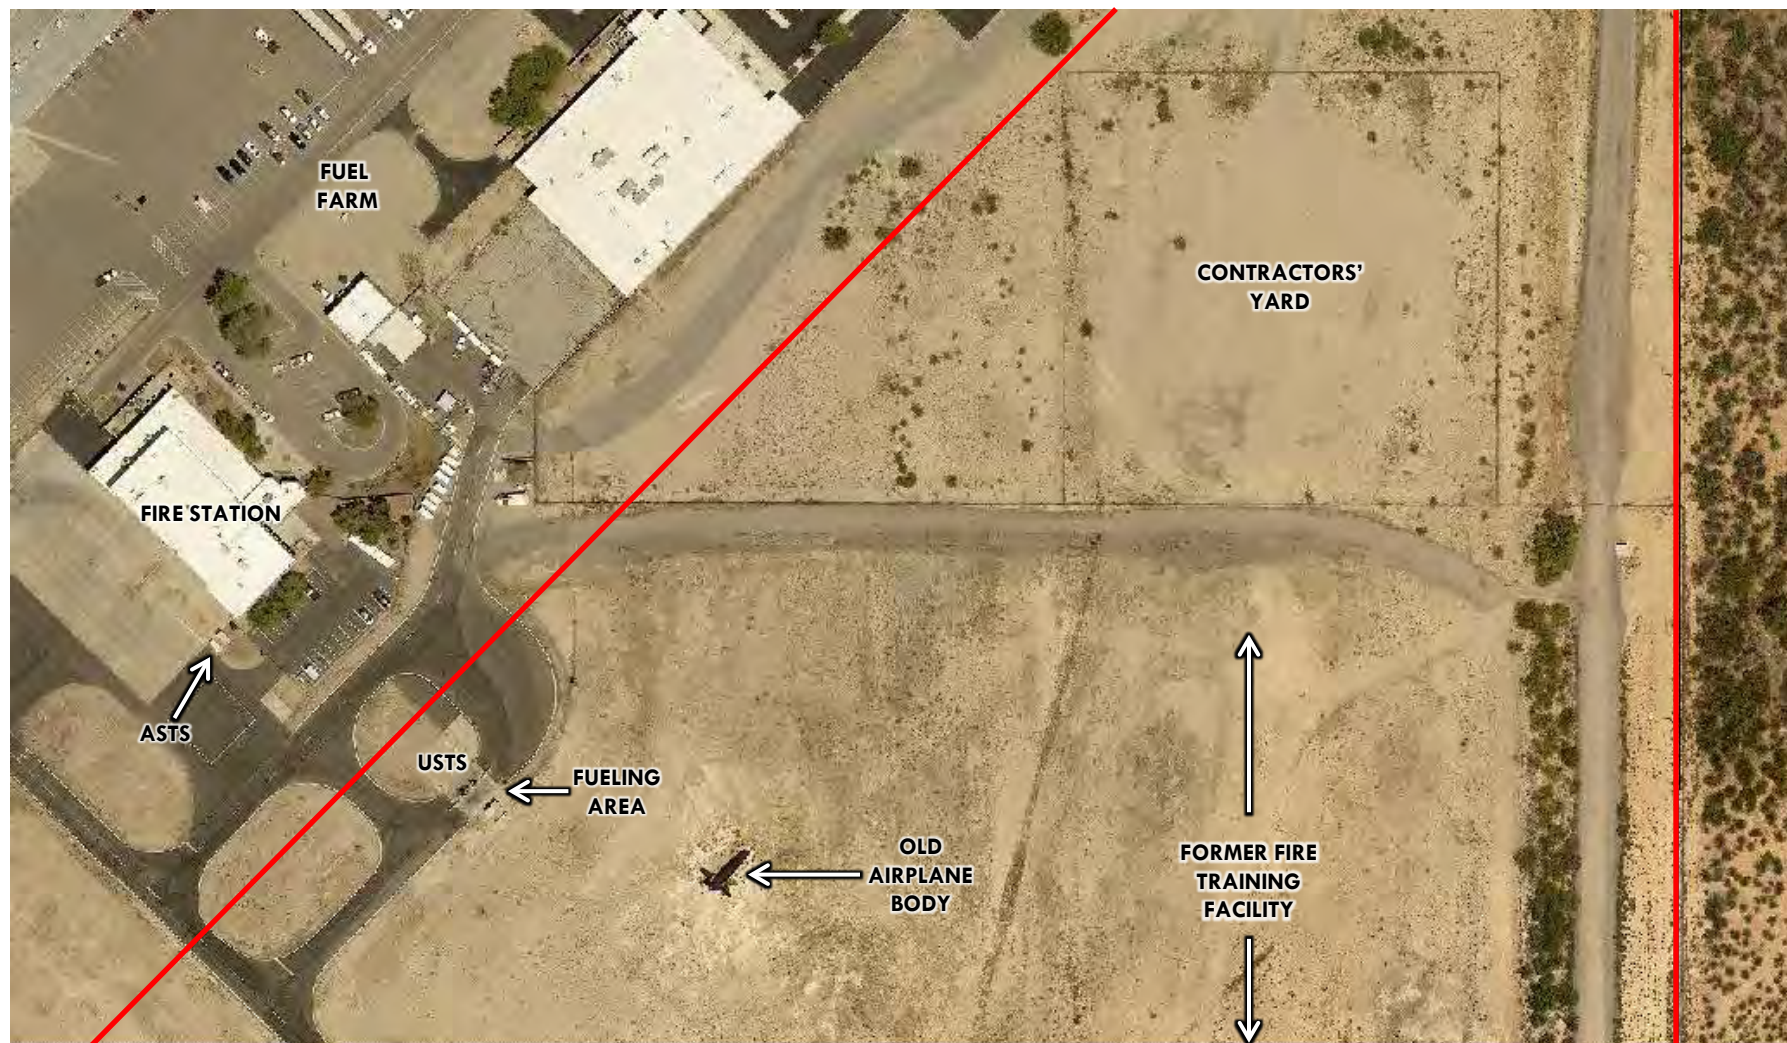
Figure 8A
Site Detail –Contractors' Yard
and Portion of Fire Training Area

- Known hydrocarbon contamination is present in the subsurface at the former fire training facility in the eastern portion of the Site. Because this area has reportedly been characterized and because hydrocarbons are not currently regulated in Arizona, this area is not considered a REC; however, if possible, project activities should avoid disturbing this area.

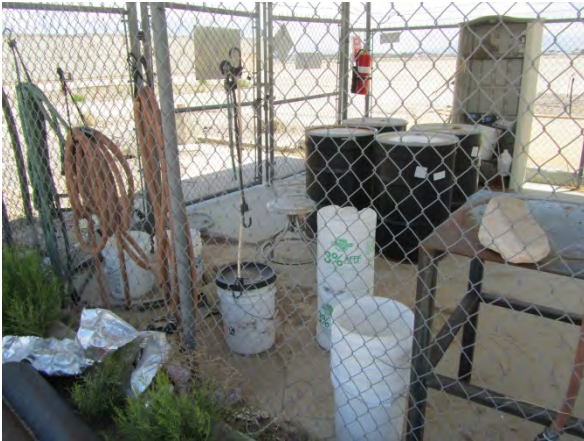
Photograph 49. Hazardous waste storage area. View to the northeast.

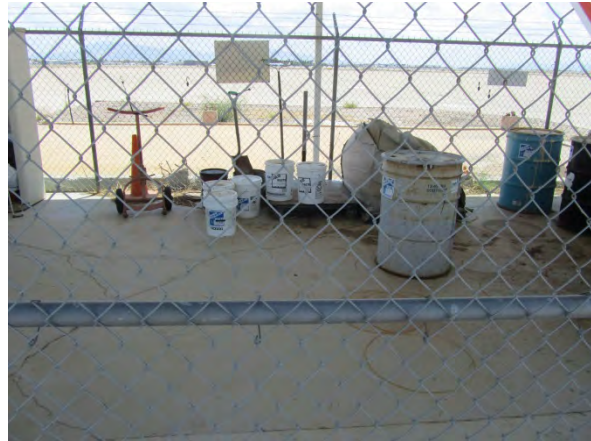
Photograph 50. Hazardous waste storage area. View to the east.
