Phase I Environmental Due Diligence Audit (EDDA)

Environmental Impact Statement for the Proposed Airfield Safety Enhancement Project and Land Transactions for the Tucson International Airport Tucson, Arizona

January 23, 2018
AAI Date: December 27, 2016
File No. 01216132.01

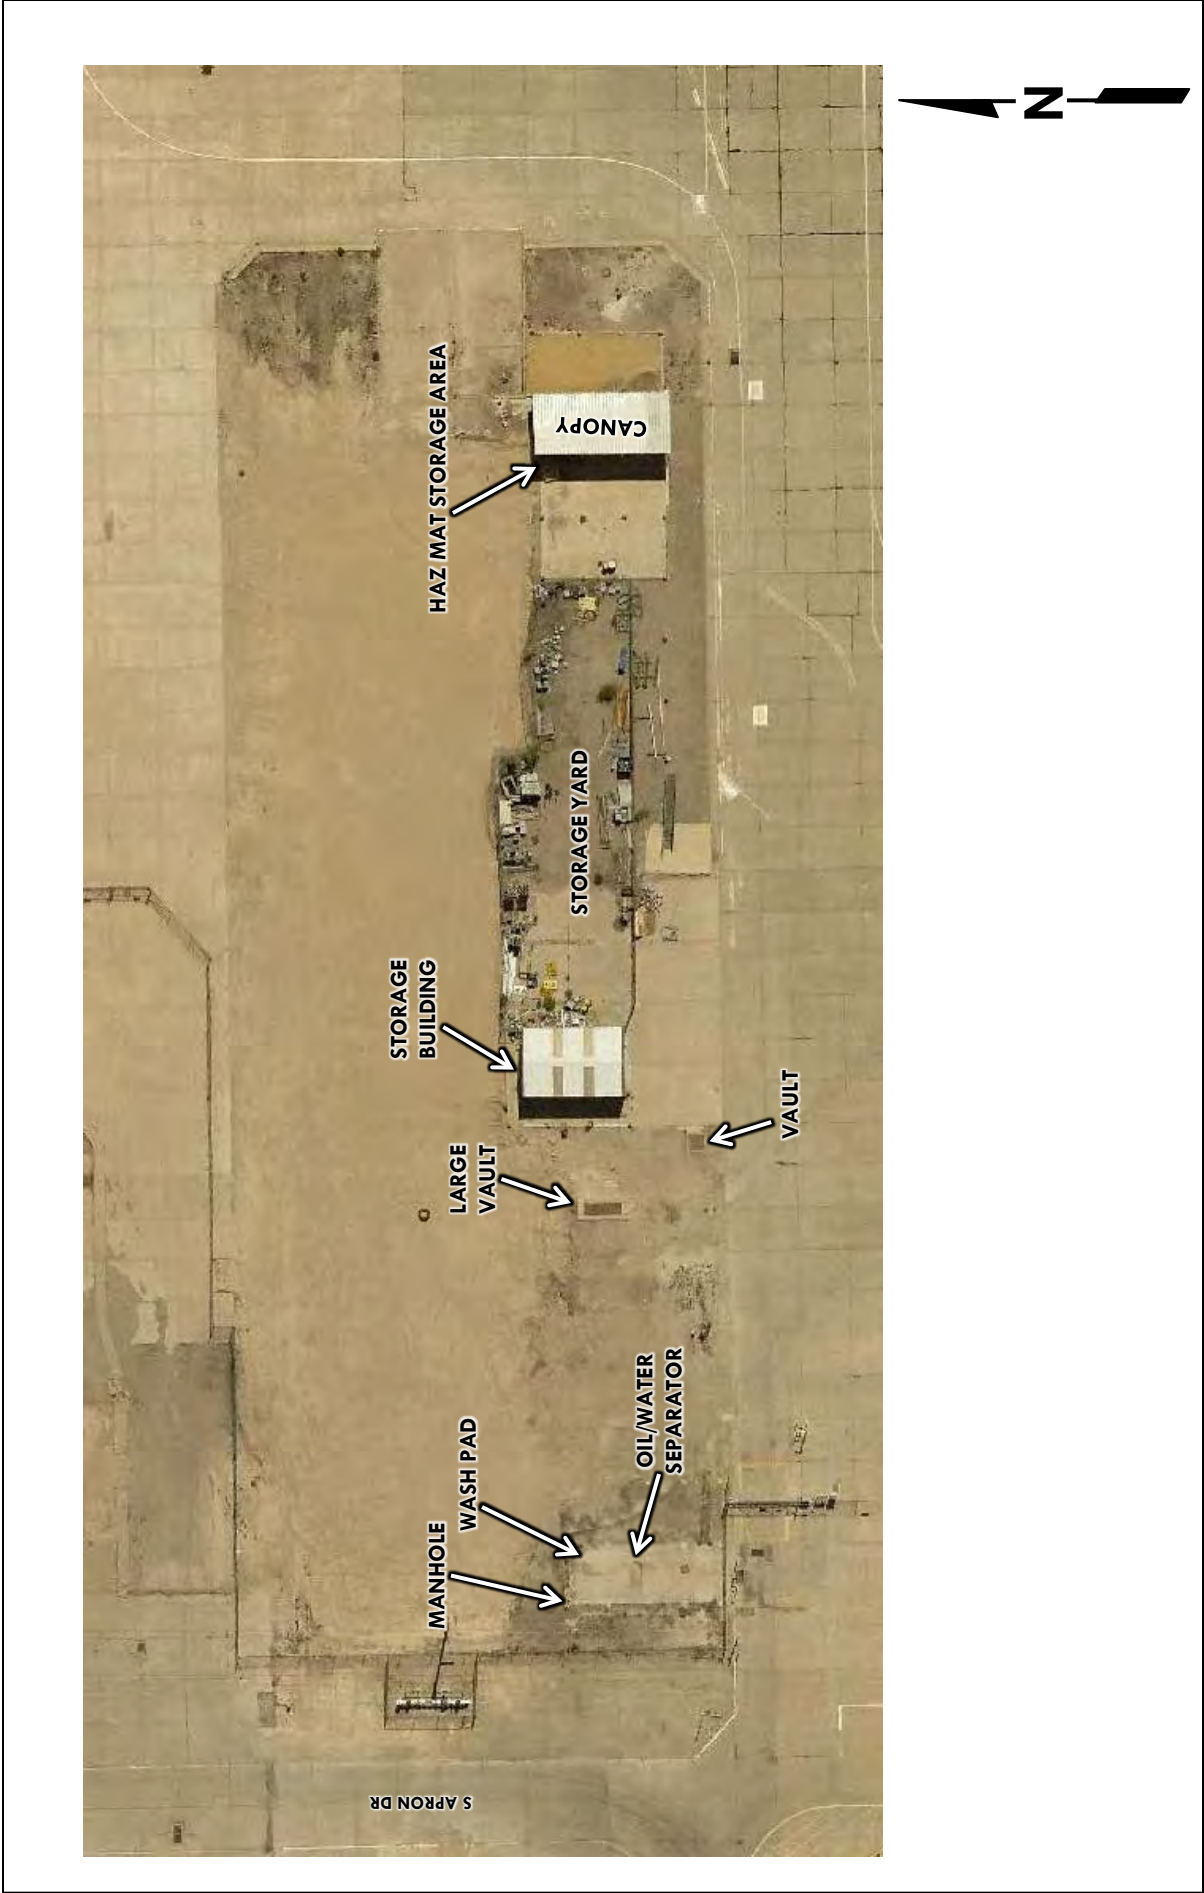
Figure 5C
Site Detail
Former Fire Station

- Also present in the western portion of the Site on South Apron Drive was a former fire station that was demolished. Two closed LUSTs were reported at the old fire station site. There could be residual concentrations of contaminants in soil associated with these releases, and it was unclear if there had also been investigations of the wash rack and separator; therefore, these features are considered a potential REC for the Site.

- Although the two LUST cases at the former fire station were closed, there could still be residual levels of contamination present. The former facility drain and oil-water separator should be removed and it should be determined whether the water drained

to the sewer or to a leach field. A soil sampling investigation should be performed to evaluate whether there were impacts to soil from the separator.

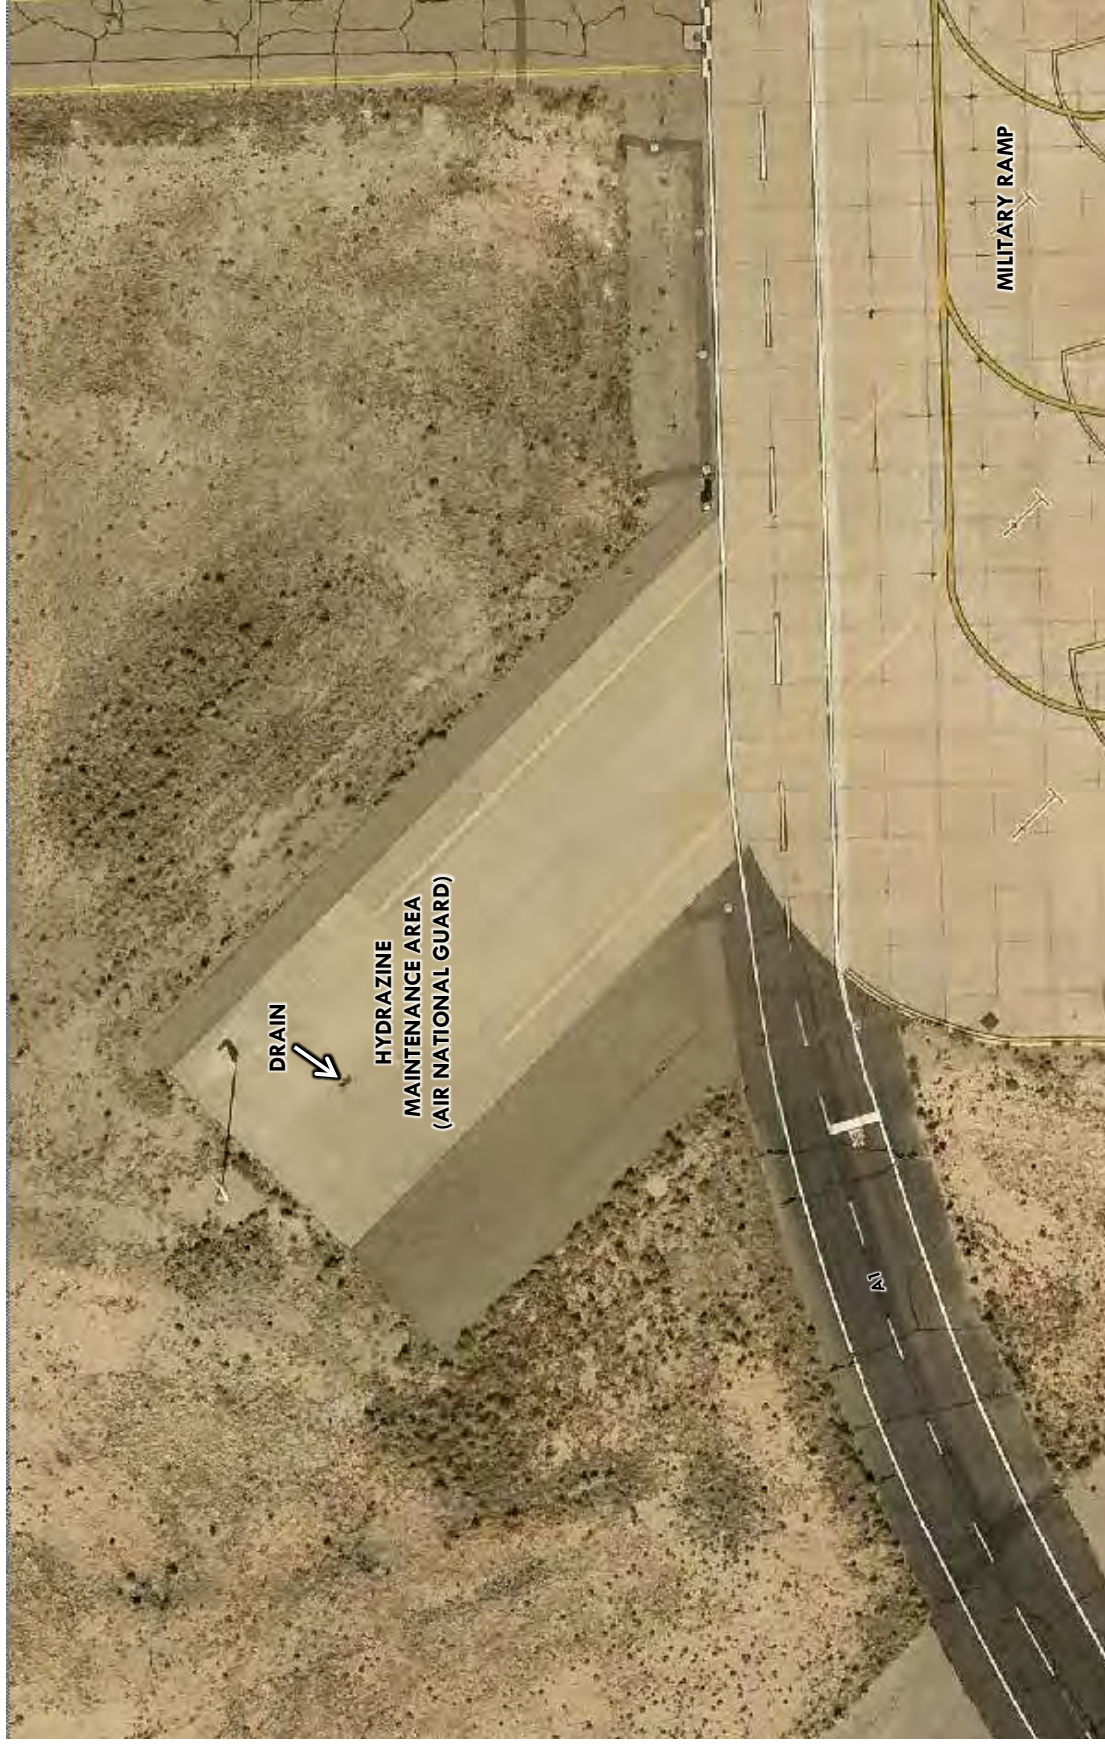
Figure 5E
Site Detail
Hydrazine Maintenance Area

<ul style="list-style-type: none"> An AANG hydrazine maintenance area consisting of a concrete pad with a drain is located in the northwest portion of the Site. Hydrazine is used in F-16 fighter jets to fuel their emergency power units. This maintenance area is reportedly only used when other maintenance areas are not available. It was believed that the drain goes to a holding tank. 	Yes
Valencia Road Properties, 1000 and 1070 East Valencia Road: The hangar and other structures at 1000 East Valencia Road appeared to be vacant; a prior occupant was Sun West Aviation. The hangar and other structures at 1070 East Valencia Road appeared occupied, possibly by Aerovation (engineering and development company). Four groundwater monitoring wells associated with the AANG are apparently located on these parcels. L&B and Tucson Airport Authority (TAA) stated that no inspection was required for these properties; therefore, they were not accessed.	Yes

- The fuel tanks and vaults associated with the four AANG arresting systems, the AANG hydrazine maintenance area, and the hazardous material storage area adjoining the former fire station should be investigated to determine whether the use and storage of fuel or chemicals in these areas has impacted Site soils.

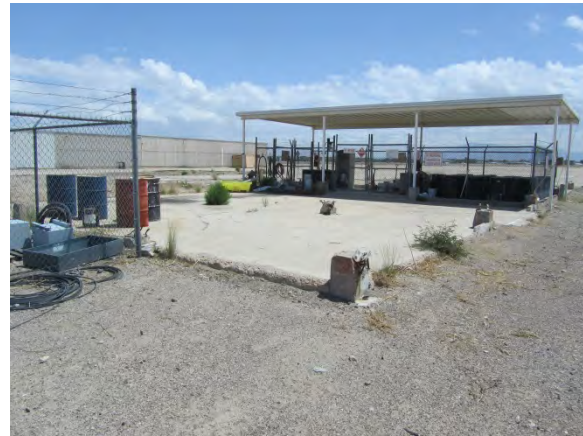
Photograph 45. Storage yard east of the storage building. View to the northwest.

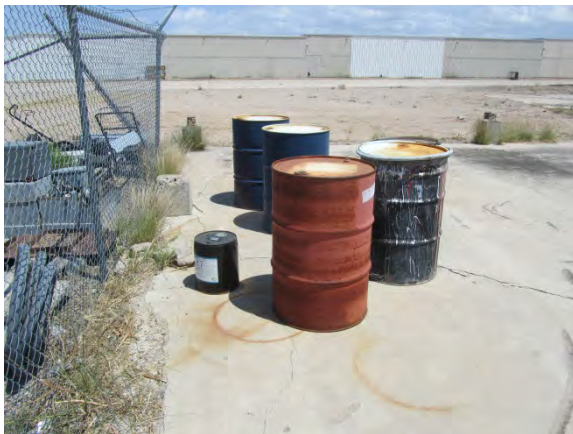
Photograph 46. Hazardous waste storage area east of the storage yard. View to the northeast.

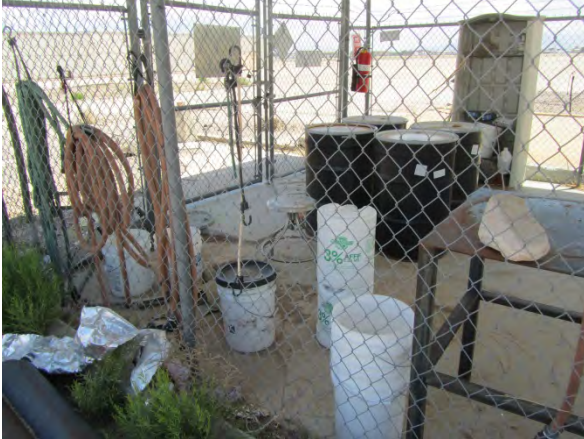
Photograph 48. Hazardous waste storage area. View to the northeast.

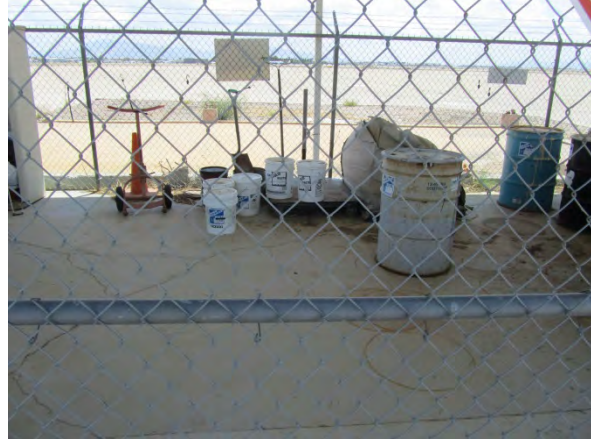
Photograph 49. Hazardous waste storage area. View to the northeast.

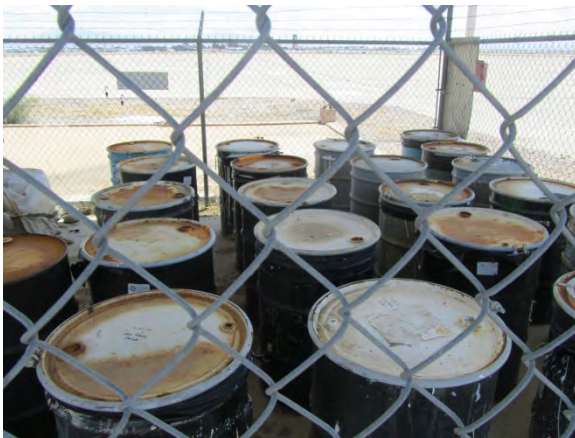
Photograph 50. Hazardous waste storage area. View to the east.

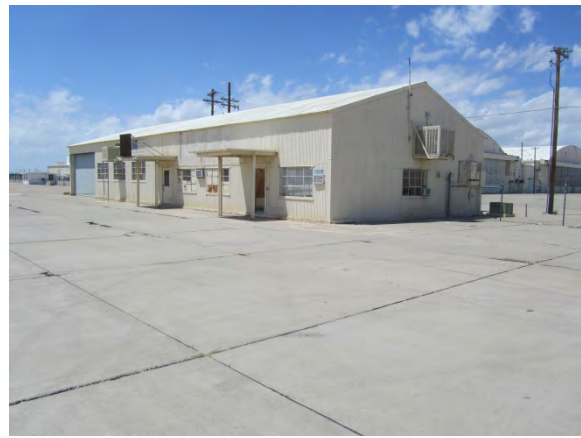
Photograph 51. Hazardous waste storage area. View to the east.
