# **APPENDIX A**

## **PUBLIC INVOLVEMENT**

**KENTON COUNTY AIRPORT BOARD  
NOTICE OF AVAILABILITY OF A DRAFT  
ENVIRONMENTAL ASSESSMENT (EA)**

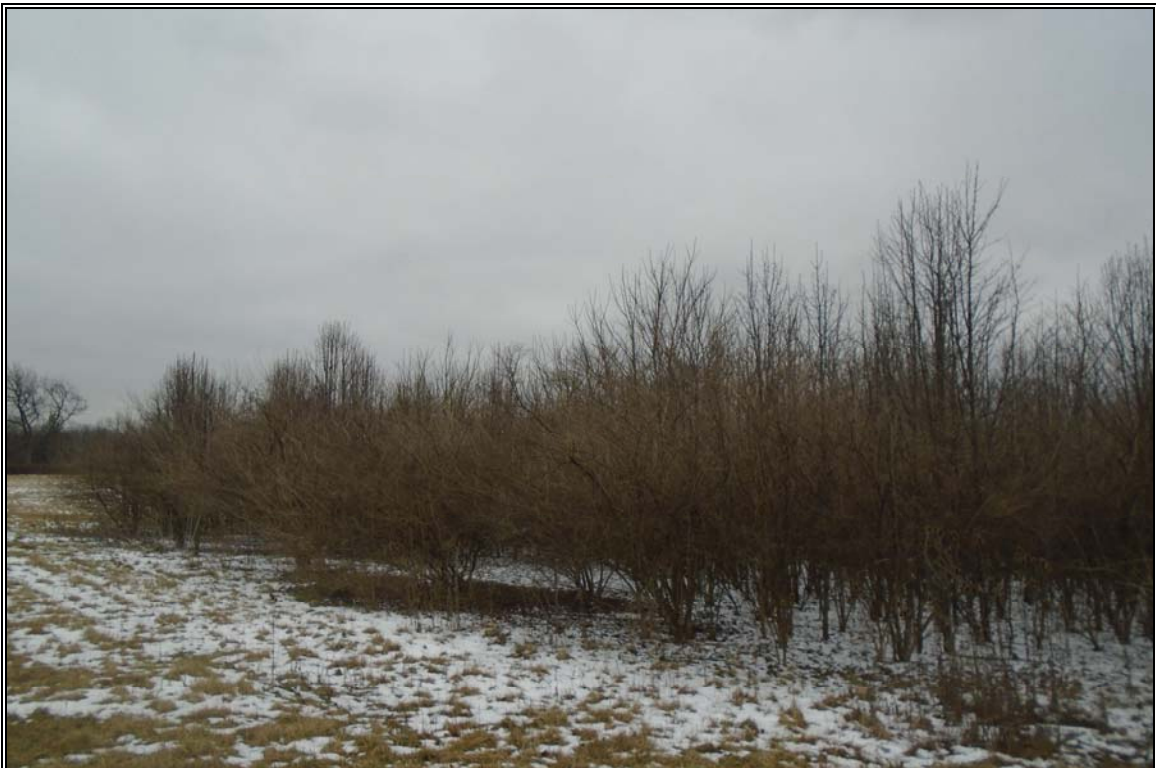
Photograph 4: View of scrub/shrub habitat located east of Wetland 2 and Ephemeral Stream 2. This habitat is not considered suitable bat habitat. February 17, 2016.

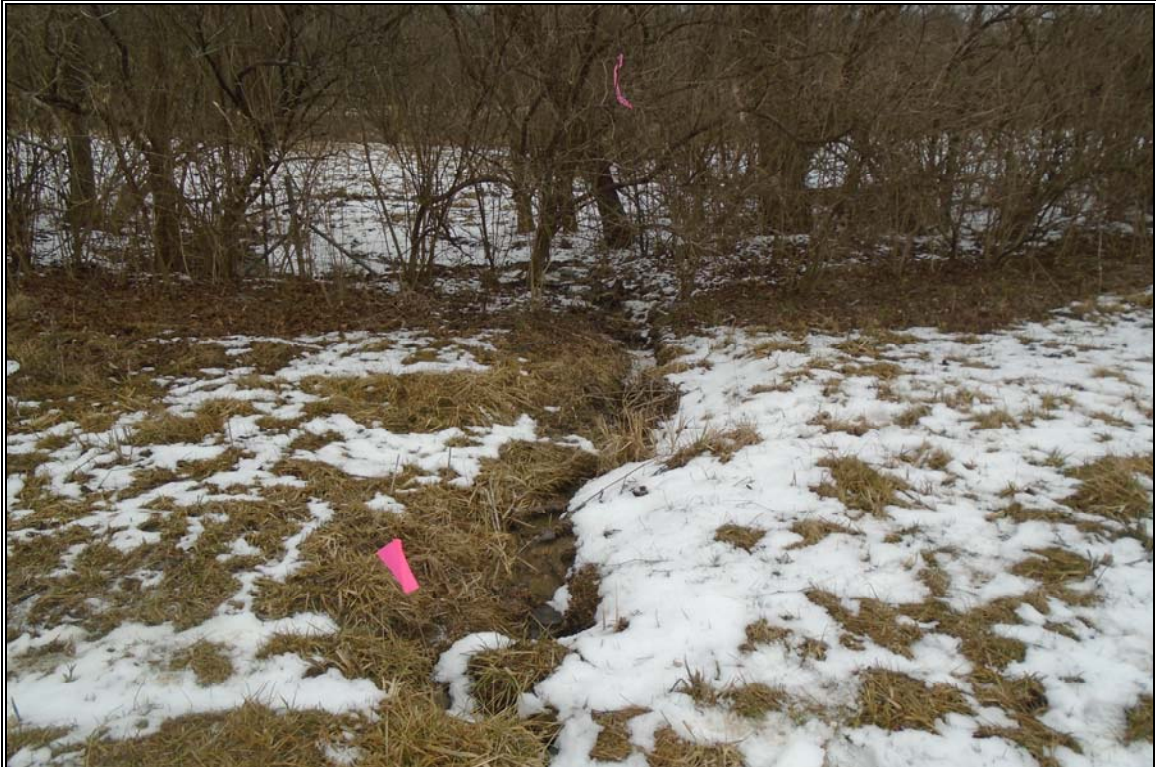
Photograph 5: View of Ephemeral Stream 1 which drains Wetland 1 and flows towards the Interstate 275 right-of-way. February 17, 2016.

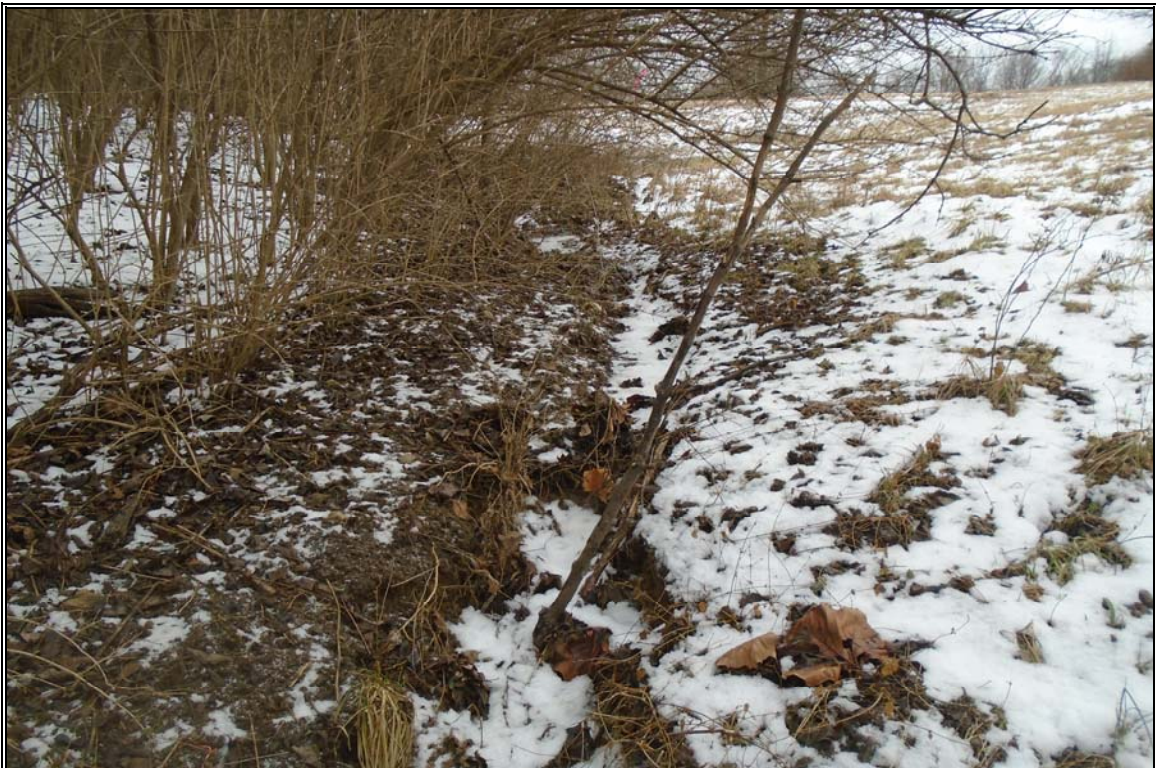
Photograph 6: View of the upstream portion of Ephemeral Stream 2, located in the central portion of the site. February 17, 2016.

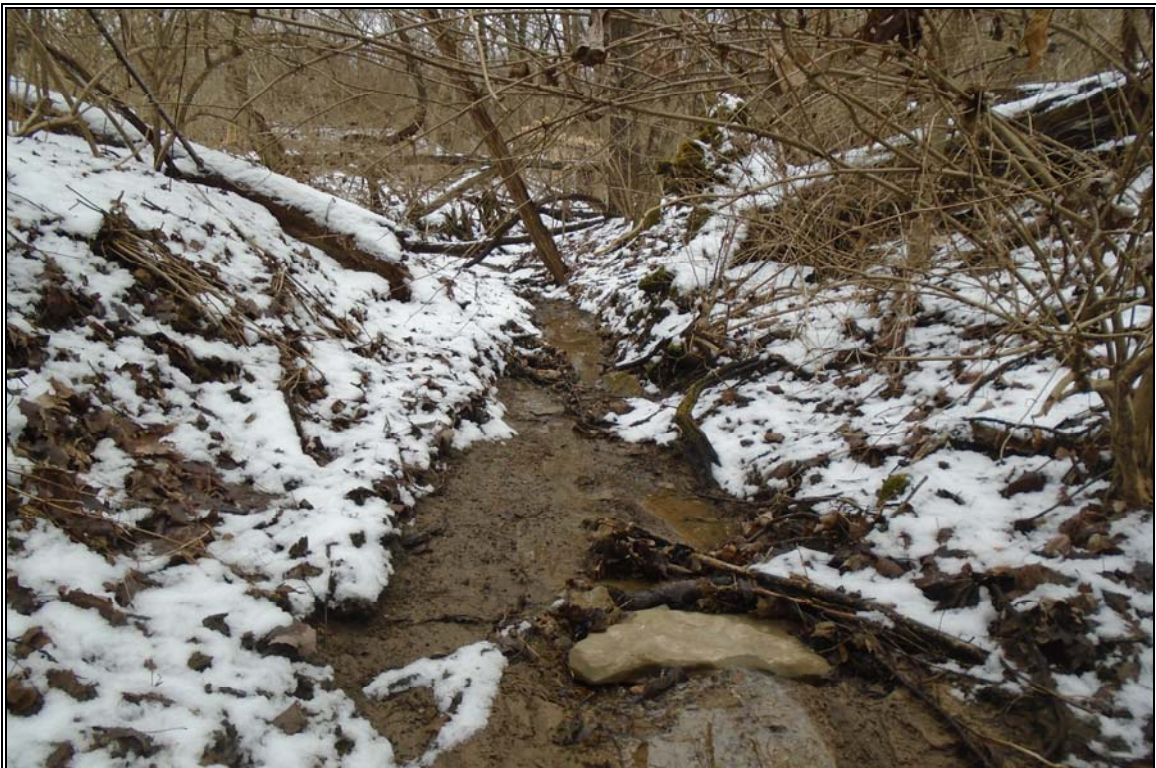
Photograph 8: View of Ephemeral Stream 3, located in the western portion of the site. February 17, 2016.

Ephemeral Stream 3 is a small stream that is located in the western portion of the site. Ephemeral Stream 3 flows for approximately 530 linear feet (0.024 acre) before it exits the property to the northwest. The stream is one to three feet wide, with bank heights ranging from six inches to 3 feet. The substrate is composed entirely of silt and gravel. During the site visit, up to two inches of water was observed in the channel. Ephemeral Stream 3 is considered to be jurisdictional due to its direct connection to downstream waters.

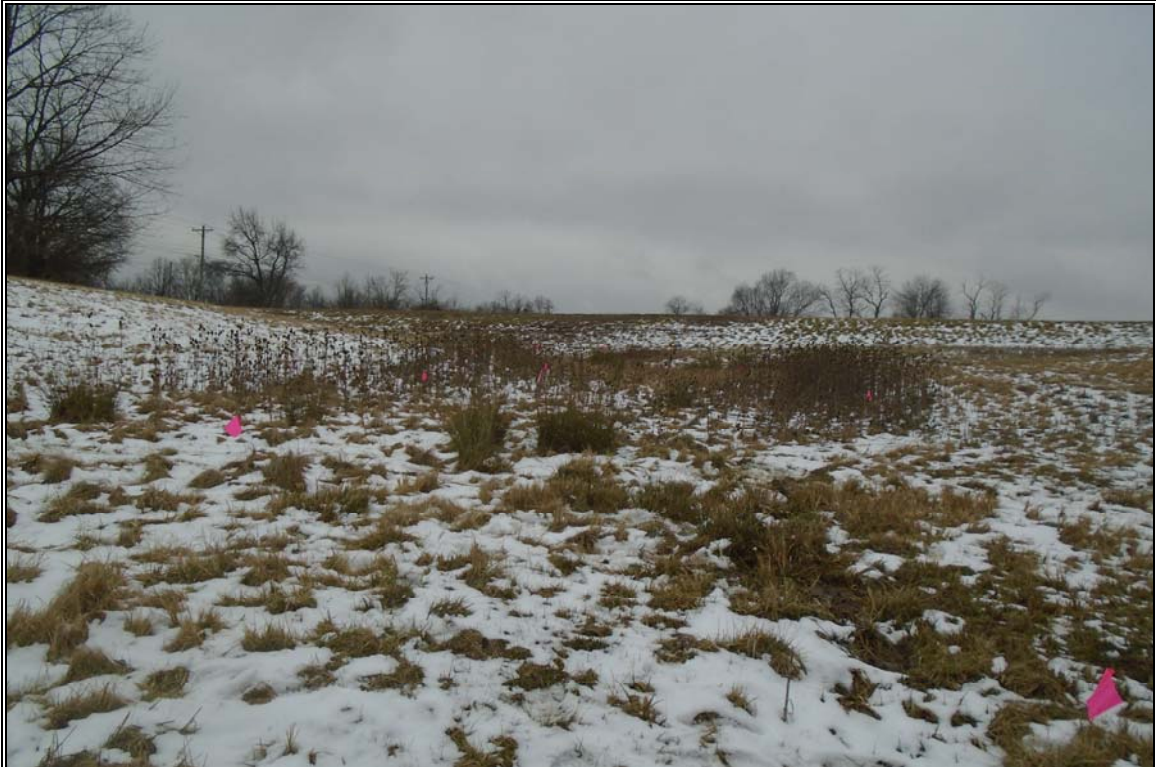
Photograph 9: Wetland 1 is an emergent wetland located south of Ephemeral Stream 1. February 17, 2016.

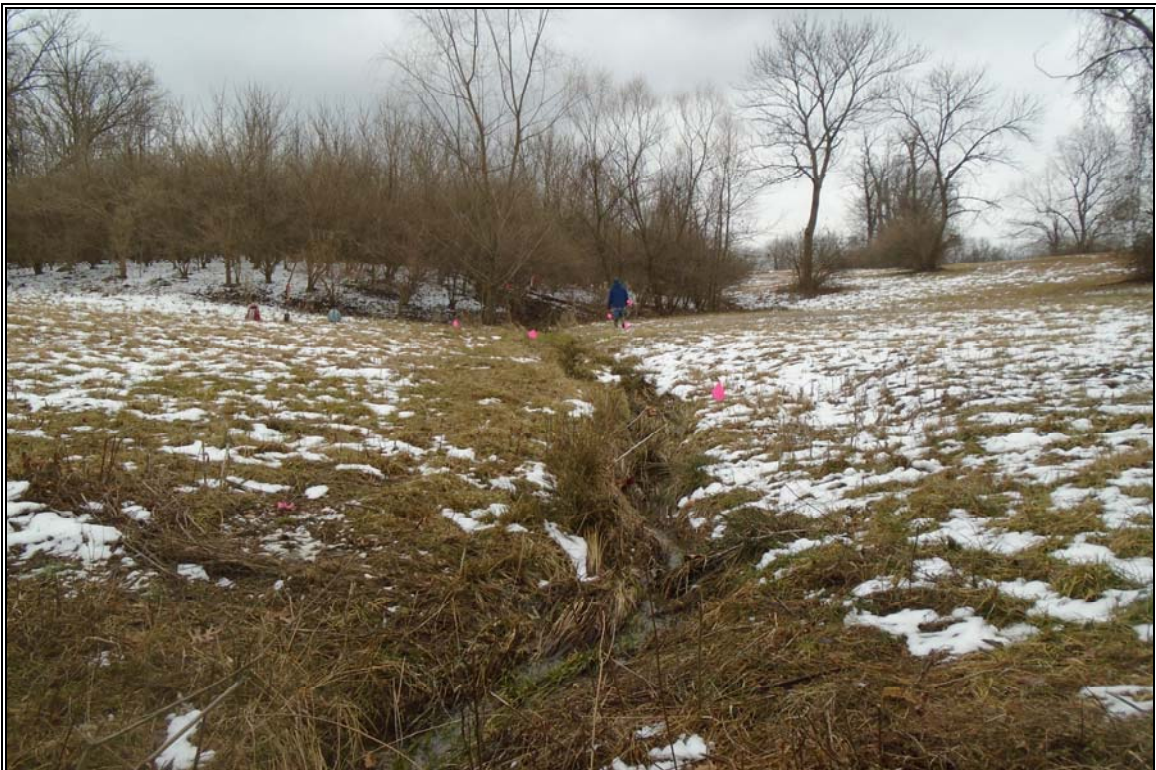
Photograph 10: View of the emergent wetland portion of Wetland 2. February 17, 2016.

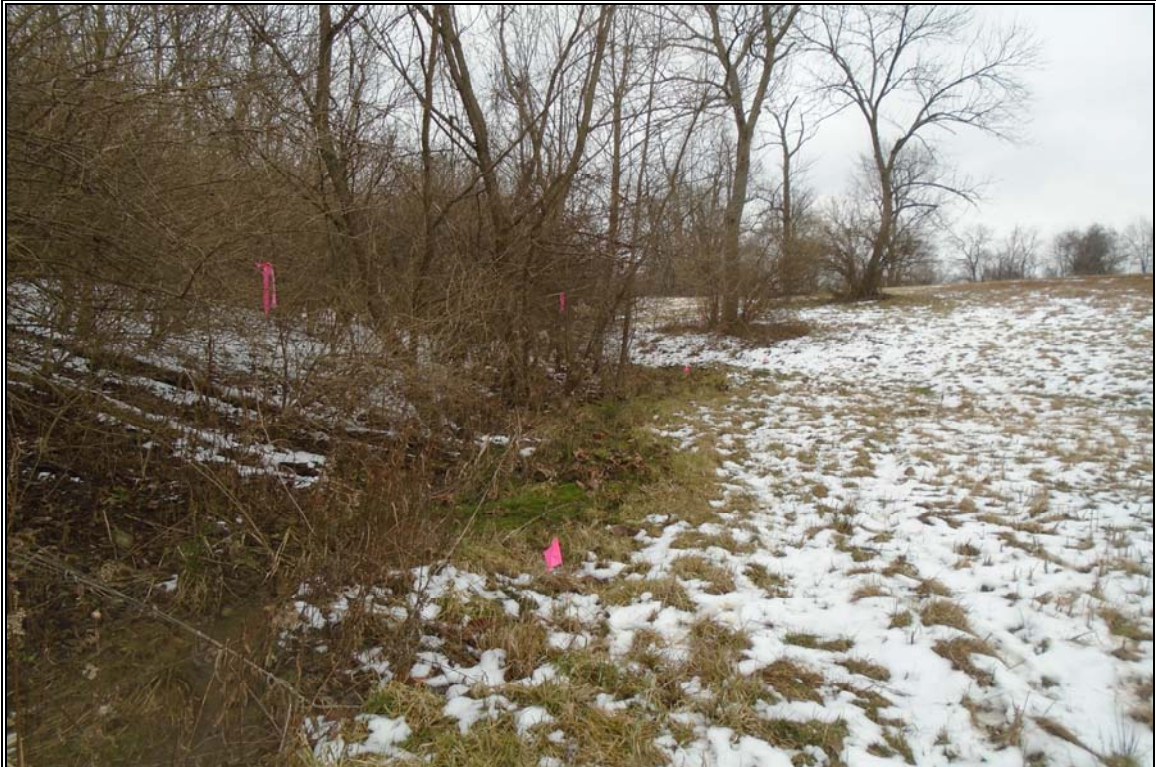
Photograph 11: View of the scrub/shrub portion of Wetland 2. February 17, 2016.

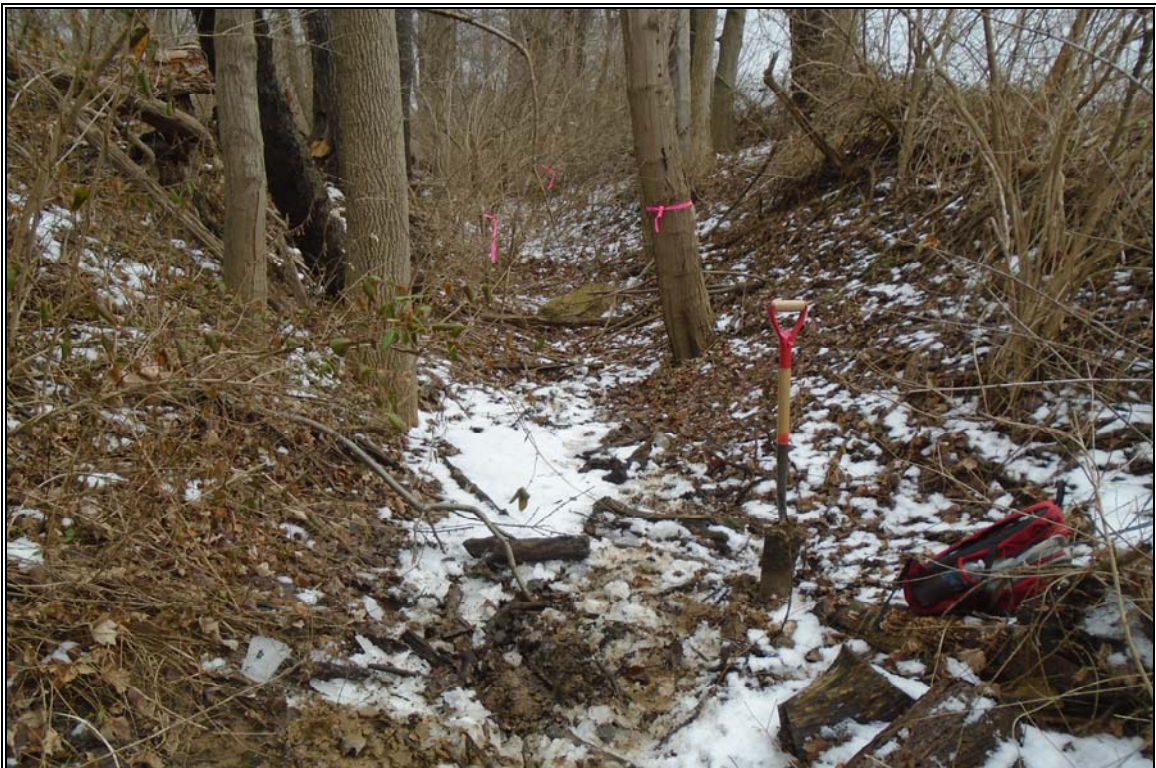
Photograph 12: Wetland 3 is a small forested wetland located near the northwest corner of the site. February 17, 2016.

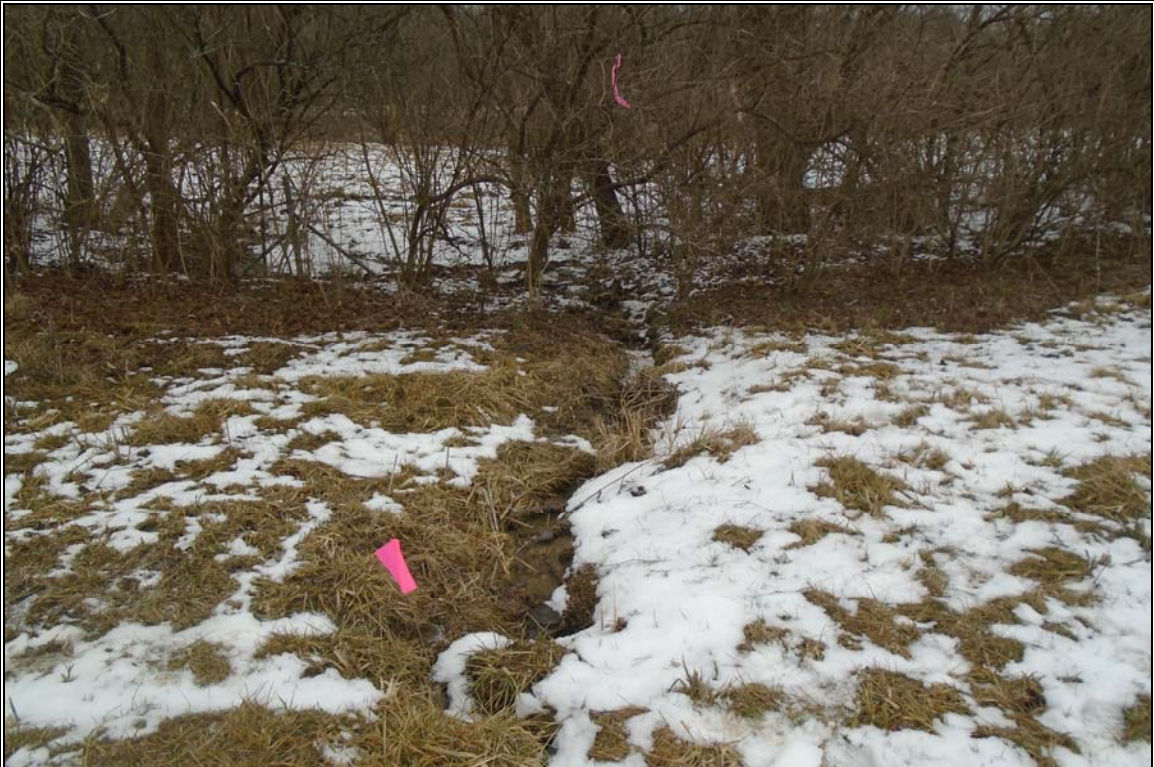
Photograph 5: View of Ephemeral Stream 1 which drains Wetland 1 and flows towards the Interstate 275 right-of-way. February 17, 2016.

Ephemeral Stream 1 is located near the eastern corner of the site and acts as a drainage for Wetland 1. Ephemeral Stream 1 measures 25 linear feet (0.0004 acre), is six to twelve inches wide, with bank heights of six inches. The substrate is primarily composed of silt and gravel. Up to half an inch of water was observed in the channel during the delineation. Ephemeral Stream 1 is considered jurisdictional due to its connection to the offsite interstate right-of-way drainage system.

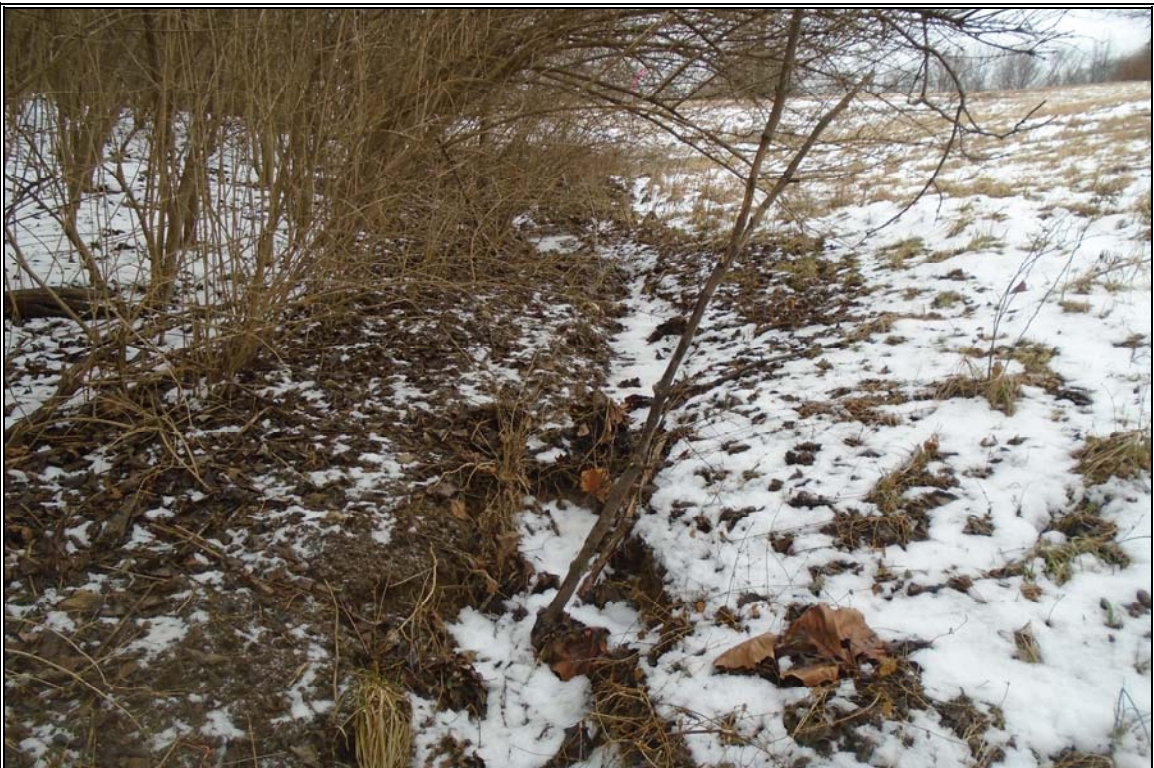
Photograph 6: View of the upstream portion of Ephemeral Stream 2, located in the central portion of the site. February 17, 2016.

One to two inches of water was observed in low-lying areas within the channel from a recent rainfall and snow melt during the field assessment. Ephemeral Stream 2 is considered to be jurisdictional due to its direct connection to downstream waters.

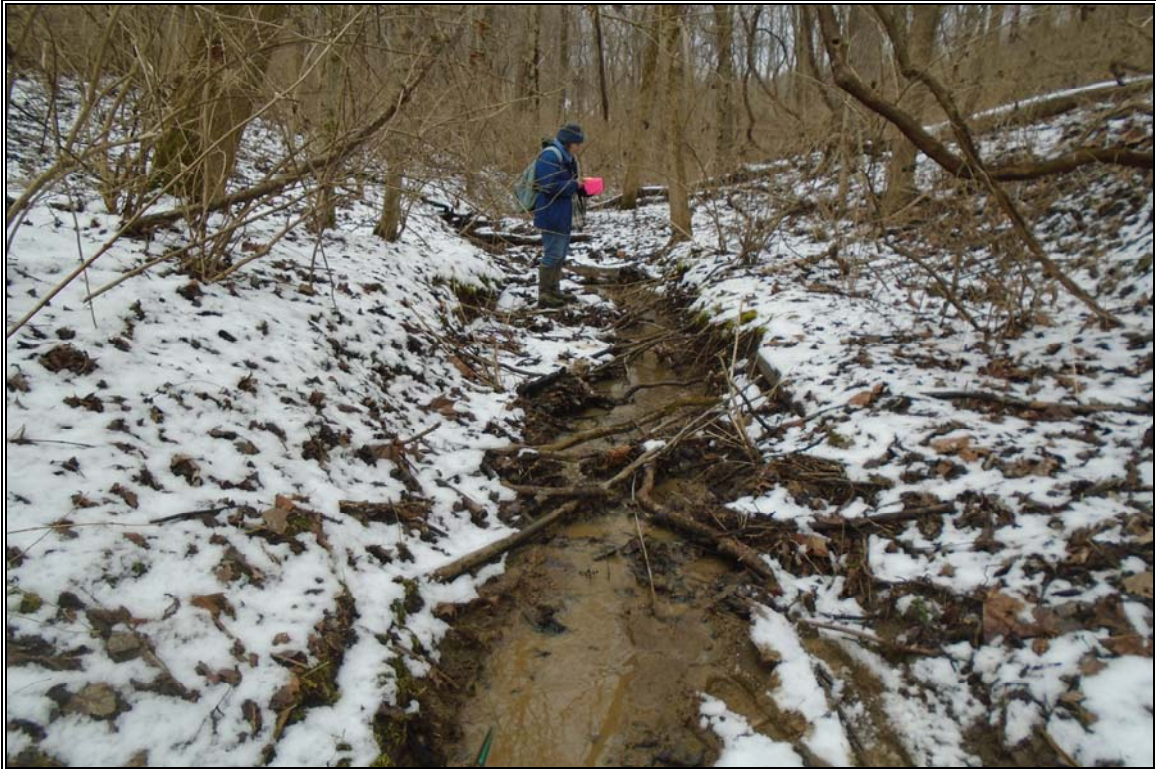
Photograph 7: View of the downstream portion of Ephemeral Stream 2. February 17, 2016.

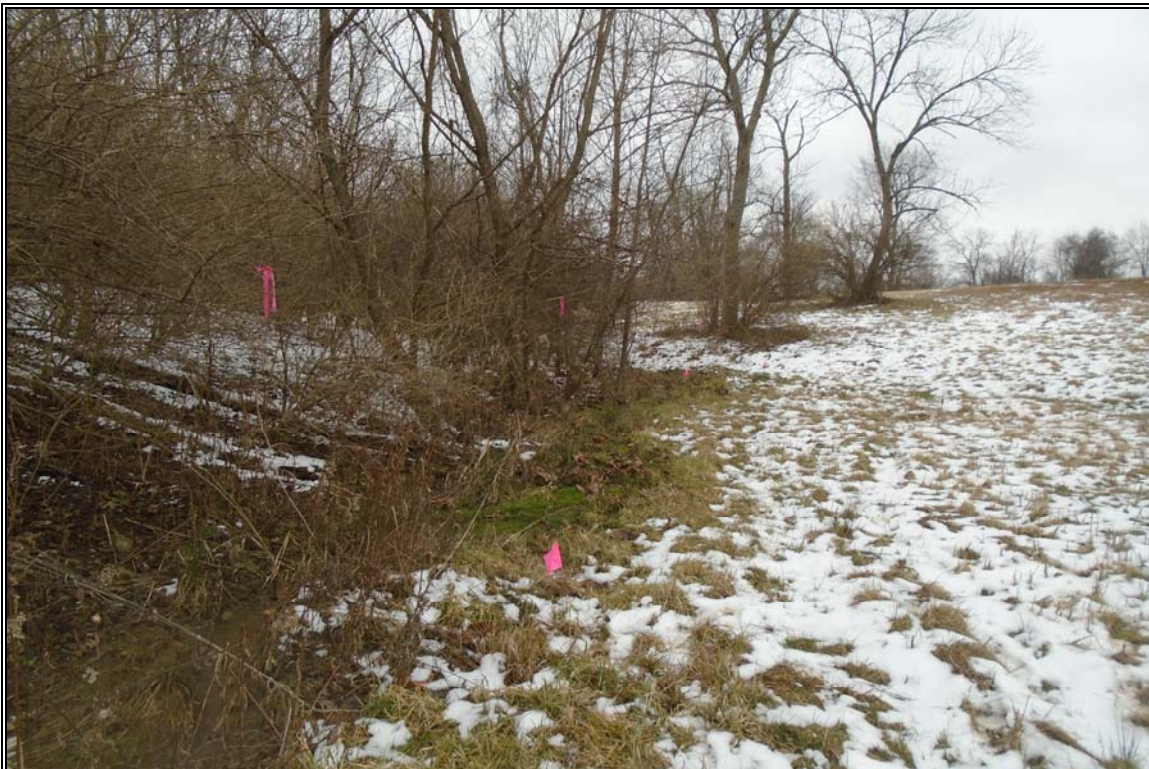
Photograph 11: View of the scrub/shrub portion of Wetland 2. February 17, 2016.

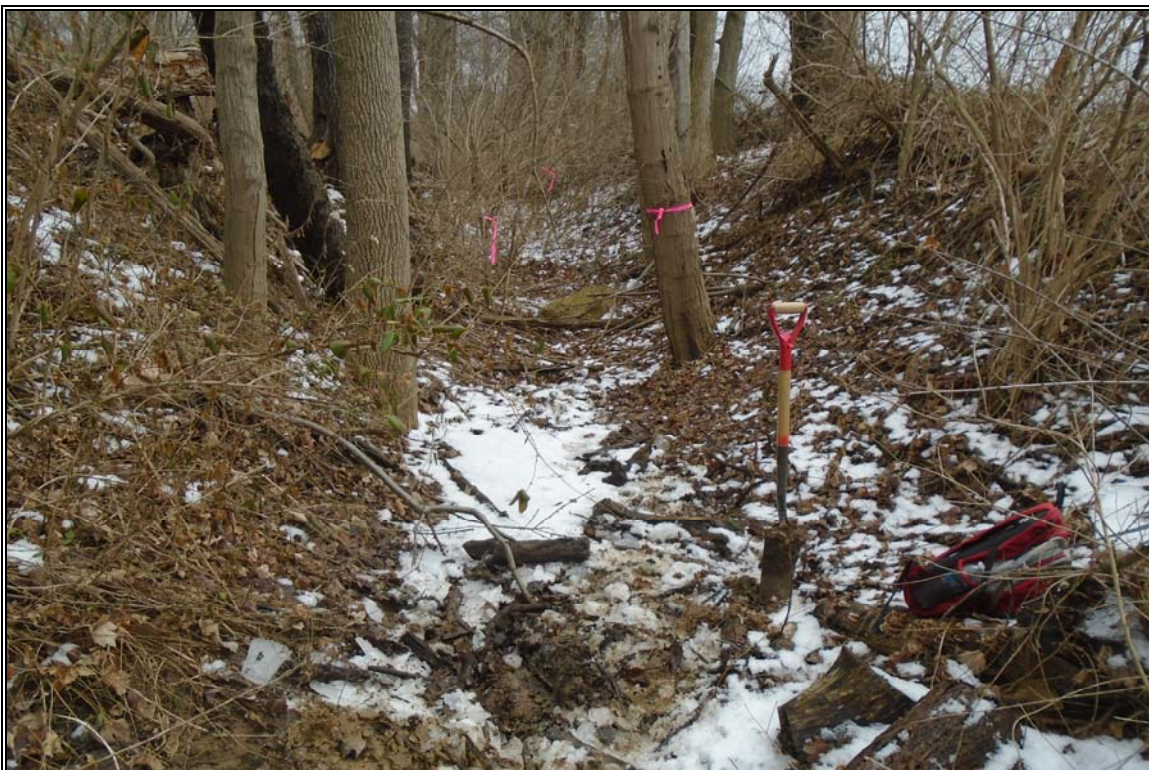
Photograph 12: Wetland 3 is a small forested wetland located near the northwest corner of the site. February 17, 2016.

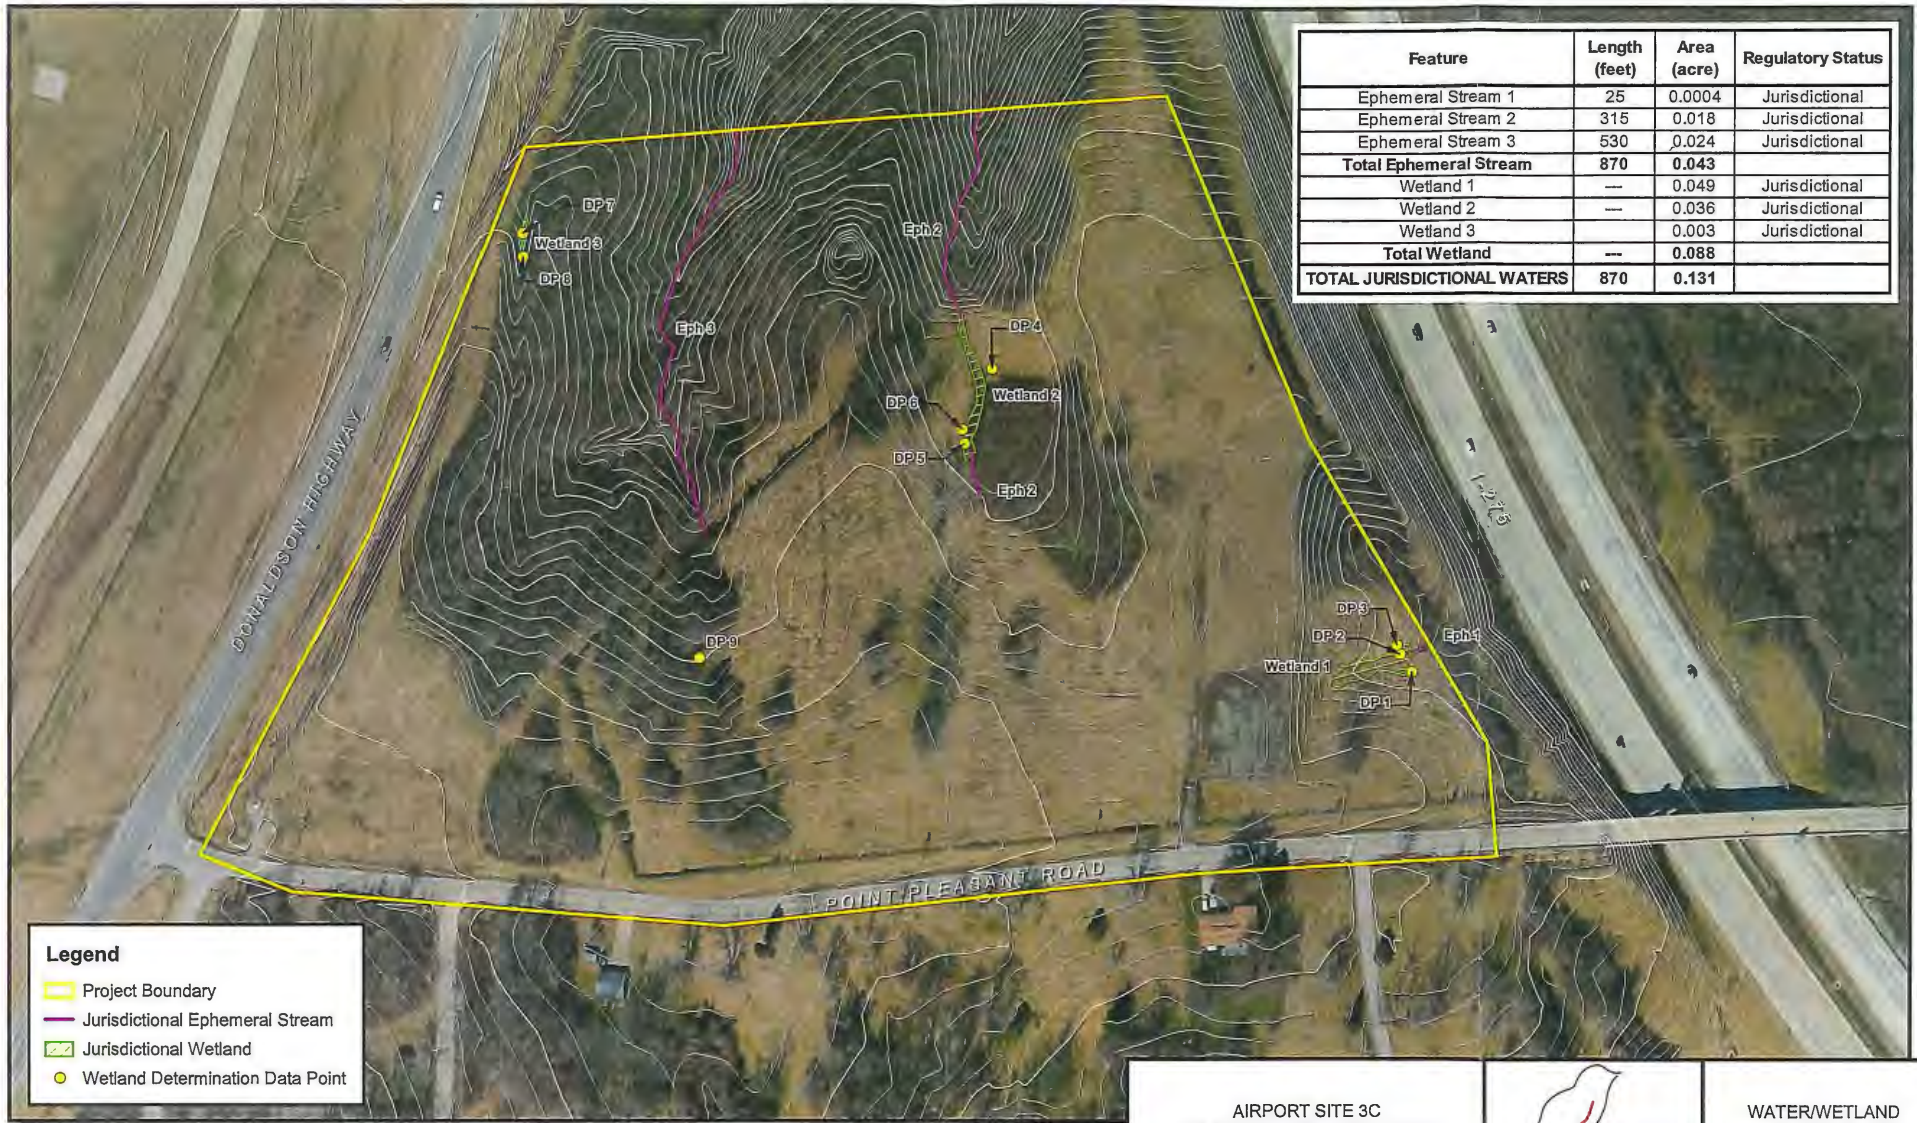
FIGURE 2

- ▭ Project Boundary
- Jurisdictional Ephemeral Stream
- ▨ Jurisdictional Wetland
- Wetland Determination Data Point

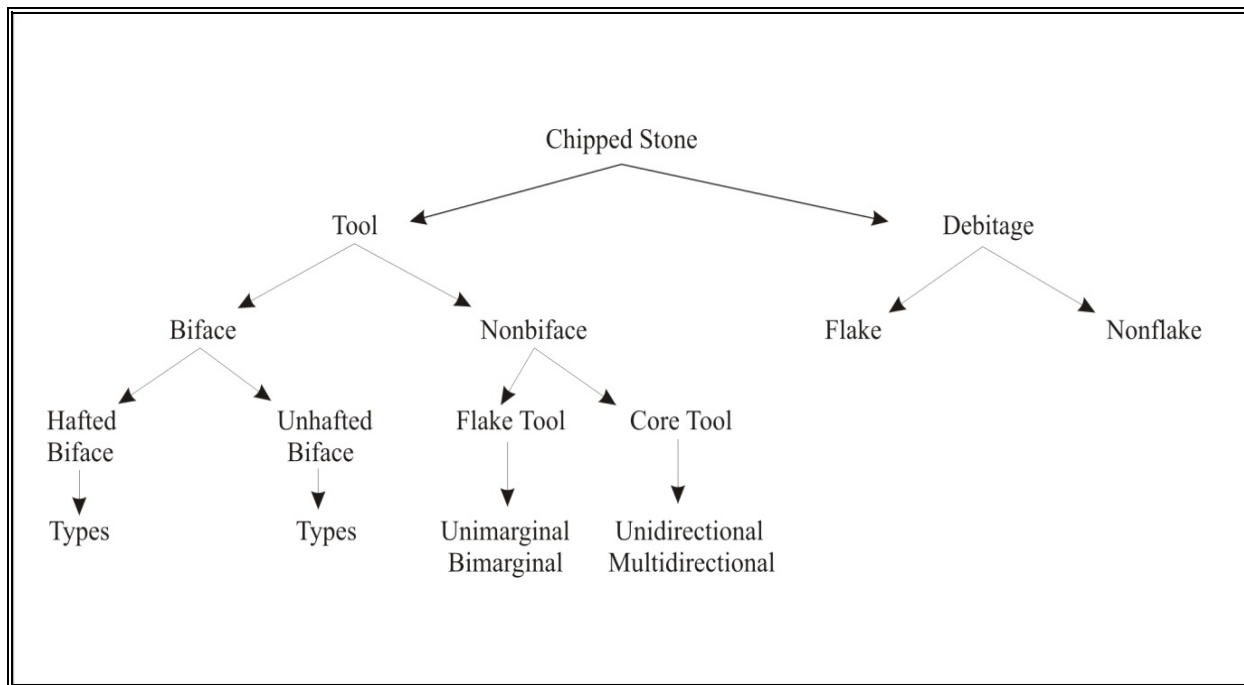
Morphological Typology of Chipped Stone Tools and Debitage (After Andrefsky 2005: Figure 4.7).

Identification of lithic types within the chipped stone assemblage was accomplished through the use of a standardized morphological typology as presented in Andrefsky (2005). This typology divides the lithic assemblage into categories that are discussed below. The typology was based upon the morphology of chipped stone artifacts and is not intended to suggest function nor chronology. These categories were based on the presence or absence of particular attributes on a specimen.

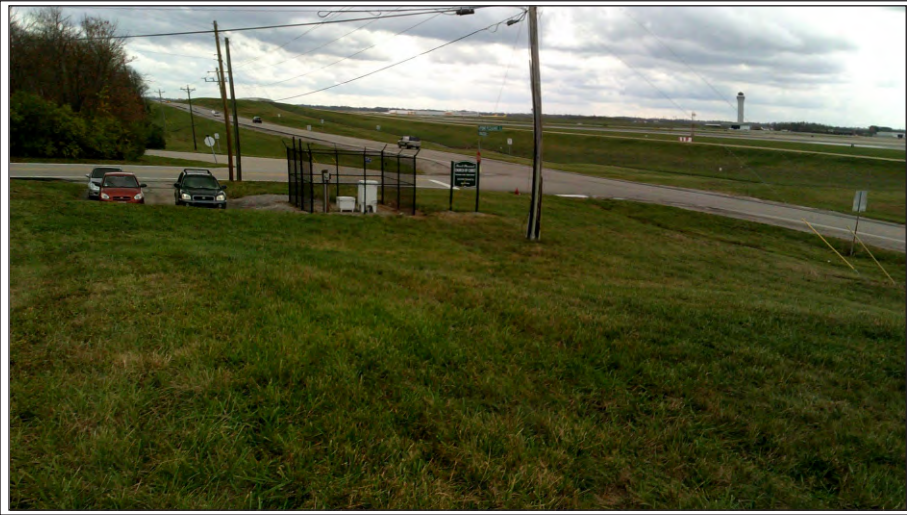
Photo 8. View of Southwestern Disturbed Area, Facing South.

Photos 8 and 9 are views of the southwestern portion of the project area that were bulldozed, at the intersection of KY-238 and Point Pleasant Road. The shovel tests in this area had a top strata that

was 10YR 6/3, 10YR 5/2, 10YR 3/6, 10YR 5/4, or 10YR 6/4 silty clay, sometimes mixed with gravel fill, and extended between 6 and 35 centimeters below the surface (cmbs). Sometimes there was no second strata. Those that did have a second strata included 10YR 5/6, 10YR 6/4, 10YR 6/6, and 10YR 5/8 clay to silty clay, to sandy clay, and often more than one soil was included and mixed together, along with human introduced gravel. Figure 17 shows an example of a disturbed soil profile from this area. This area is the former location of structures S#4, S#11, S#12, and S#16. Structure S#10 is outside of the project area to the west of this section within the ROW of KY-236.

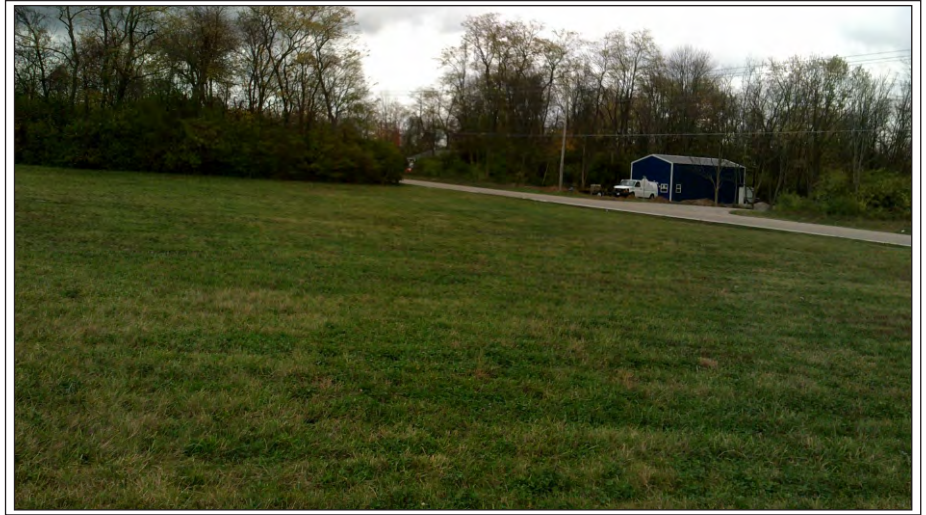
Photo 9. View of Southwestern Disturbed Area, Facing East by Northeast.

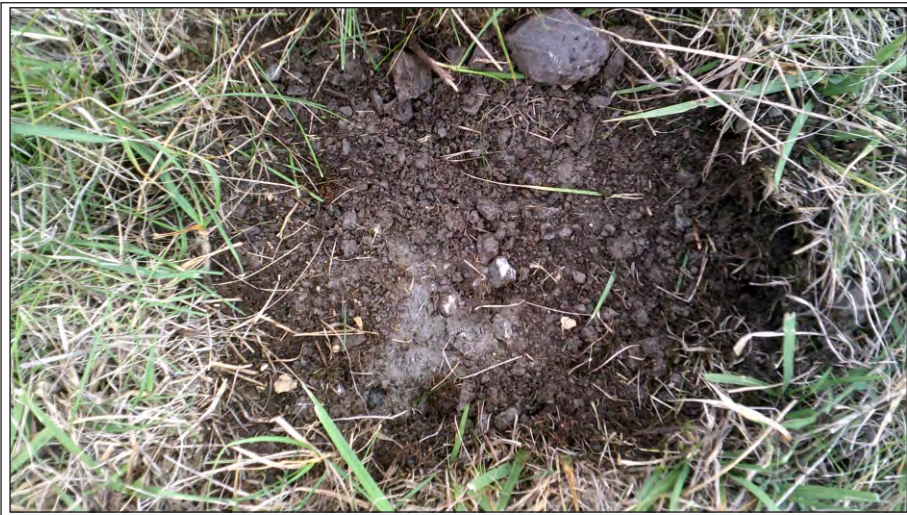
Photo 10. Disturbed Shovel Test in Southeastern Disturbed Area.

Photo 10 shows a disturbed shovel test that was excavated within this section of the project area. Photos 11 and 12 show the project area within this portion of the survey area. Some excavated and disturbed shovel tests within this area were entirely gravel fill. Others exhibited only one strata of 10YR 2/2, 10YR 3/2, 10YR 3/3, 10YR 4/4, and 10YR 4/6 silty clay loam that was mixed with human introduced gravel fill. This strata extended between 4 and 35 cmbs. In some shovel tests a second strata of 10YR 5/4, 10YR 5/6, 10YR 6/4, and/or 10YR 6/6 silty clay was present, frequently mixed. Figure 17 shows an example of a disturbed soil profile from this area. This area is the former location of structures S#2, S#17, and S#24. Structures S#5 and S#9 are outside the project area to the east of this section within I-275 and the ROW of I-275.

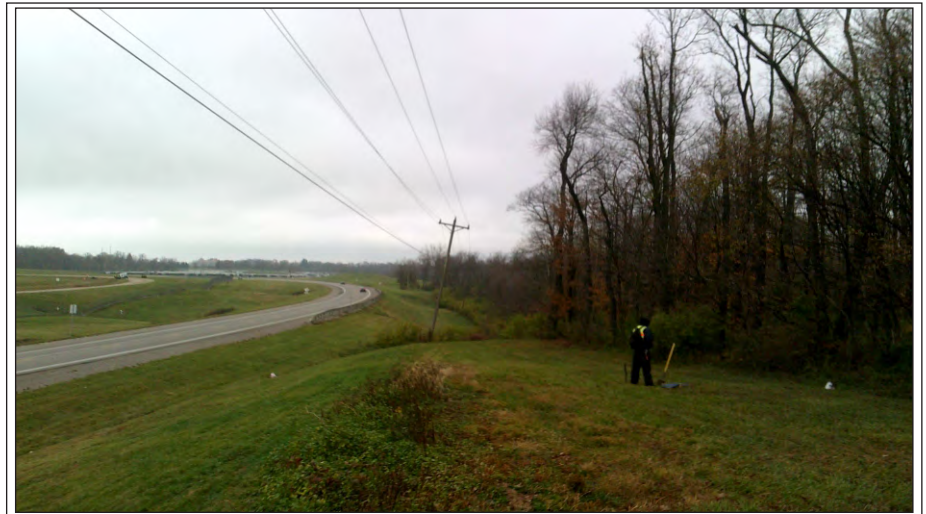
Photo 11. View of Southeastern Disturbed Area Along I-275, Facing South.

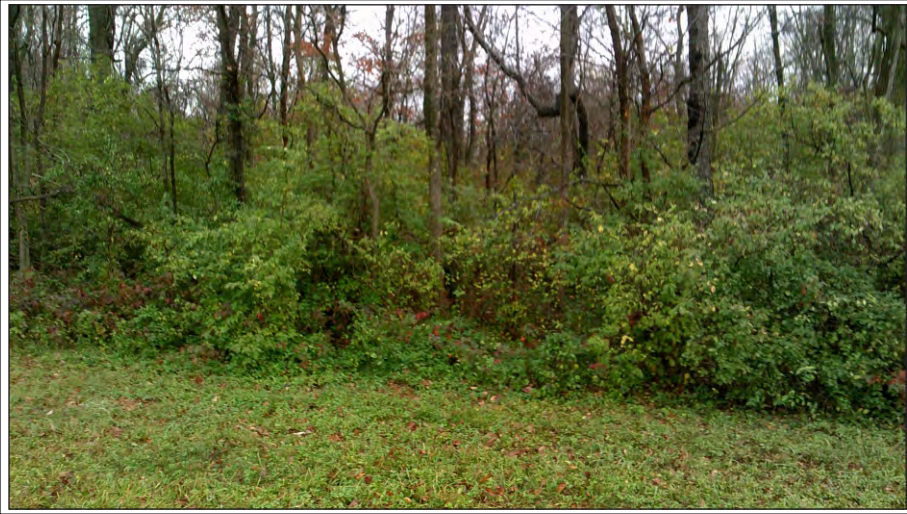
Photo 12. View of Southeastern Disturbed Area, Facing West.

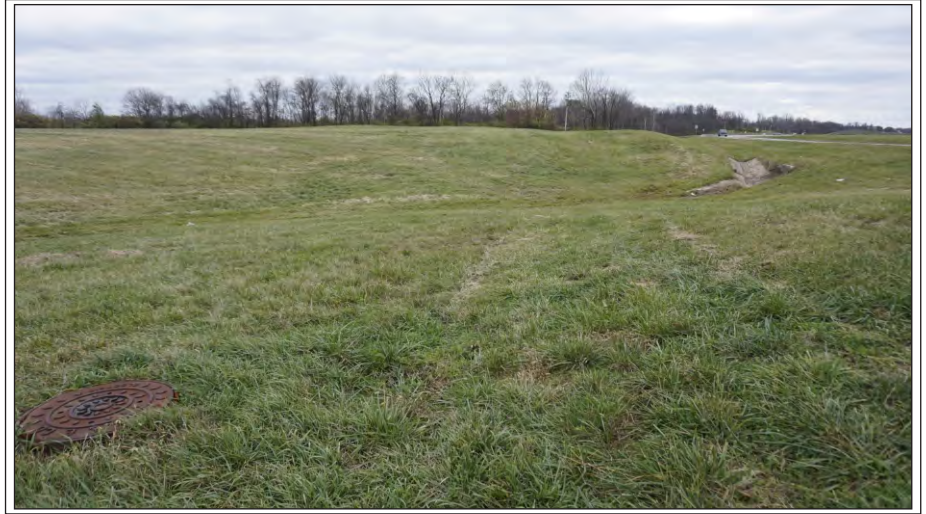
Photo 13. View of Central Disturbed Area, Facing Southeast.

Photo 13 shows the project area within this portion of the survey area. All of the disturbed shovel tests in this area exhibited only one strata of soil. This was fill from razing and filling activities, and the shovel tests occasional terminated in gravel. The soils in this area were a 10YR 4/4, 10YR 4/6, 10YR 3/6, 10YR 5/6, or 10YR 6/6 silty clay loam excavated between 10 and 35 cmbs. Figure 17 shows an example of a disturbed soil profile from this area. This area is the former location of structures S#1, S#22, and S#23. Structure S#19 is outside this portion of the project area to the west, within KY-236.

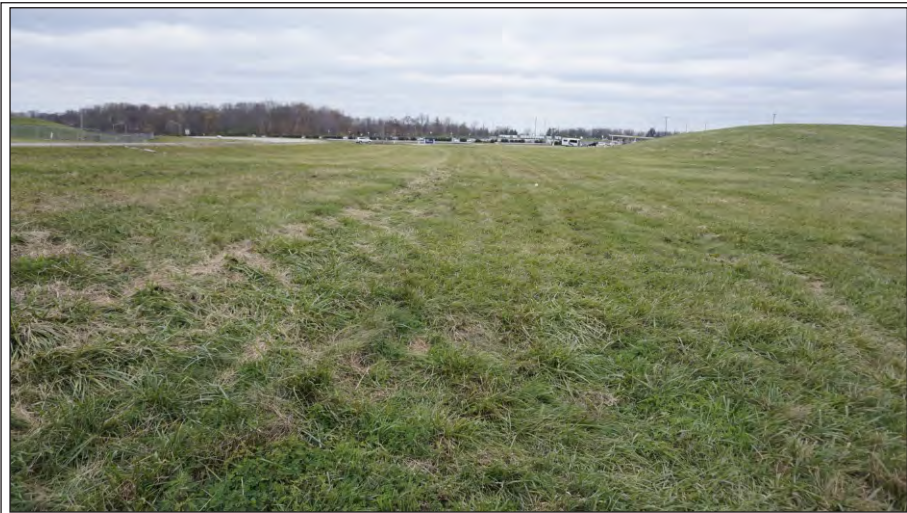
Photo 14. View of Northern Disturbed Area, Facing Northwest.

Photo 14 shows the project area within this portion of the survey area. The disturbed shovel tests in this area were similar to those of the Central Portion Disturbance. The majority of the disturbed soil profiles exhibited only one strata of soil due to fill from razing and filling activities, with shovel tests occasionally terminating in gravel and gravel frequently mixed in with the soils. The soils in this area were 10YR 3/4, 10YR 3/6, 10YR 4/4, 10YR 4/6, 10YR 5/4, or 10YR 5/6 silty clay loam that extended 4 to 40 cmbs. Occasionally disturbed soil profiles had a second strata of 10YR 4/4 or 10YR 5/6 silty clay loam. Figure 17 shows an example of a disturbed soil profile from this area. This area is the former location of structures S#13, S#14, S#15, S#20, S#25, S#26, and S#27. Structures S#6, S#21, S#27, S#28, and S#29 were outside of the project area in this portion to the north within the existing parking lot and parking lot access road.

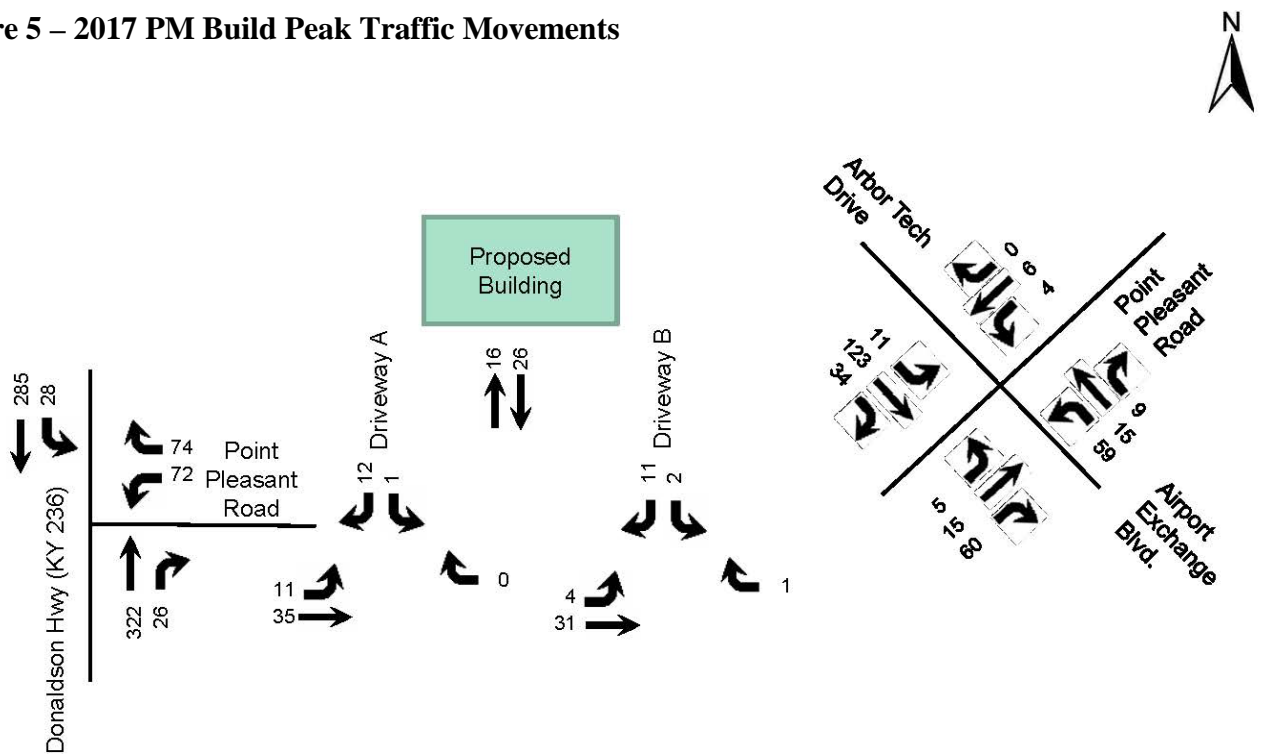
**Figure 5 – 2017 PM Build Peak Traffic Movements**

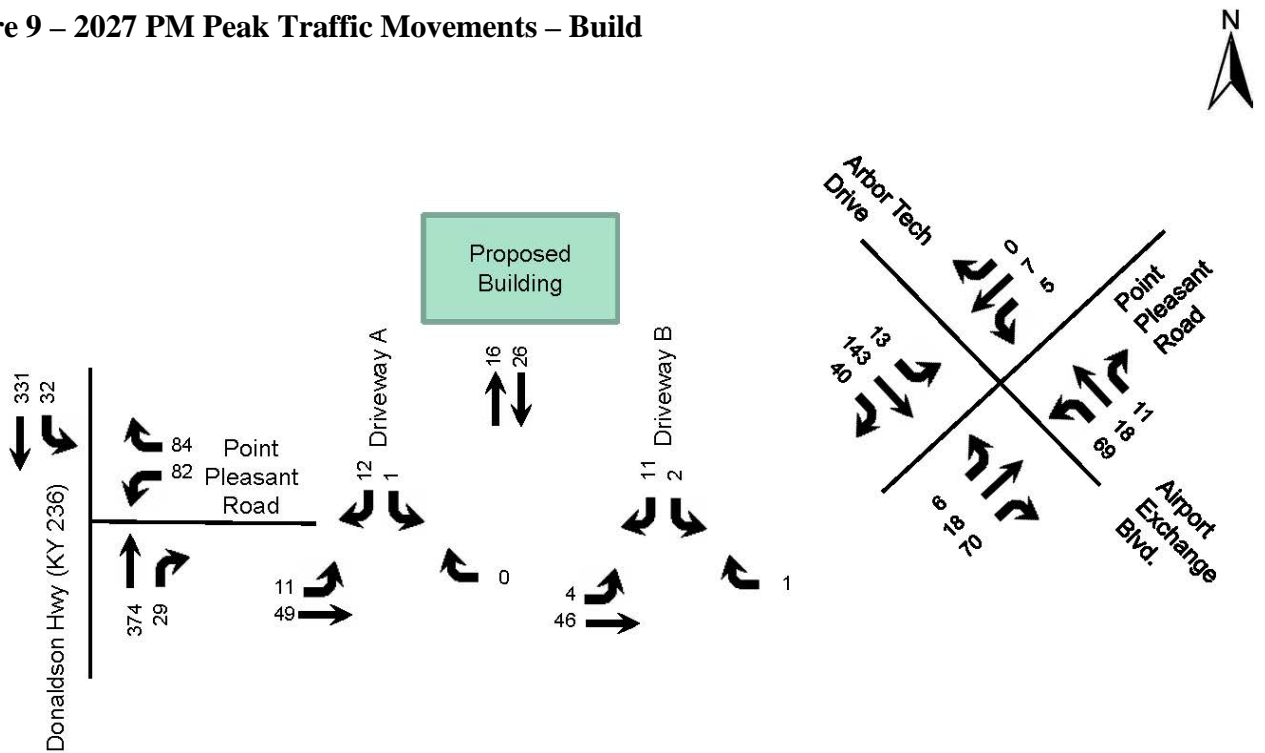
**Figure 9 – 2027 PM Peak Traffic Movements – Build**

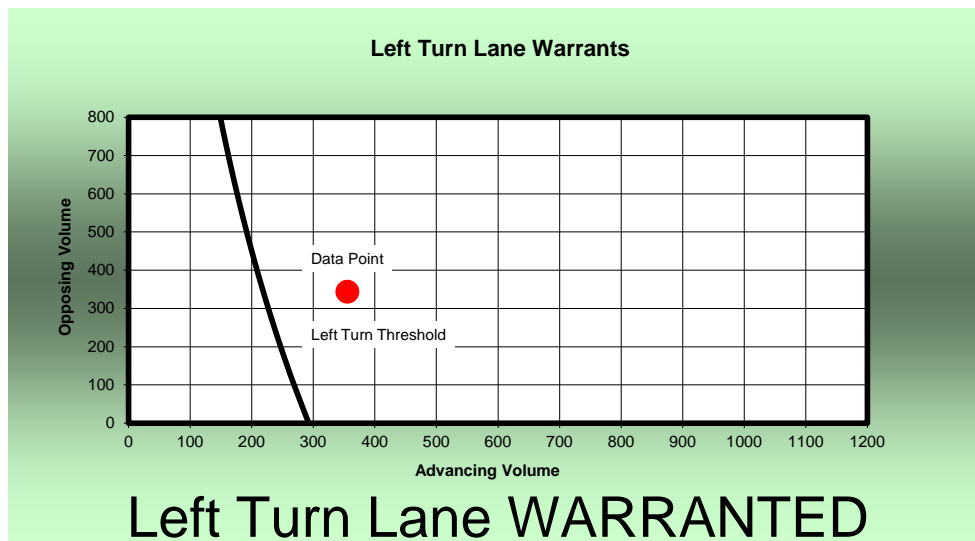
Left Turn Volume (vph)	77	Speed Limit (mph)	50
Advancing Volume (vph)	349	No. of through lanes	1
Opposing Volume (vph)	345	Percent Heavy Vehicles (decimal percent)	0.07

Note: This spreadsheet is intended to supplement the guidance provided in the Auxiliary Turn Lane policy outlined in the KYTC Highway Design Manual. This policy should be fully reviewed and understood prior to using this application.

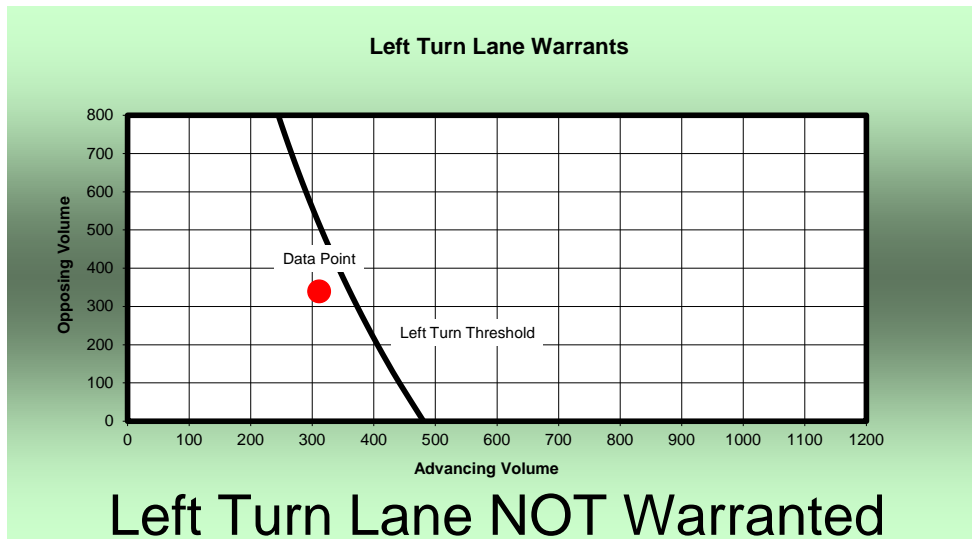
Left Turn Volume (vph)	21	Speed Limit (mph)	50
Advancing Volume (vph)	306	No. of through lanes	1
Opposing Volume (vph)	340	Percent Heavy Vehicles (decimal percent)	0.07

Note: This spreadsheet is intended to supplement the guidance provided in the Auxiliary Turn Lane policy outlined in the KYTC Highway Design Manual. This policy should be fully reviewed and understood prior to using this application.
