# **APPENDIX A**

## **PUBLIC INVOLVEMENT**

**KENTON COUNTY AIRPORT BOARD  
NOTICE OF AVAILABILITY OF A DRAFT  
ENVIRONMENTAL ASSESSMENT (EA)**

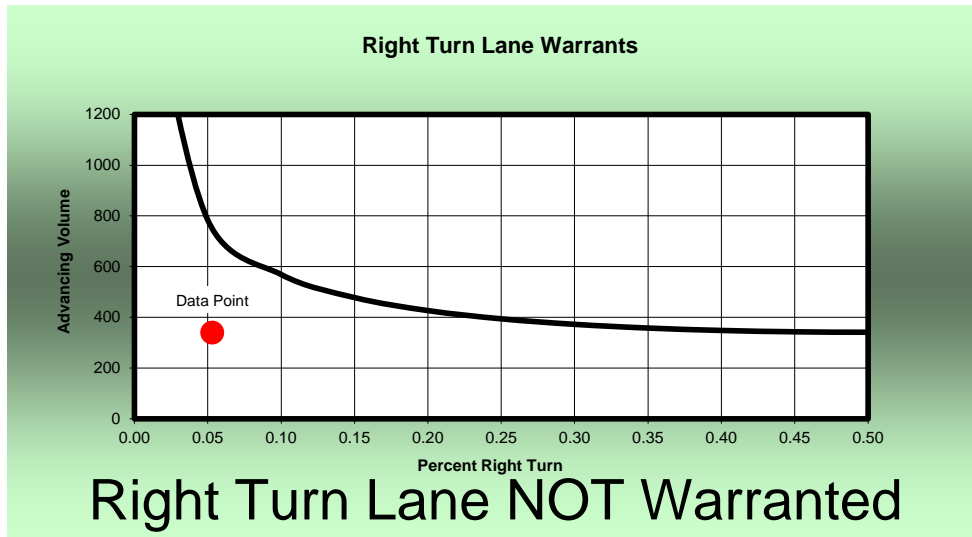
Advancing Volume (vph)

340

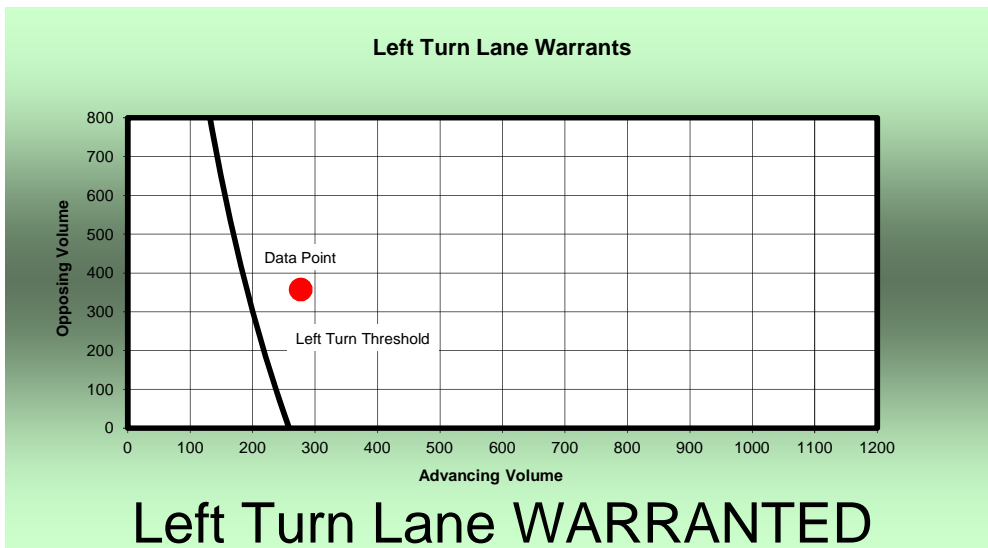
### Input Fields

Left Turn Volume (vph)	89	Speed Limit (mph)	50
Advancing Volume (vph)	272	No. of through lanes	1
Opposing Volume (vph)	357	Percent Heavy Vehicles (decimal percent)	0.07

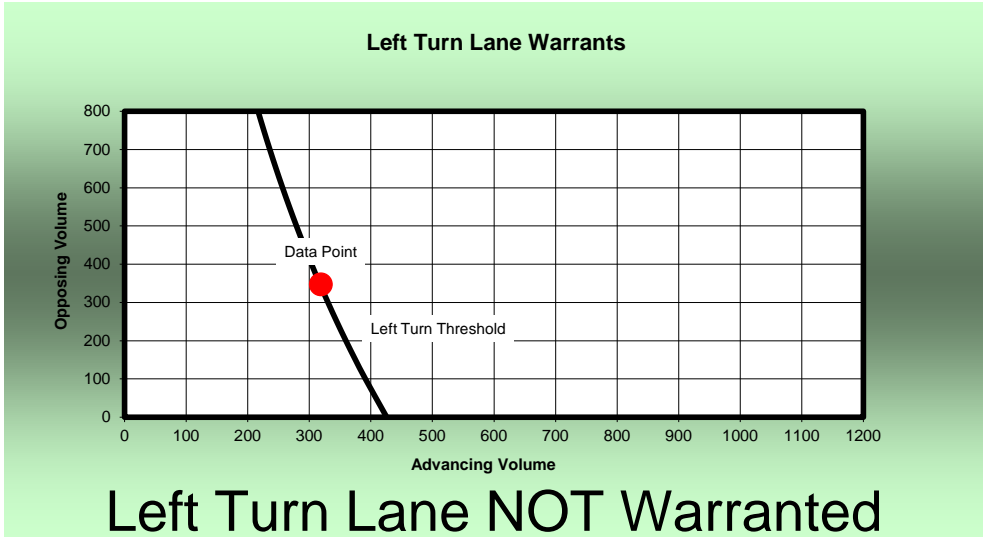
### Input Fields

Left Turn Volume (vph)	28	Speed Limit (mph)	50
Advancing Volume (vph)	313	No. of through lanes	1
Opposing Volume (vph)	348	Percent Heavy Vehicles (decimal percent)	0.07

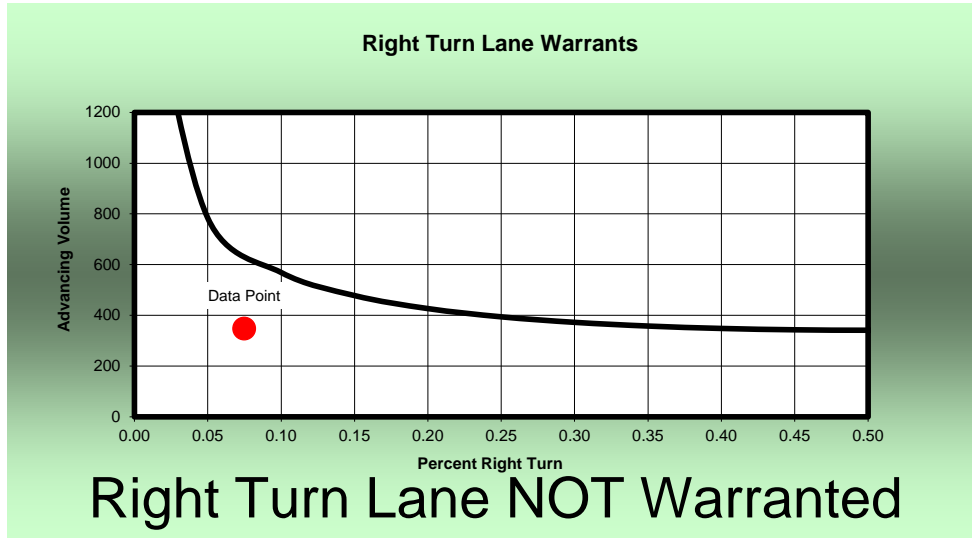
Advancing Volume (vph)

348

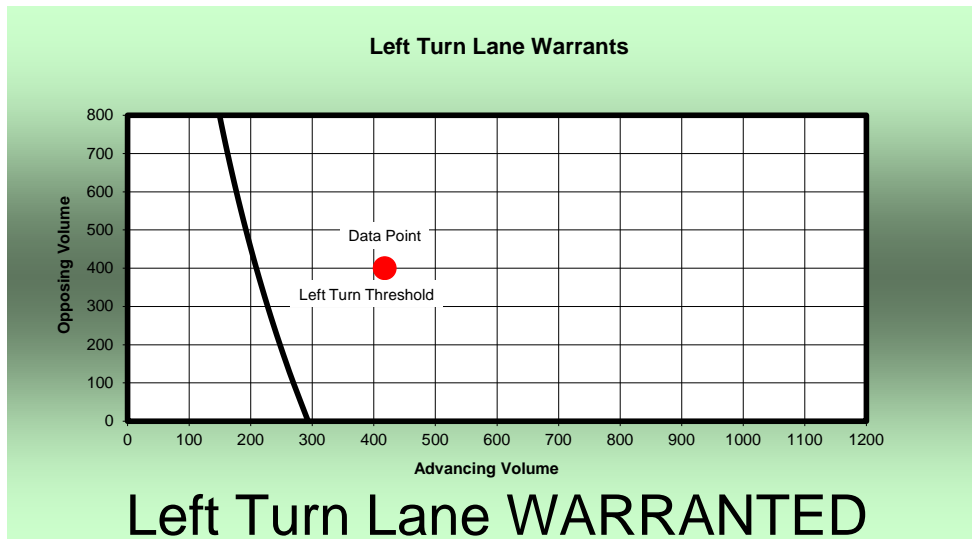
### Input Fields

Left Turn Volume (vph)	90	Speed Limit (mph)	50
Advancing Volume (vph)	406	No. of through lanes	1
Opposing Volume (vph)	401	Percent Heavy Vehicles (decimal percent)	0.1

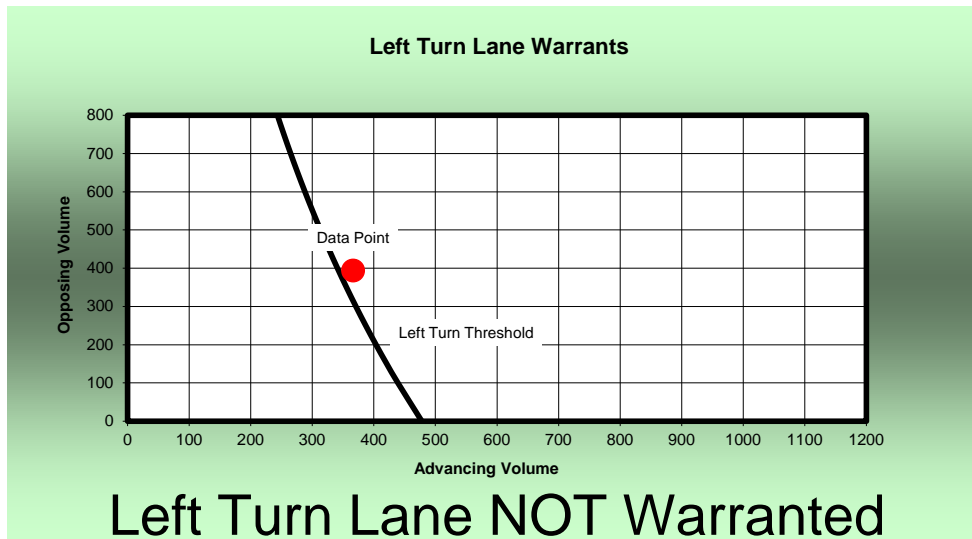
### Input Fields

Left Turn Volume (vph)	25	Speed Limit (mph)	50
Advancing Volume (vph)	356	No. of through lanes	1
Opposing Volume (vph)	395	Percent Heavy Vehicles (decimal percent)	0.1

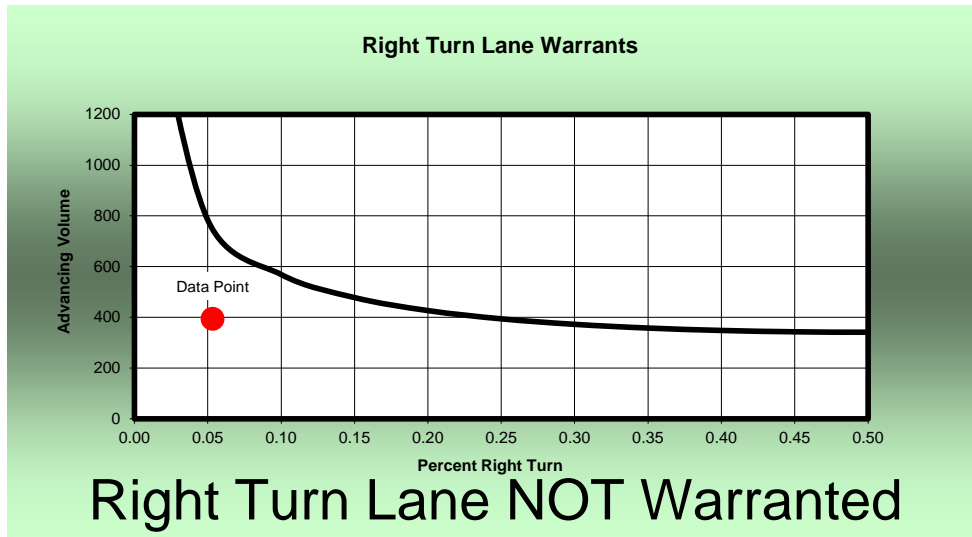
Advancing Volume (vph)

395

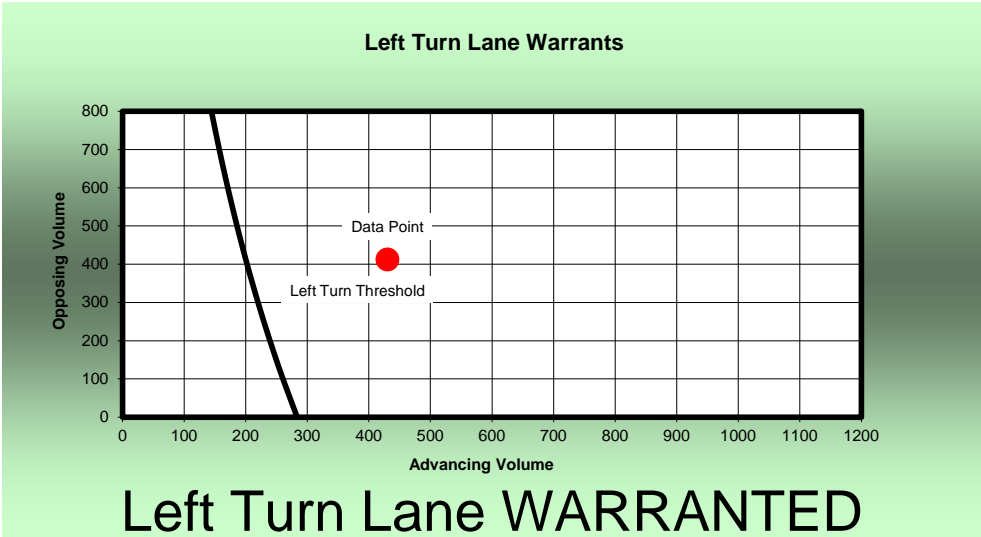
### Input Fields

Left Turn Volume (vph)	102	Speed Limit (mph)	50
Advancing Volume (vph)	418	No. of through lanes	1
Opposing Volume (vph)	413	Percent Heavy Vehicles (decimal percent)	0.1

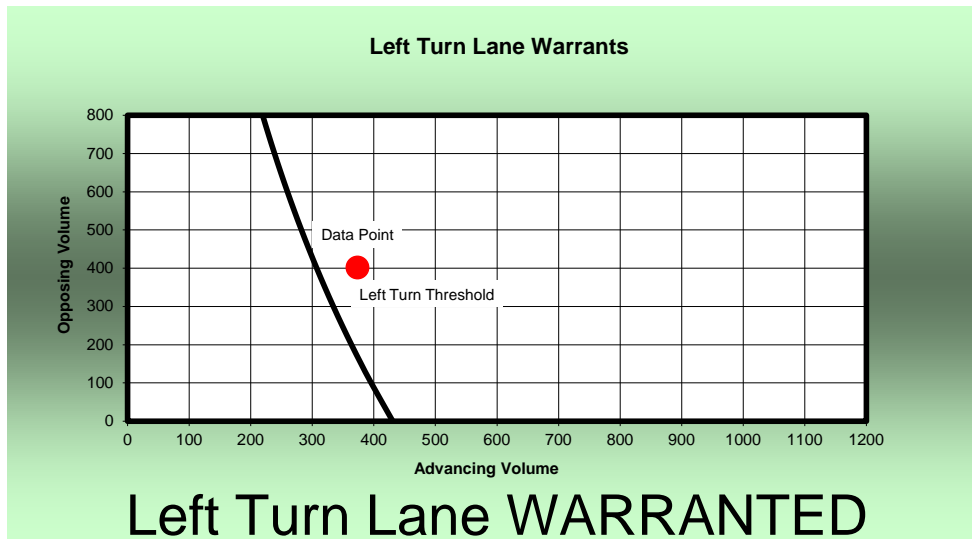
### Input Fields

Left Turn Volume (vph)	32	Speed Limit (mph)	50
Advancing Volume (vph)	363	No. of through lanes	1
Opposing Volume (vph)	403	Percent Heavy Vehicles (decimal percent)	0.1

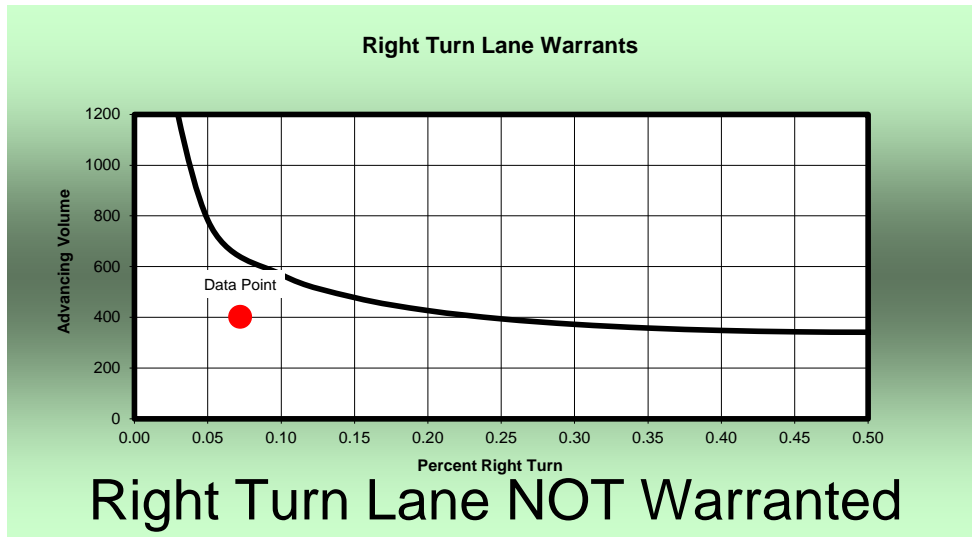
Advancing Volume (vph)

403
