APPENDIX F

Hazardous Materials, Solid Waste, and Pollution Prevention

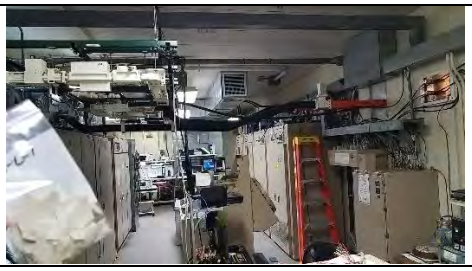
Photo 1: View toward site.	Photo 2: View of main building.	Photo 3: View of main building interior.

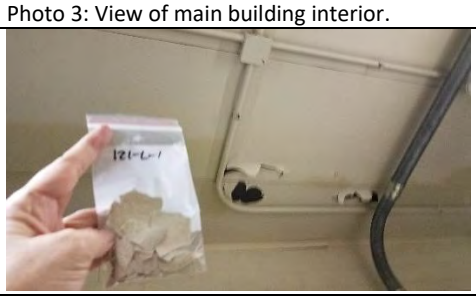
Photo 4: View of two sheds.	Photo 5: View of a third shed.	Photo 6: Paint-Sample 121-L-1. No lead detected.
Photo 7: Paint-Sample 121-L-2. No lead detected.	Photo 8: Paint-Sample 121-L-3. No lead detected.	Photo 9: 1x1 Floor Tile.

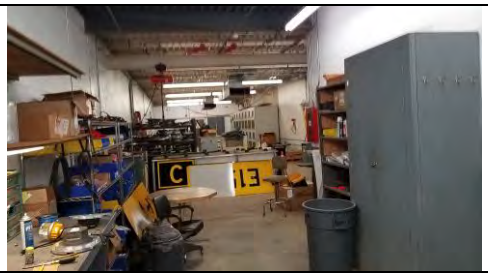
Photo 2: View of building interior.

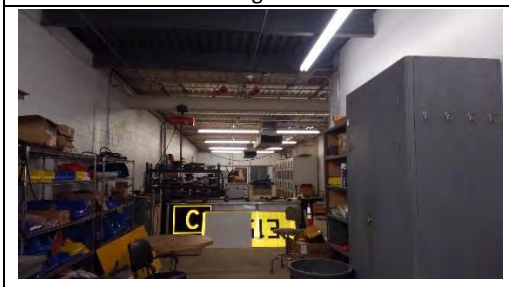
Photo 10: Interior of building.

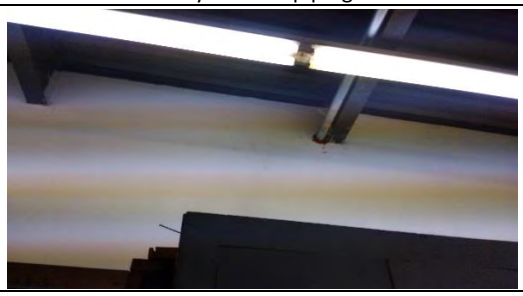
Photo 11: Drywall and wall penetrations.

Photo 12: HVAC system with caulk.

Photo 13: Floor tiles in electrical room.

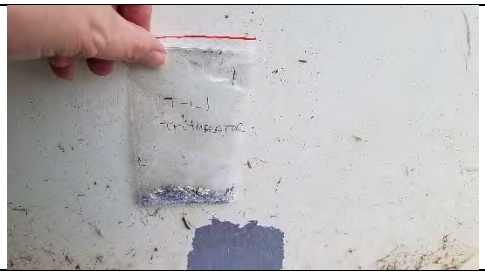
Photo 1: View toward site.	Photo 2: Paint-Sample 123-L-1. No lead detected.	Photo 3: Exterior of pump house.

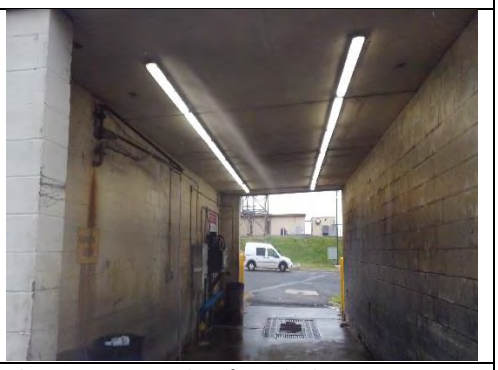
Photo 4: Interior of pump house.	Photo 5: Pipe connecting the pump house and drainage bay.	Photo 6: Drainage bay for vehicles.

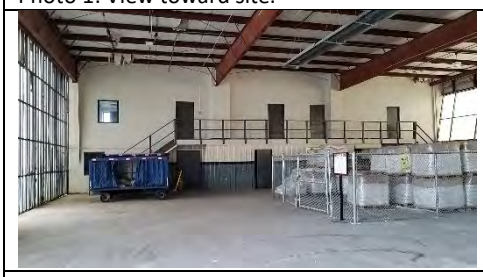
Photo 4: View of building interior of vacant, de-icing storage warehouse.

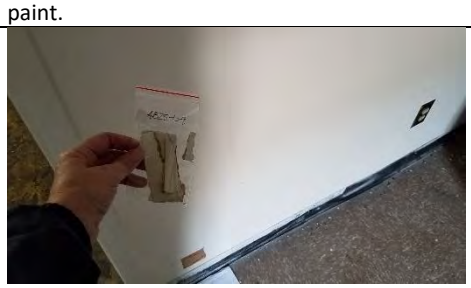
Photo 15: Paint-Sample 4825-L-9. No lead detected.

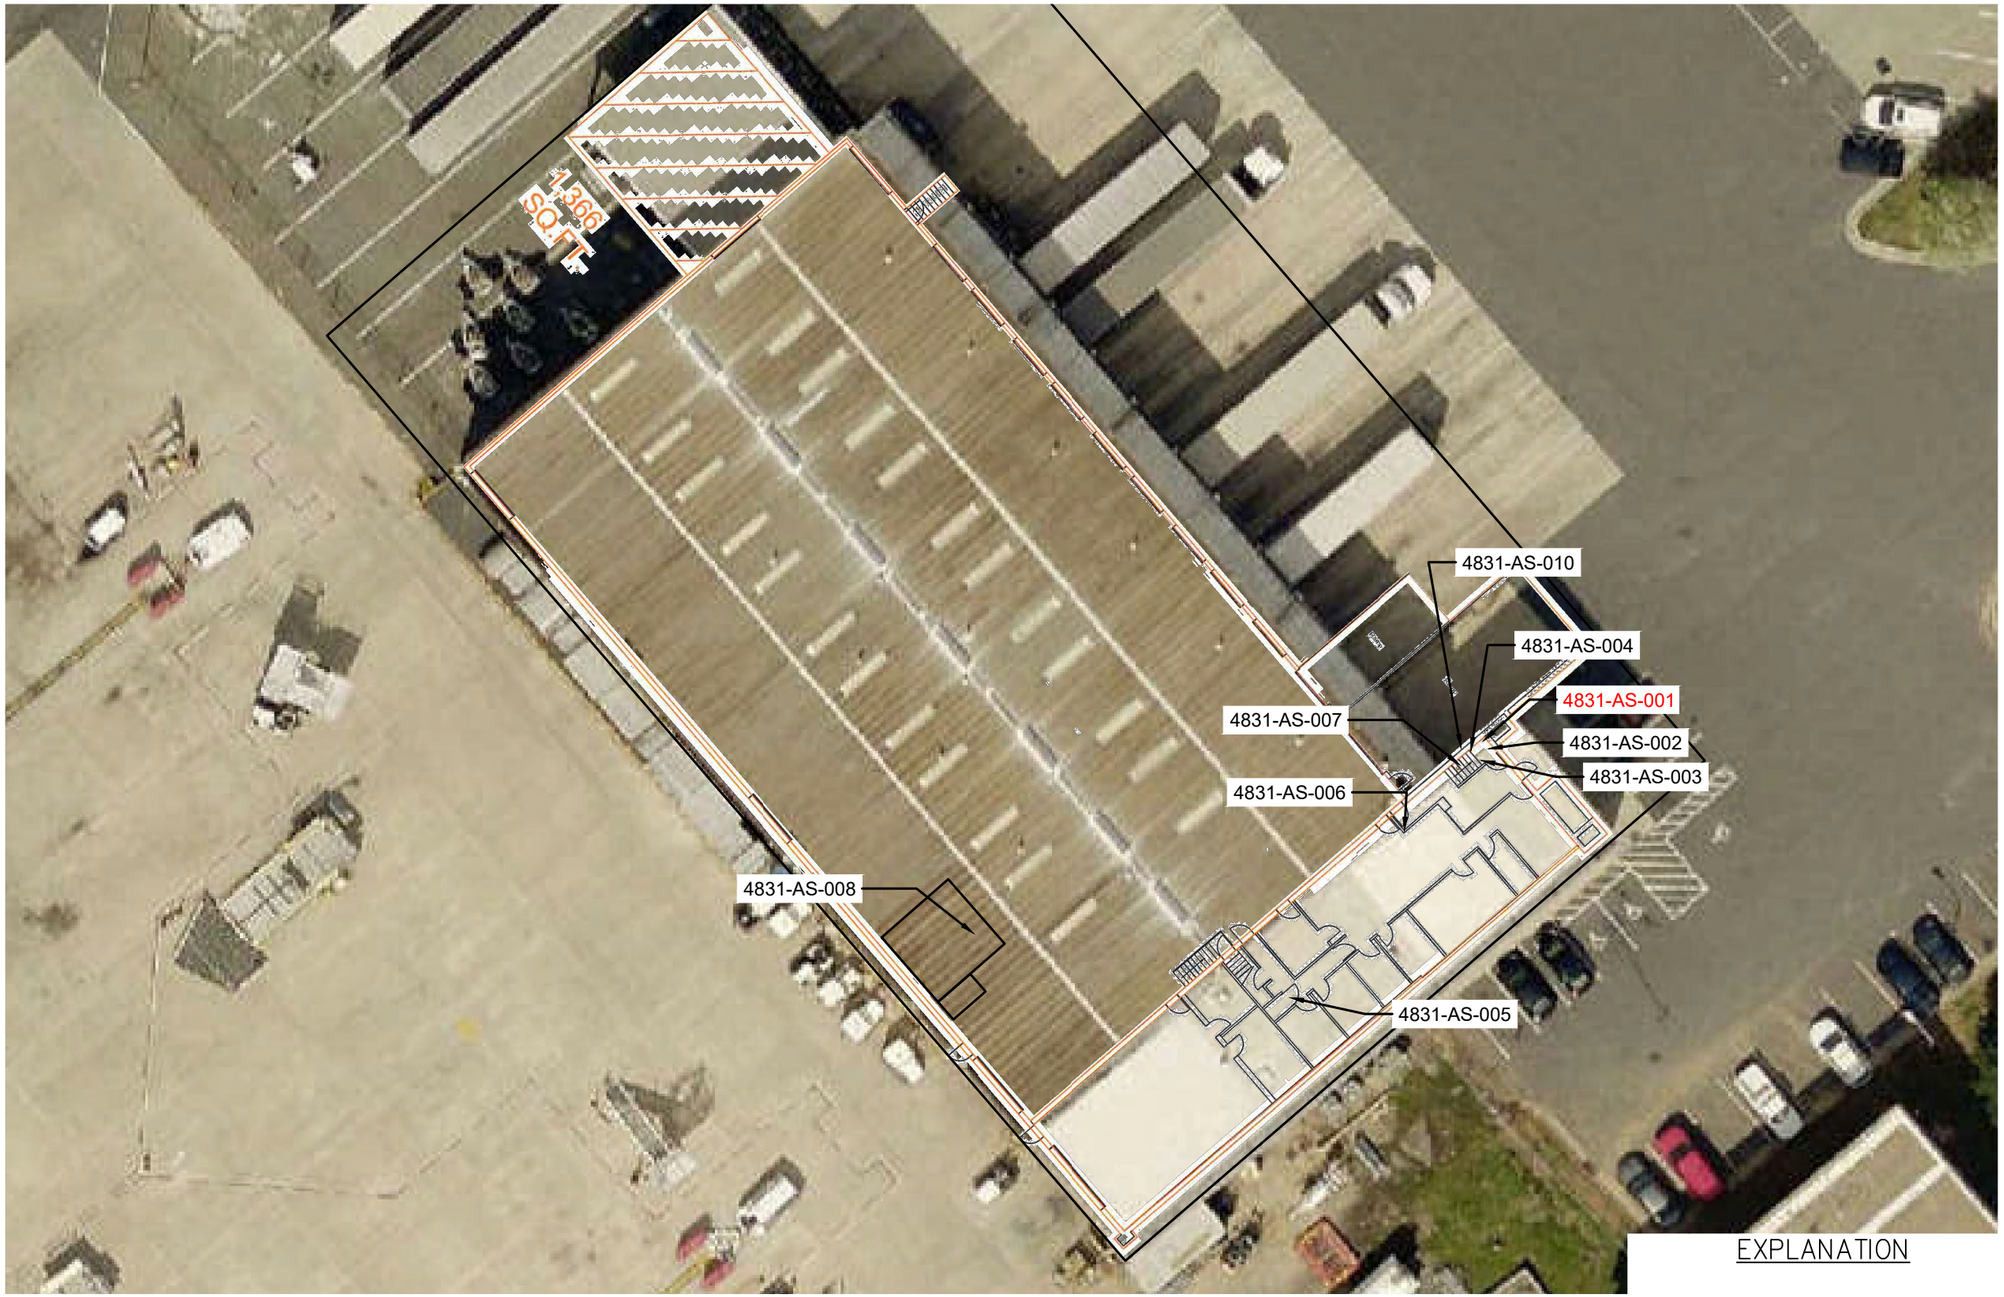
4831-AS-002 Bulk Samples Found to Contain Detectable ACM.

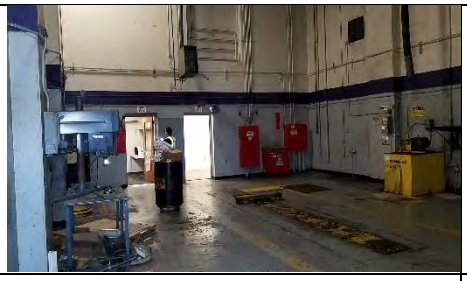
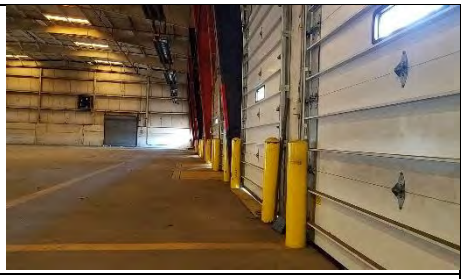
Photo 1: View toward site.	Photo 2: View of building interior, bay.	Photo 3: View of building interior, warehouse.

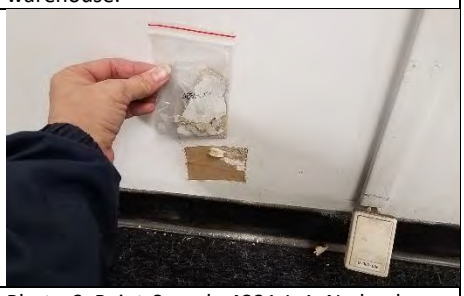
Photo 4: View of building interior, warehouse.	Photo 5: View of building interior, office.	Photo 6: Paint-Sample 4831-L-1. No lead detected.

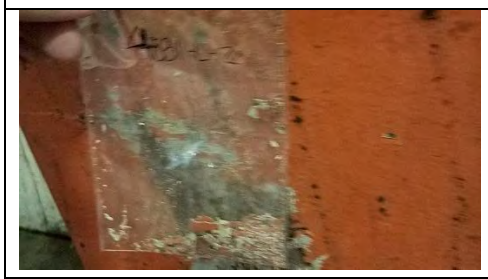
Photo 7: Paint-Sample 4831-L-2. No lead detected.	Photo 8: Paint-Sample 4831-L-3. No lead detected.	Photo 9: Paint-Sample 4831-L-4. Yellow paint in warehouse is lead-containing paint.
Photo 10: Paint-Sample 4831-L-5. No lead detected.	Photo 11: Paint-Sample 4831-L-6. No lead detected.	Photo 12: Paint-Sample 4831-L-7. Gray paint (lower layer blue-gray) seen in office area and bay.

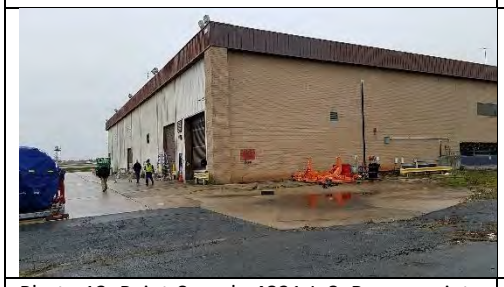
Photo 13: Paint-Sample 4831-L-8. Brown paint on exterior bay doors and frames. No lead detected.	Photo 14: Paint-Sample 4831-L-9. No lead detected.	Photo 15: Paint-Sample 4831-L-10. Tan/white paint on exterior walls in lead-containing paint.

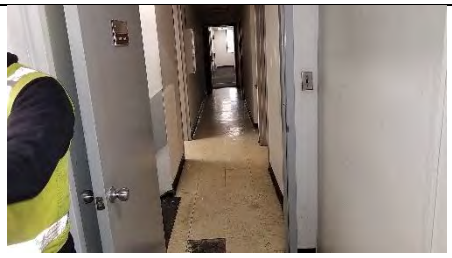
Photo 16: Paint-Sample 4831-L-11. No lead detected.	Photo 17: 1x1 VTF on second floor hall.	Photo 18: Carpet in offices.

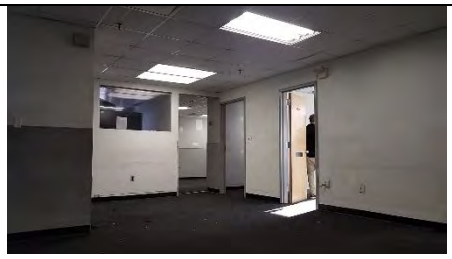
Photo 19: 1x1 VTF on first floor.	Photo 20: Carpet in offices on first floor.	Photo 21: Warehouse office.

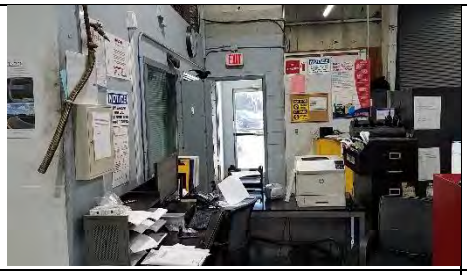
Photo 1: View of building interior, maintenance bay/warehouse.

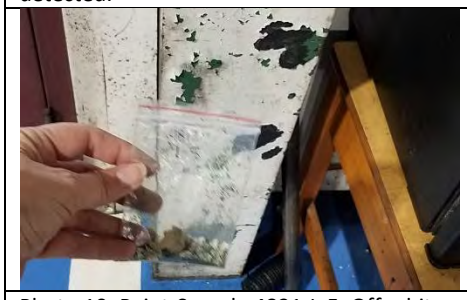
Photo 10: Paint-Sample 4831-L-5. Off-white paint (lower layers, tan and forest green) in maintenance bay/warehouse is lead-containing paint.

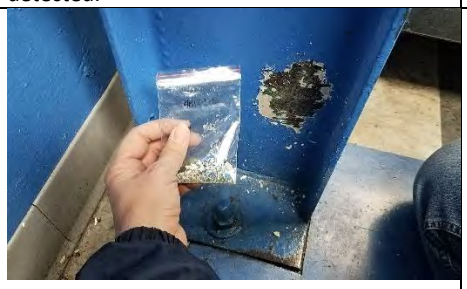
Photo 11: Paint-Sample 4831-L-6. Blue paint (lower layer, gray and forest green) in kitchen in lead-containing paint.

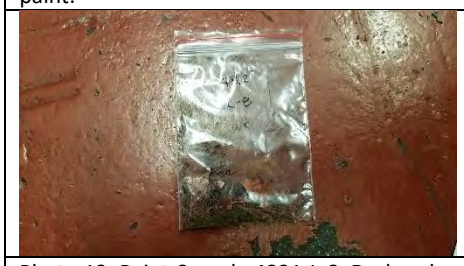
Photo 13: Paint-Sample 4831-L-8. Dark red (lower layer, gray) in NAPA parts area is lead-containing paint.

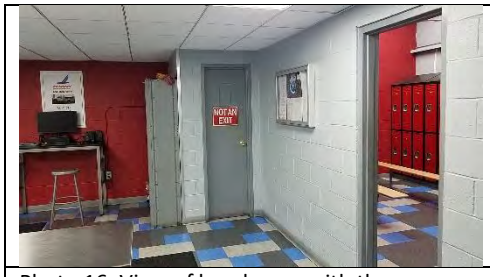
Photo 16: View of break area with three colored vinyl tiles and ceiling tiles.	Photo 17: View of 2’x1’ ACM tiles in NAPA storage area.	Photo 18: View of security room at rear of building.

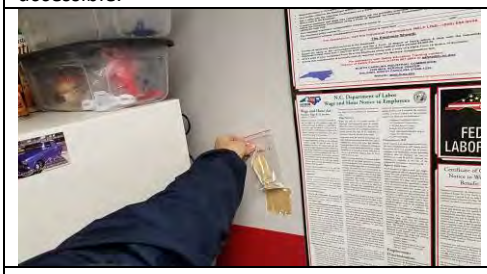
Photo 10: Paint-Sample 4818-L-3. No lead detected.	Photo 11: Paint-Sample 4818-L-4. No lead detected.	Photo 12: Paint-Sample 4818-L-5. Off-white paint (lower layers, black and dark red) in STS is lead-containing paint.
Photo 13: Paint-Sample 4818-L-6. No lead detected.	Photo 14: Paint-Sample 4818-L-7.No lead detected.	Photo 15: Paint-Sample 4818-L-8.No lead detected.

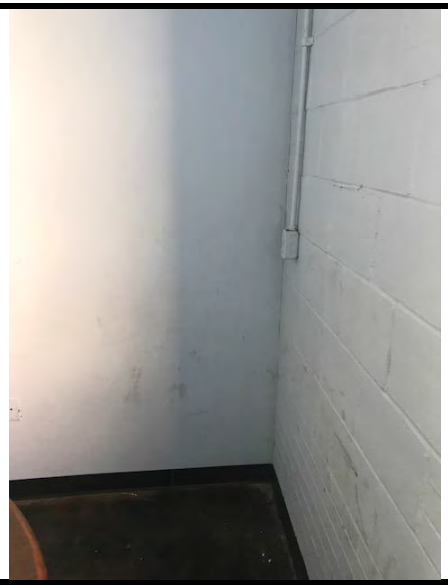
4 **Sample A**
Black cove base with cream colored mastic – ND

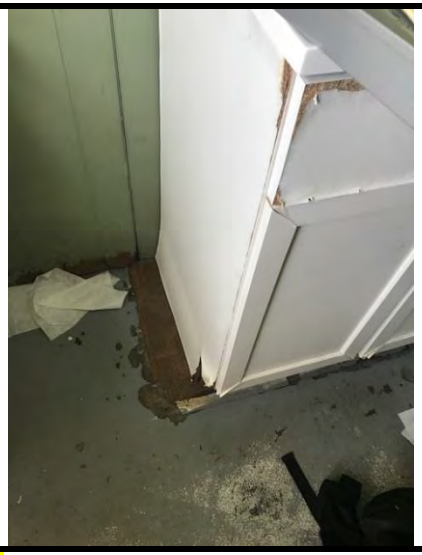
15	**Sample L** 12x12 Vinyl tile, wood patterned, with beige mastic – Vinyl tile – 3% Chrysotile, Mastic – ND

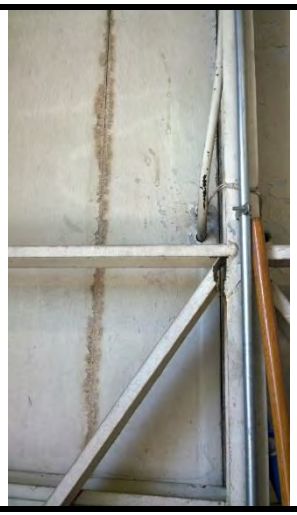
21 **Sample R**
Transite board – 15% Chrysotile

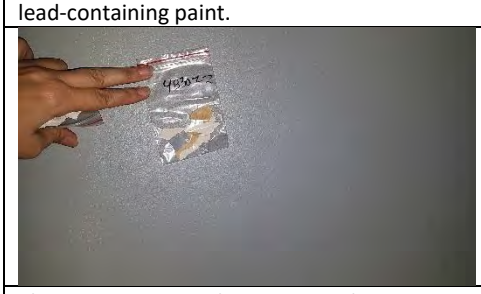
Photo 1: Paint-Sample 4830-L-1. White paint (lower layer – tan) on men's restroom wall on 2nd floor, also seen in warehouse exterior is lead-containing paint.	Photo 2: View of rwhite paint (lower layer-tan) lead-containing paint seen in men's restroom on 2nd floor.	Photo 3: View of white paint (lower layer-tan) lead-containing paint seen in warehouse on 2nd floor, approximately 180 SF of wall.

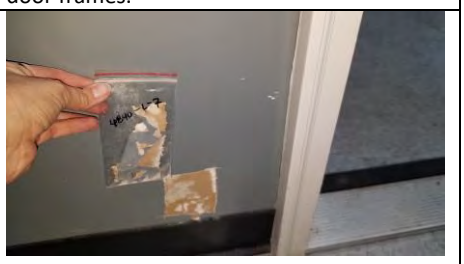
Photo 13: Paint-Sample 4840-L-5. Off-white paint (lower layers, white and dark red) in warehouse of Express Catering warehouse is lead-containing paint.	Photo 14: Paint-Sample 4840-L-6. No lead detected.	Photo 15: Paint-Sample 4840-L-7. No lead detected.

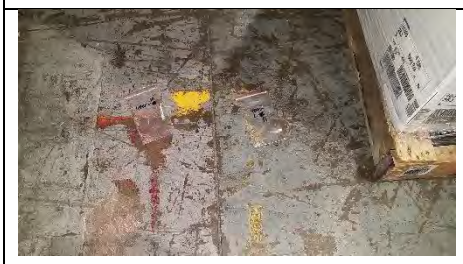
Photo 16: Paint-Sample 4840-L-8. No lead detected.	Photo 17: Paint-Sample 4840-L-9. No lead detected.	Photo 18: Paint-Sample 4840-L-10 (on left). Light gray paint (lower layer, red) on floor in Paradises warehouse is lead-containing paint.

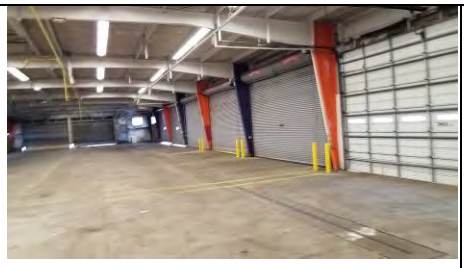
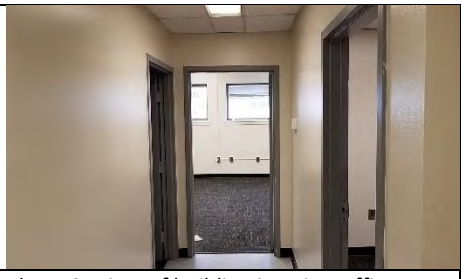
Photo 1: View of building exterior.	Photo 2: View of building interior, warehouse.	Photo 3: View of building interior, office.
Photo 4: Paint-Sample 4850-L-1. No lead detected.	Photo 5: Paint-Sample 4850-L-2. No lead detected.	Photo 6: Paint-Sample 4850-L-3. No lead detected.

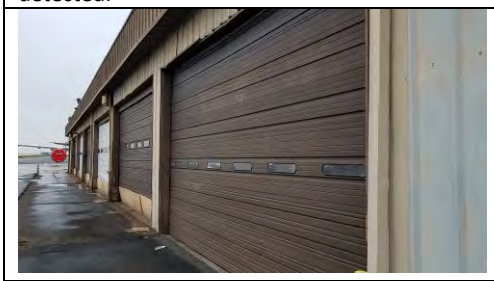
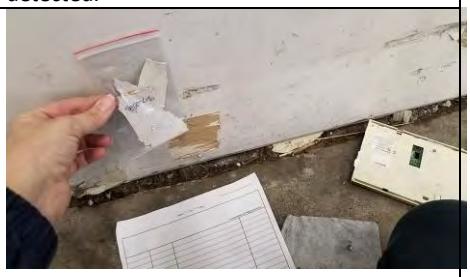
Photo 7: View of building interior. Paint-Sample 4850-L-4. Brown paint on bay doors and frames is lead-containing paint.	Photo 8: Paint-Sample 4850-L-5. No lead detected.	Photo 9: Paint-Sample 4850-L-6. No lead detected.

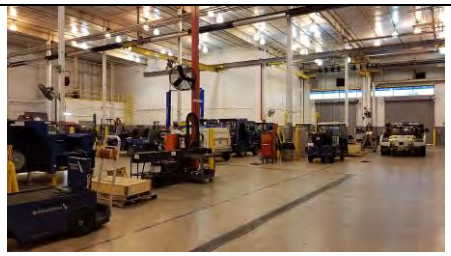
Photo 1: View of building exterior.	Photo 2: View of building interior, warehouse.	Photo 3: View of building interior, warehouse.

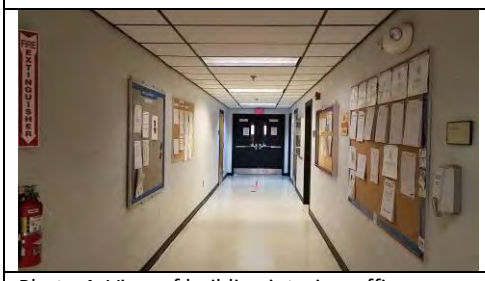
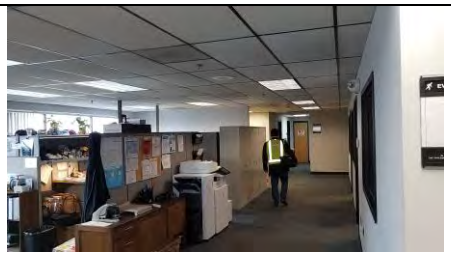
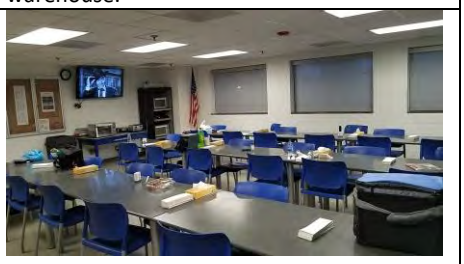
Photo 4: View of building interior, office.	Photo 5: View of building interior, office.	Photo 6: View of building interior, office.

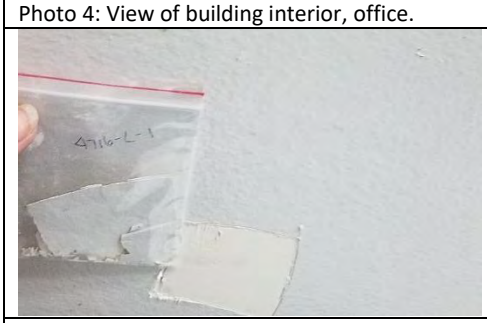
Photo 7: Paint-Sample 4716-L-1. No lead detected.	Photo 8: Paint-Sample 4716-L-2. No lead detected.	Photo 9: Paint-Sample 4716-L-3. No lead detected.

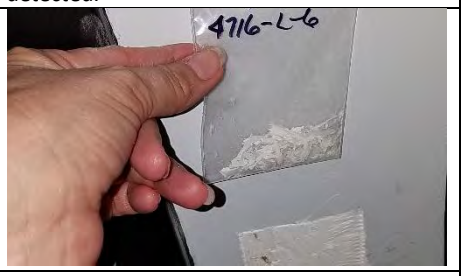
Photo 10: Paint-Sample 4716-L-4. No lead detected.	Photo 11: Paint-Sample 4716-L-5. No lead detected.	Photo 12: Paint-Sample 4716-L-6. No lead detected.
Photo 13: Paint-Sample 4716-L-7. No lead detected.	Photo 14: Paint-Sample 4716-L-8. No lead detected.	Photo 15:

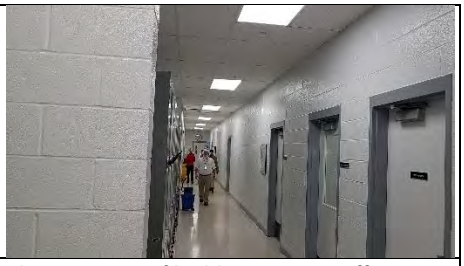
Photo 1: View of building exterior.	Photo 2: View of building interior, dish wash area.	Photo 3: View of building interior, office.

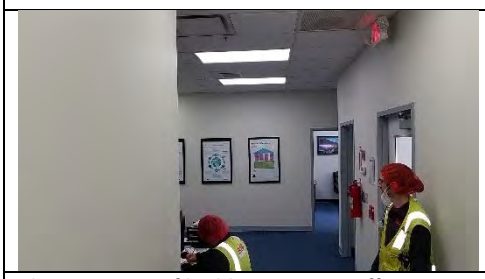
Photo 4: View of building interior, office.	Photo 5: Paint-Sample 4710-L-1. No lead detected	Photo 6: Paint-Sample 4710-L-2. No lead detected
Photo 7: Paint-Sample 4710-L-3. No lead detected.	Photo 8: Paint-Sample 4710-L-4. No lead detected.	Photo 9: Paint-Sample 4710-L-5. No lead detected.

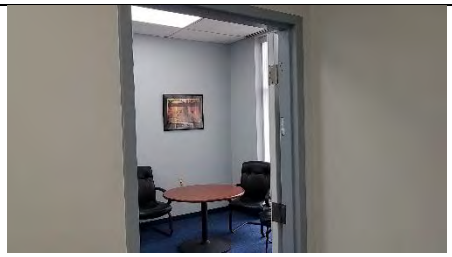
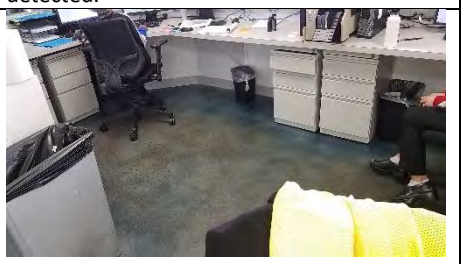
Photo 10: Paint-Sample 4710-L-6 (white paint on building exterior). No lead detected.	Photo 11:Typical office conditions.	Photo 12:Dispach with stair tread.

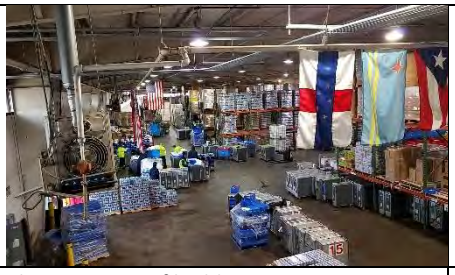
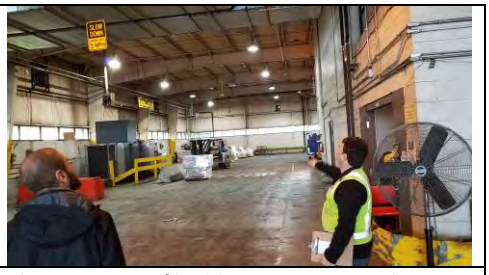
Photo 1: View of building exterior.	Photo 2: View of building interior, warehouse.	Photo 3: View of building interior, warehouse.

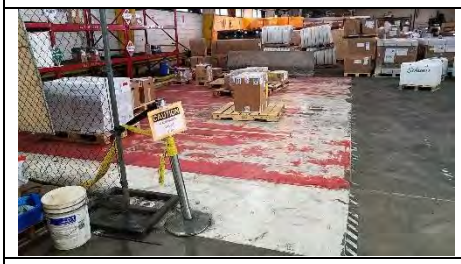
Photo 4: View of building interior, warehouse.	Photo 5: View of building interior, warehouse.	Photo 6: View of building interior, package distribution area below 2nd floor office area.

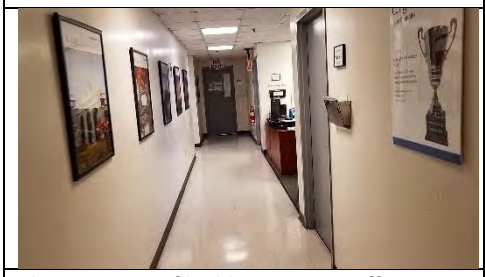
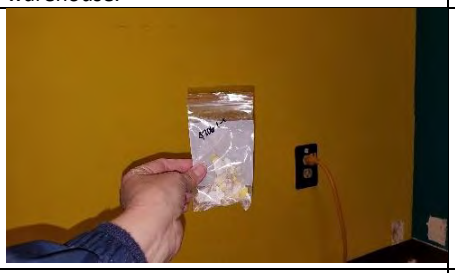
Photo 7: View of building interior, office.	Photo 8: Paint-Sample 4706-L-1. No lead detected.	Photo 9: Paint-Sample 4706-L-2. No lead detected.

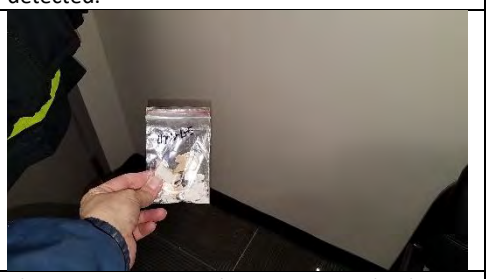
Photo 10: Paint-Sample 4706-L-3. No lead detected.	Photo 11: Paint-Sample 4706-L-4. No lead detected.	Photo 12: Paint-Sample 4706-L-5. No lead detected.

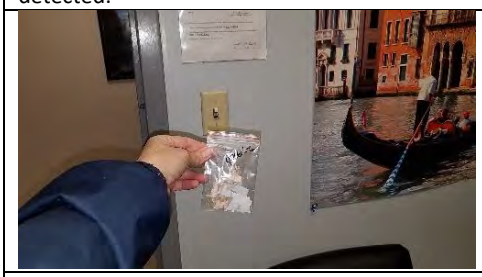
Photo 13: Paint-Sample 4706-L-6. No lead detected.	Photo 14: Paint-Sample 4706-L-7.Fire red paint (lower layer, Dark red/brown) on stairwell. Also seen on doors, door frames, and warehouse shelving.	Photo 15: Paint-Sample 4706-L-8. No lead detected.

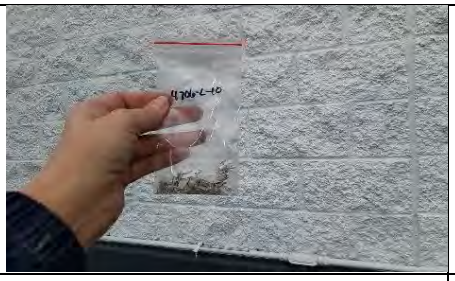
Photo 16: Paint-Sample 4706-L-9. No lead detected.	Photo 17: Paint-Sample 4706-L-109. No lead detected.	Photo 18: Paint-Sample 4706-L-11. Yellow paint seen on safety barriers and other equipment in the warehouse area is lead-containing paint. Also seen on safety barriers on exterior of building.

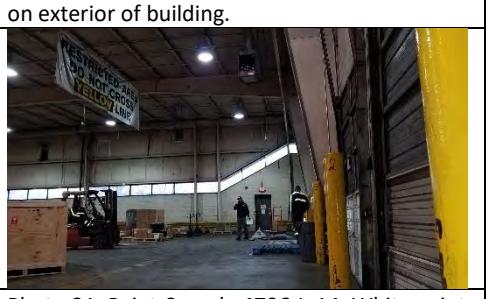
Photo 19: Paint-Sample 4706-L-12. No lead detected.	Photo 20: Paint-Sample 4706-L-13. No lead detected.	Photo 21: Paint-Sample 4706-L-14. White paint on warehouse interior. No lead detected.

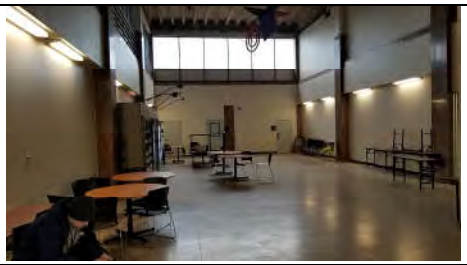
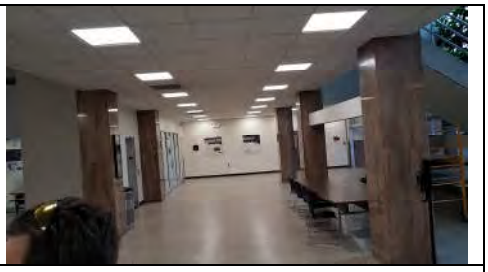
Photo 1: View of building exterior.	Photo 2: View of building interior, 1st floor.	Photo 3: View of building interior, 1st floor.

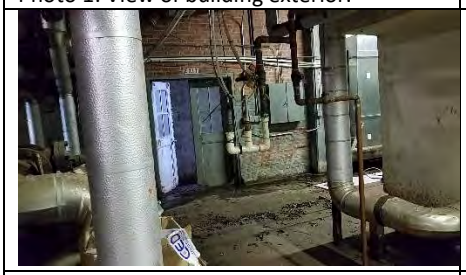
Photo 4: View of building interior, basement (east mechanical room).	Photo 5: View of building interior, basement (west mechanical room).	Photo 6: View of building interior, basement (east boiler room).

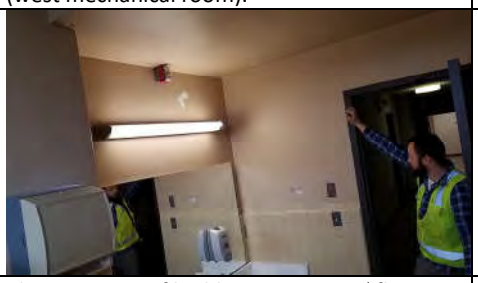
Photo 7: View of building interior, office (east stairwell).	Photo 8: View of building interior, 2nd floor restroom.	Photo 9: View of building interior, 2nd floor restroom.
Photo 10: Paint-Sample 4700-L-1. Olive green seen in basement east boiler room and west mechanical room is lead-containing paint.	Photo 11: Paint-Sample 4700-L-2. Dark gray paint (lower layer, black) seen in basement west mechanical room is lead-containing paint.	Photo 12: Paint-Sample 4700-L-3. No lead detected.

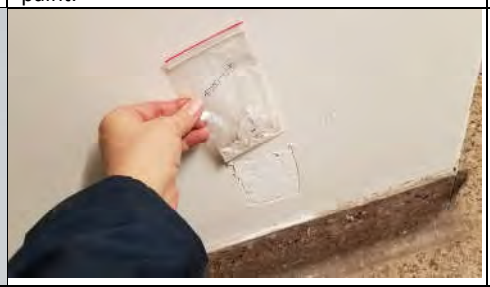
Photo 13: Paint-Sample 4700-L-4. No lead detected.	Photo 14: Paint-Sample 4700-L-5. Off-white paint (no lower layers) on basement plaster walls. No lead detected.	Photo 15: Paint-Sample 4700-L-6. Off-white paint (lower layers, yellow and olive green) seen in stairwells is lead-containing paint. These paints on plaster were seen throughout the building, except basement walls with no lower layers, as shown in Photo 14.

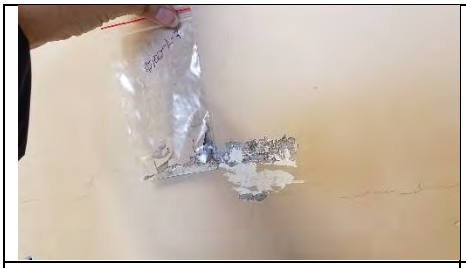
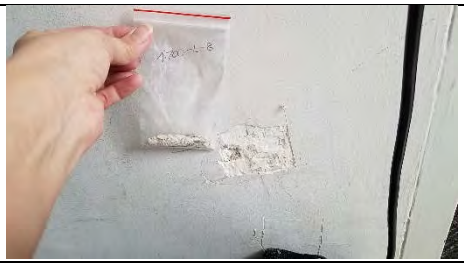
Photo 16: Paint-Sample 4700-L-7. Tan paint (lower layer brown and white) seen in 2nd floor restroom is lead-containing paint. These paints on plaster were seen elsewhere.	Photo 17: Paint-Sample 4700-L-8. White paint (lower layers, tan and white) seen in on plaster in second floor storage room (Rm 2202) is lead-containing paint. These paints on plaster were seen elsewhere.	Photo 18: Paint-Sample 4700-L-9. White paint on entrance canopy is lead-containing paint.
Photo 19: Paint-Sample 4700-L-10. Off-white paint (lower layers, yellow, olive green, and tan) seen in stairwells is lead-containing paint. These paints on plaster were seen throughout the building, except basement walls with no lower layers, as shown in Photo 14.	Photo 20: Paint-Sample 4700-L-11. White paint on the rear entrance canopy. No lead detected.	Photo 21: ACM, HA-001, Exterior Window (frame) caulk. Seen around windows and doors on ramp side.

Photo 22: ACM, HA-006, Boiler insulation.	Photo 23: ACM, HA-011, Duct Cloth Cover Insulation.	Photo 21: ACM, HA-012, Black Duct Mastic.

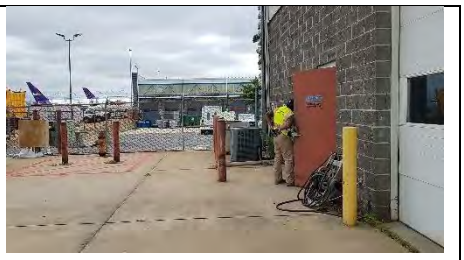
Photo 1: View of the building exterior.	Photo 2: View of the building exterior. Note, gray paint on the corrugated metal on the building exterior.	Photo 3: View of the building exterior.

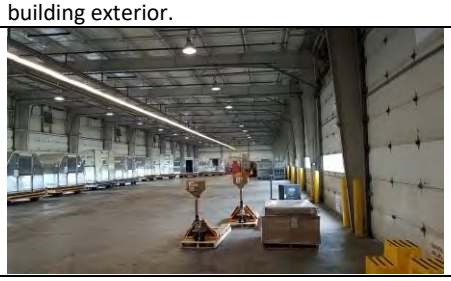
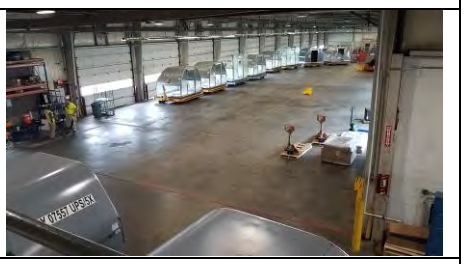
Photo 4: View of the building exterior.	Photo 5: View of the building interior.	Photo 6: View of the building interior.
Photo 7: View of the building interior.	Photo 8: View of the building interior.	Photo 9: View of Light Gray paint on stairs in warehouse. L-1 paint chip sample.

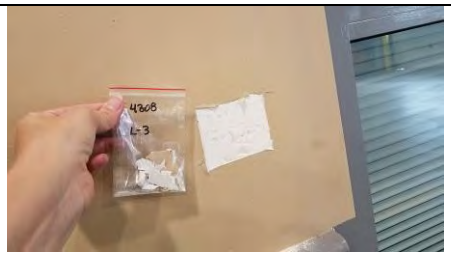
Photo 10: View of L-2 paint chip sample.	Photo 11: View of L-3 paint chip sample.	Photo 12: View of Gray paint on doors and door frames. L-4 paint chip sample.

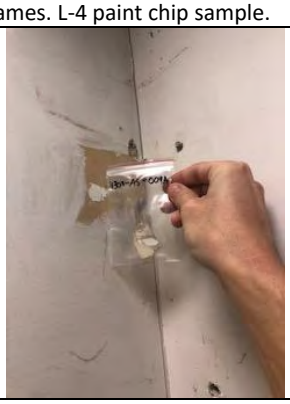
Photo 13: View of L-4 paint chip sample.	Photo 14: View of L-5 paint chip sample.	Photo 15: View of Off-White paint on drywall in Office area. L-6 paint chip sample.

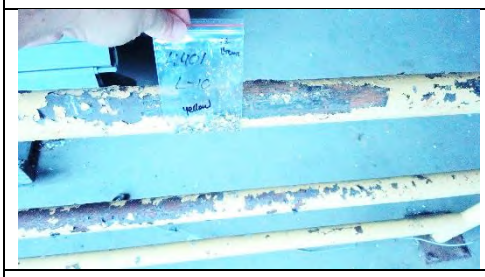
Photo 16: View of L-7 paint chip sample. Off-White paint (lower layer – Red) seen on ceiling lattice in Basement contains detectable lead.	Photo 17: View of L-8 paint chip sample. Off-White paint (lower layers – Light Yellow and Blue) seen at southeast entry to the building contains detectable lead.	Photo 18: View of L-9 paint chip sample.

Photo 19: View of L-10 paint chip sample. Yellow paint (lower layer – Brown) seen on exterior safety railing contains detectable lead.	Photo 20: View of L-11 paint chip sample.	Photo 21: View of L-12 paint chip sample.

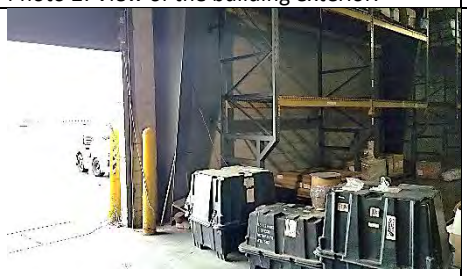
Photo 4: View of the building interior.	Photo 5: View of the building interior. Note, dark gray painted metal wall supports in warehouse.	Photo 6: View of L-1 paint chip sample. Dark Gray paint seen on warehouse wall supports contains detectable lead.

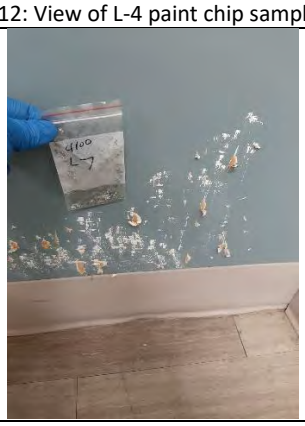
Photo 10: View of L-2 paint chip sample.	Photo 11: View of L-3 paint chip sample.	Photo 12: View of L-4 paint chip sample.

Photo 13: View of L-5 paint chip sample. Yellow paint of safety barriers found to contain detectable lead.	Photo 14: View of L-6 paint chip sample.	Photo 15: View of L-7 paint chip sample.

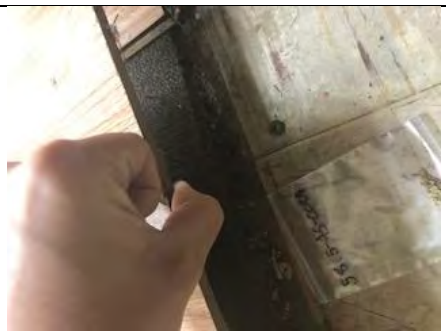
Photographic Documentation
Building No: 246 (Maintenance)
Address: 5805 Tunnel Road
Charlotte Douglas International Airport

Photo 13: View of HA 5805-AS-004. ACM Brown-Tan 9”x9” Vinyl Floor Tile (VFT). The associated Black Mastic was No Asbestos Detected (NAD).	Photo 14: View of HA 5805-AS-008. Carpet Mastic (below wood floor), which contains <1% asbestos. Additionally, HA 5805-AS-011 the ACM 9”x9” Tan VFT and ACM Black Mastic are shown on the right of the photo.	Photo 15: View of HA 5805-AS-010. Light Blue 12”x12” VFT, which is NAD. The associated Tan-Black Mastic is ACM.

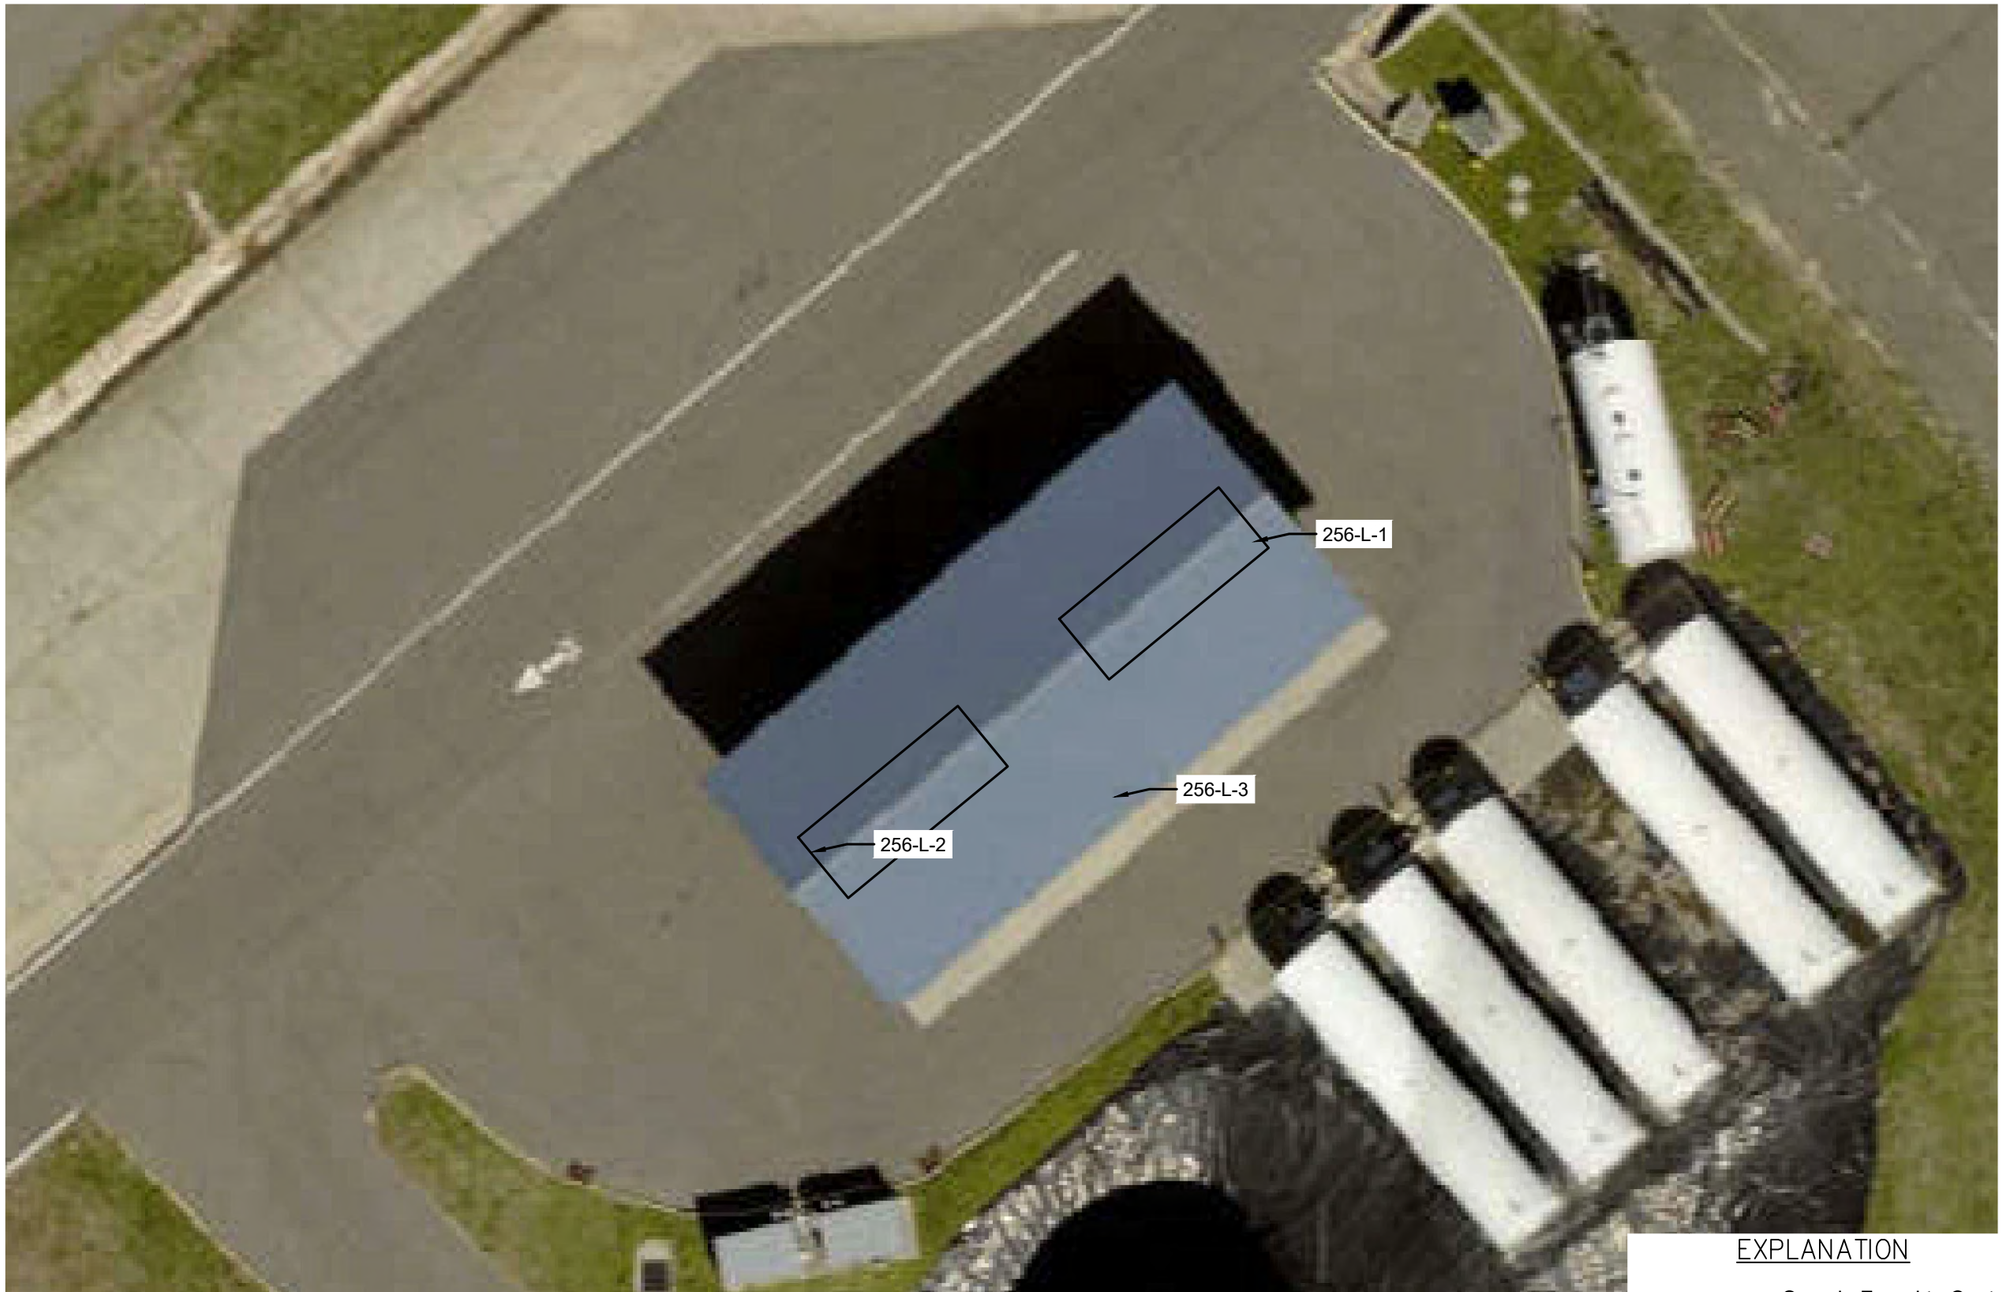
256-L-2 Sample Found to Contain Detectable Lead.

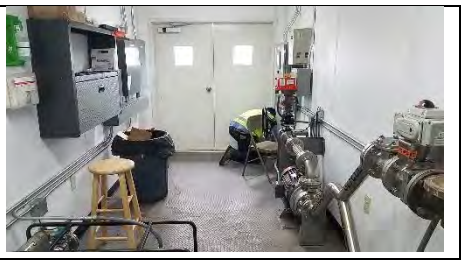
Photo 1: View toward the site and two equipment buildings.	Photo 2: View of the canopy and the supports.	Photo 3: Typical view of equipment building interior.

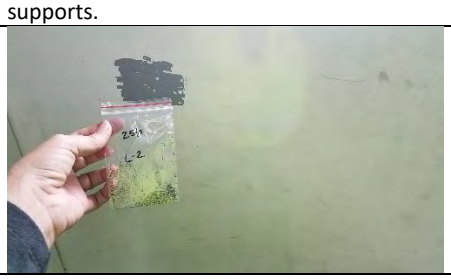
Photo 4: View of L-1 paint chip sample.	Photo 5: View of L-2 paint chip sample.	Photo 6: View of L-3 paint chip sample.

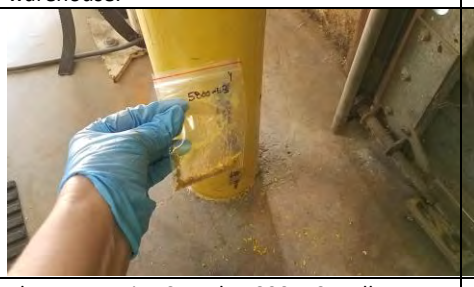
Photo 14: Paint-Sample 5800-L-3. Yellow paint (lower layer – tan) on safety barriers in warehouse in 5800D contains detectable lead.

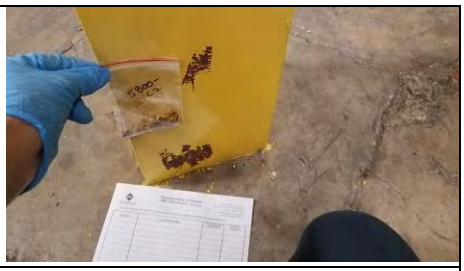
Photo 18: Paint-Sample 5800-L-7. Yellow paint (lower layer – tan) on safety barriers in warehouse in 5800C contains detectable lead.

Photo 19: Paint-Sample 5800-L-8. Light Gray/Light Blue (lower layer – light brick) in office and warehouse in 5800C contains detectable lead.

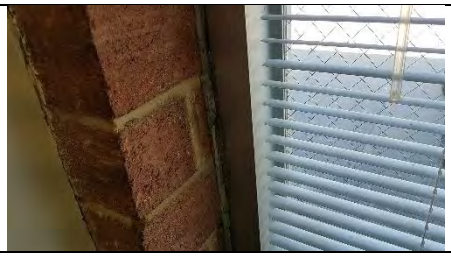
Photo 31: Paint-Sample 5800-L-20. Cream Orange on building exterior (lower layer – tan, light brick red, gray) contains detectable lead.	Photo 32: ACM Window Caulk in 5800D. Bulk Sample 5800-AS-08.	Photo 33: Wall System in 5800B, contains <1% asbestos. Bulk Sample 5800-AS-16.
