3 Affected Environment

RALEIGH-DURHAM INTERNATIONAL AIRPORT
 ENVIRONMENTAL ASSESSMENT FOR THE
 RUNWAY 5L/23R REPLACEMENT PROJECT

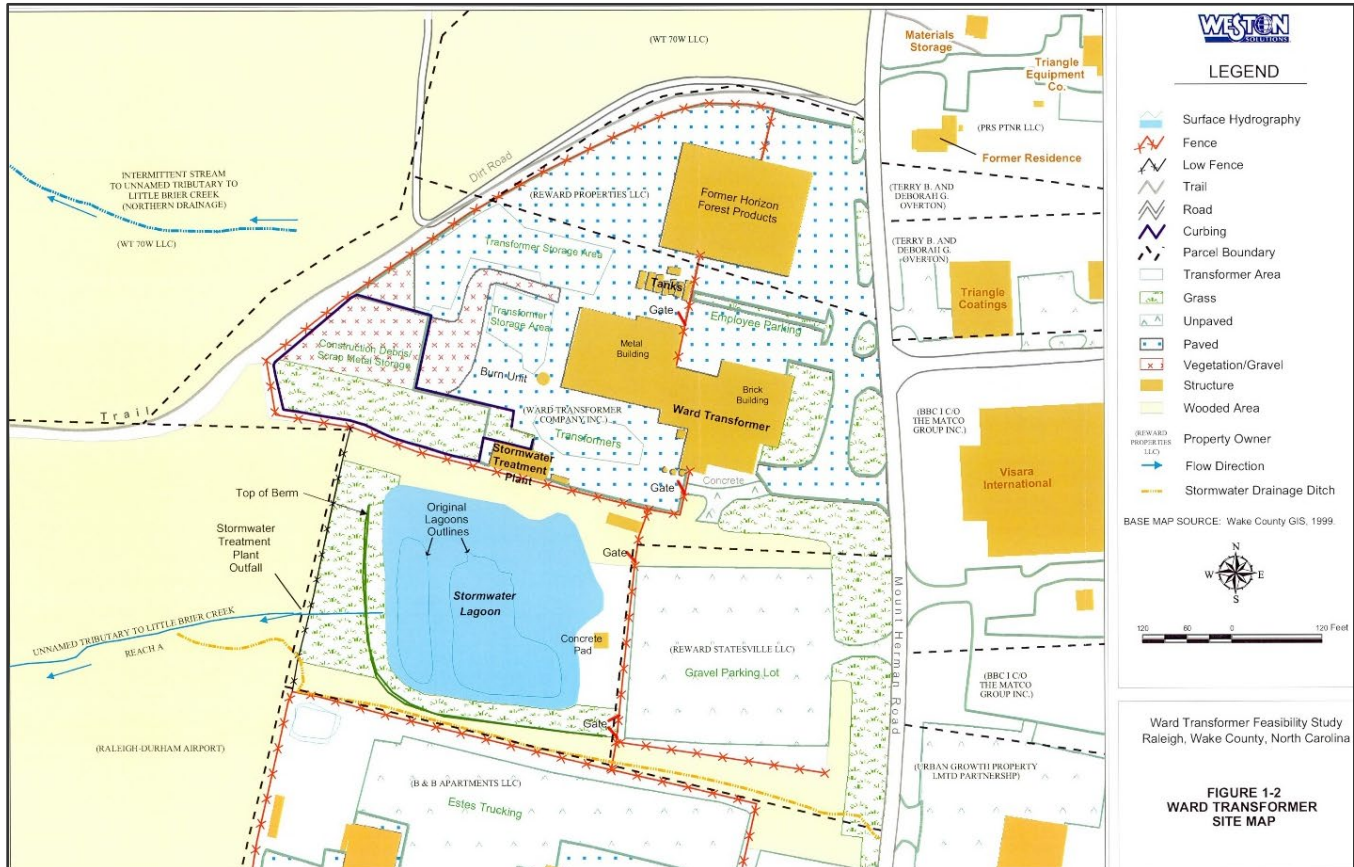
EXHIBIT 3-7, FORMER WARD TRANSFORMER FACILITY SITE MAP

were evaluated as chemicals of potential concern in the SBRA. The SBRA results showed no human health chemicals of potential concern for potential current or future occupational exposures that exceeded a cancer risk of 1×10^{-4} or non-cancer risk significantly greater than 1.0 and no site-specific ecological risk. The RA reportedly removed the sources of PCBs and used ECs and institutional controls to address PCB-impacted material that remained above the cleanup criteria. The groundwater VOC contamination was found to be limited to the vicinity of the former Ward Transformer lagoons and was expected to decrease over time.⁵⁴ The former Ward transformer lagoons and facilities are shown on **Exhibit 3-7**.
