Phase I Environmental Due Diligence Audit (EDDA)

Environmental Impact Statement for the Proposed Airfield Safety Enhancement Project and Land Transactions for the Tucson International Airport Tucson, Arizona

January 23, 2018
AAI Date: December 27, 2016
File No. 01216132.01

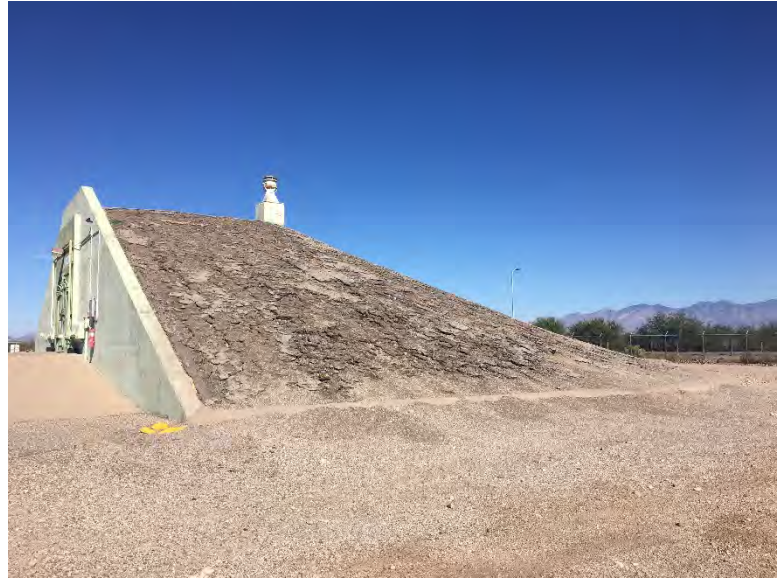
Photograph 2. View across the site parcel at 1000 East Valencia Road toward the structure on the site parcel at 1070 East Valencia Road. View to the east.

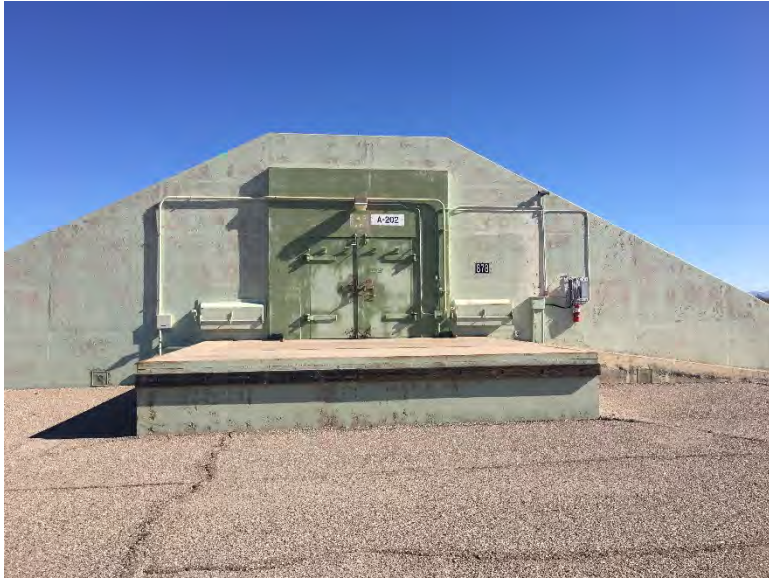
Photograph 5. View across the site from the West Apron. View to the east-northeast.

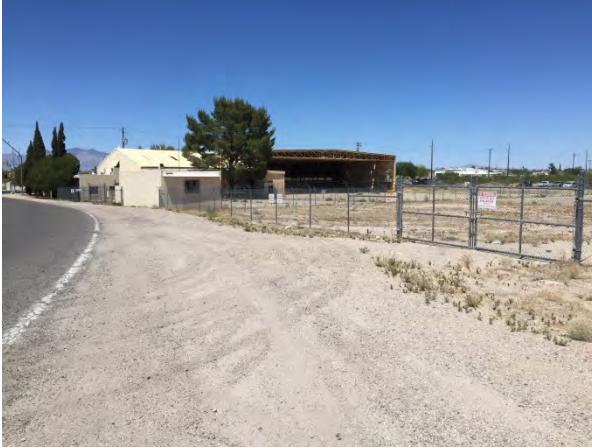
Photograph 1. Vacant site parcel at the southeast corner of Park Avenue and Valencia Road (1000 East Valencia Road). View to the northeast.

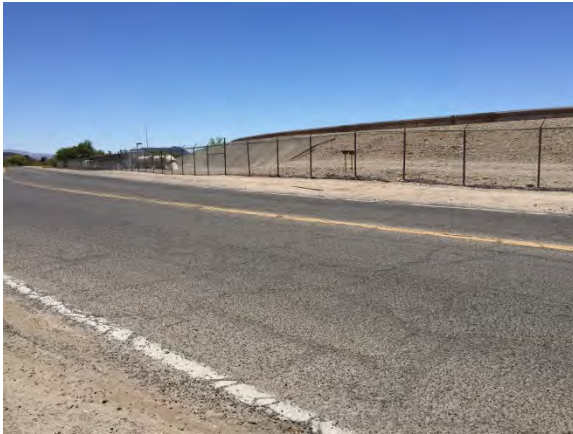
Photograph 3. Park Avenue and Tucson Water's Martin Reservoir adjoining the northwest portion of the site to the west. View to the southwest.

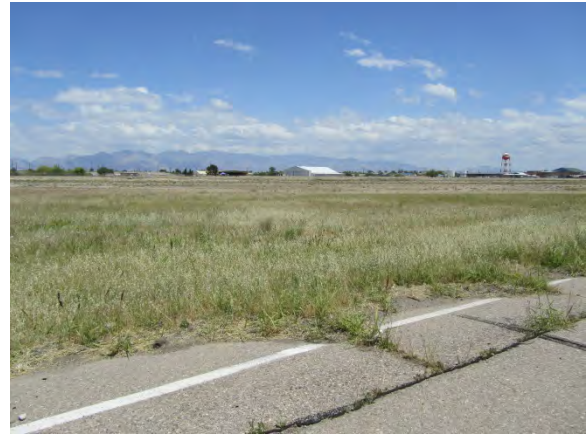
Photograph 4. View across the northwest portion of the site from the perimeter road. View to the northeast.

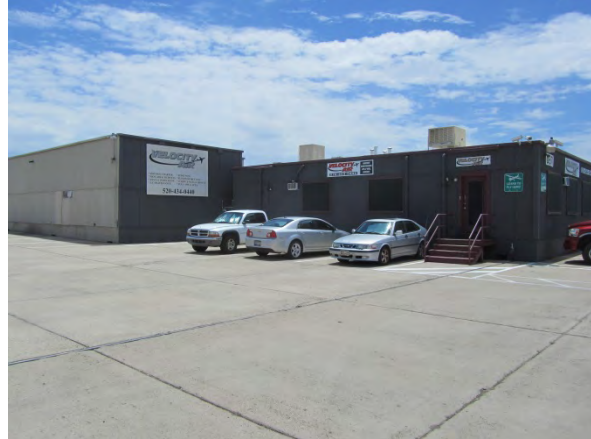
Photograph 14. Velocity Air hangar and offices. View to the southeast.

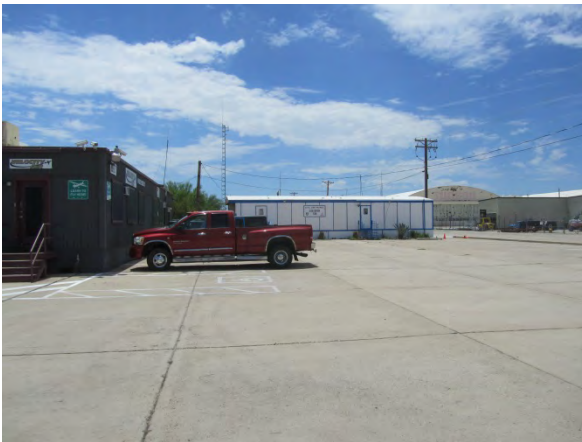
Photograph 15. Velocity Air office building on the left and Civil Air Patrol offices in the center. View to the south.

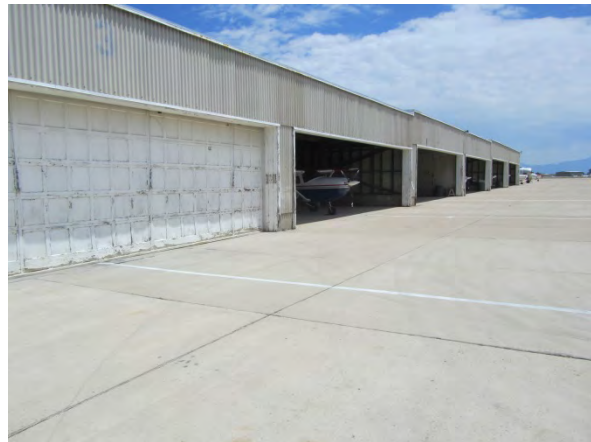
Photograph 16. Velocity Air north hangars. View to the northeast.

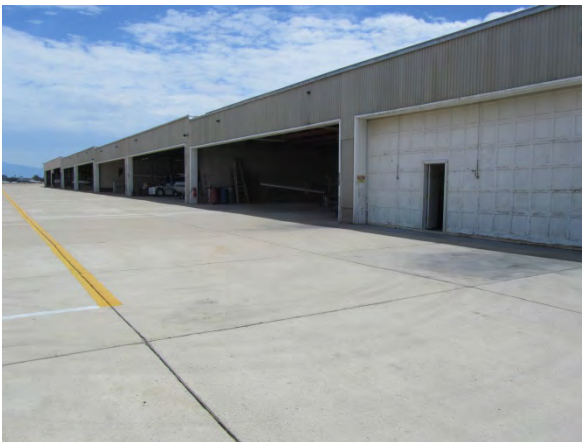
Photograph 17. Velocity Air south hangars. View to the southeast.

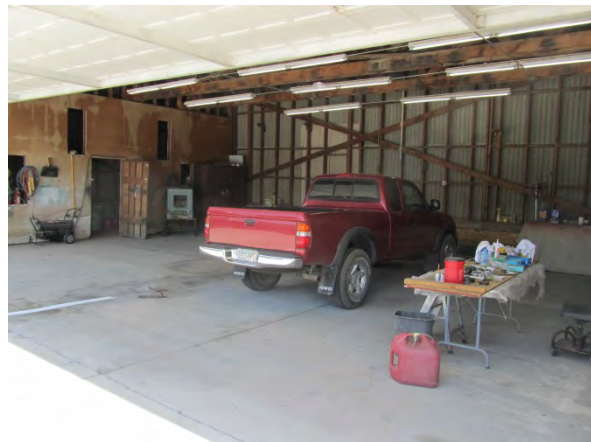
Photograph 18. Maintenance area in the west end of the Velocity Air north hangar. View to the southwest.

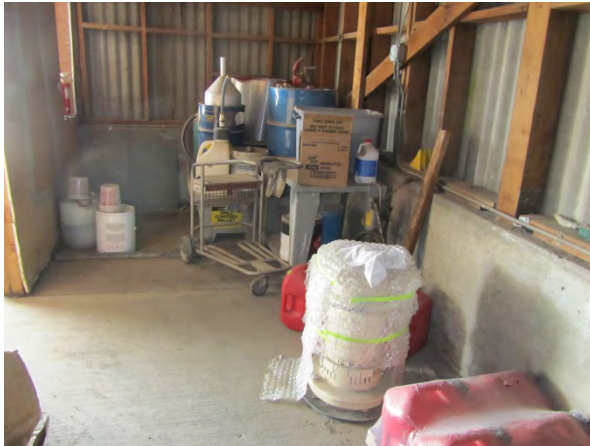
Photograph 19. Storage area in the west side of the maintenance area. View to the south.

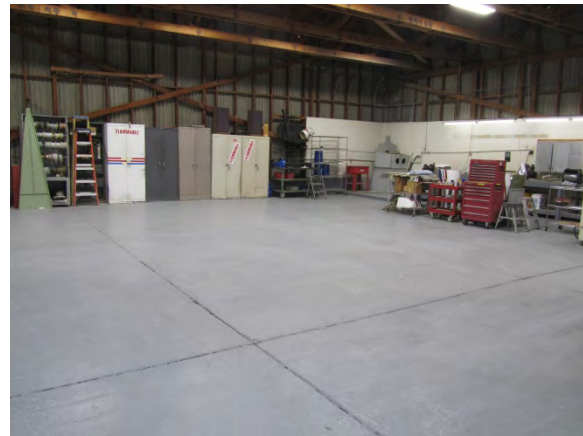
Photograph 22. The shop area in the west end of the Velocity Air south hangar. View to the southwest.

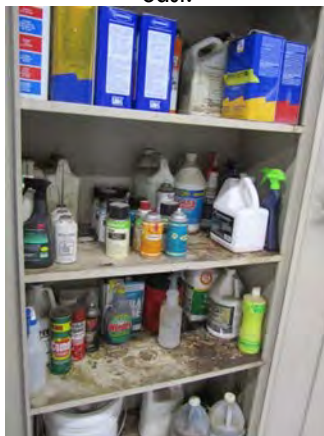
Photograph 23. Typical materials stored in cabinets in the shop area of the Velocity Air south hangar. View to the south.

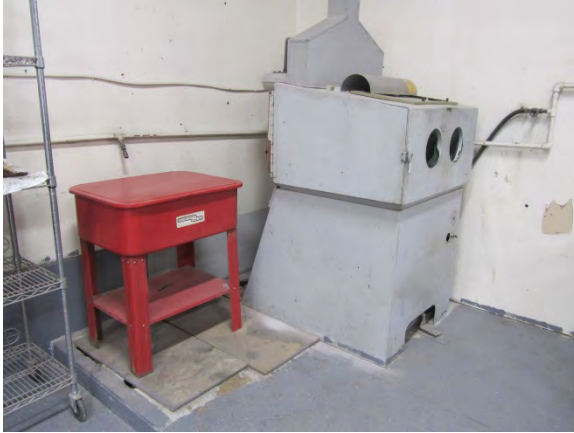
Photograph 25. Sand blasting equipment in the southwest corner of the shop. View to the southwest.

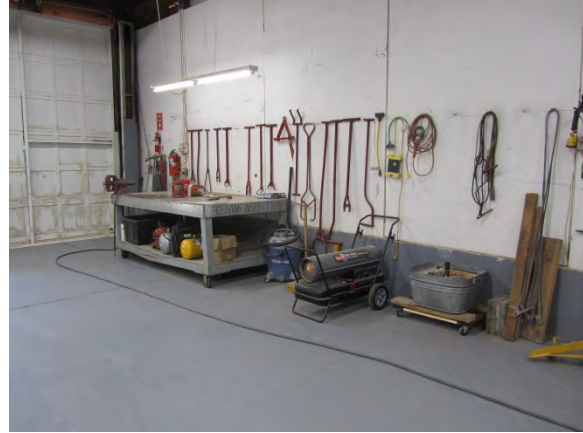
Photograph 26. Equipment and materials in the shop. View to the northeast.

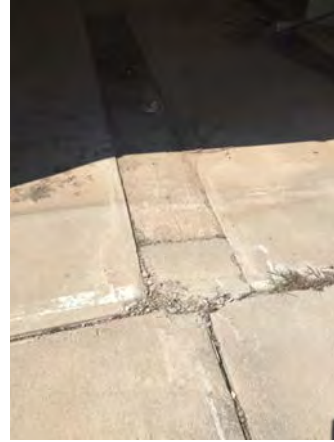
Photograph 44. Concrete-filled apparent linear drain in the center of the storage building. View to the northeast.

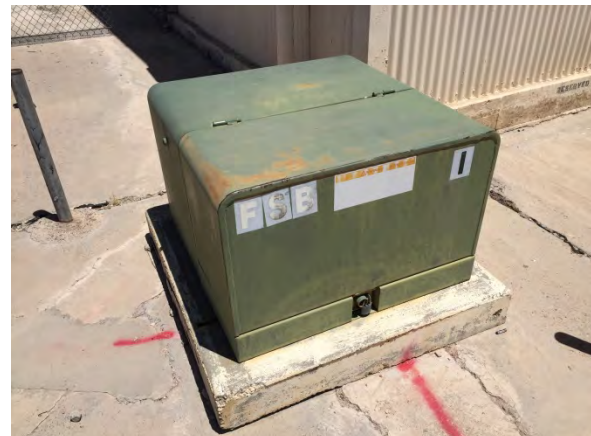
Photograph 54. Pad-mounted transformer at the northwest corner of the USFWS structure. View to the southeast.

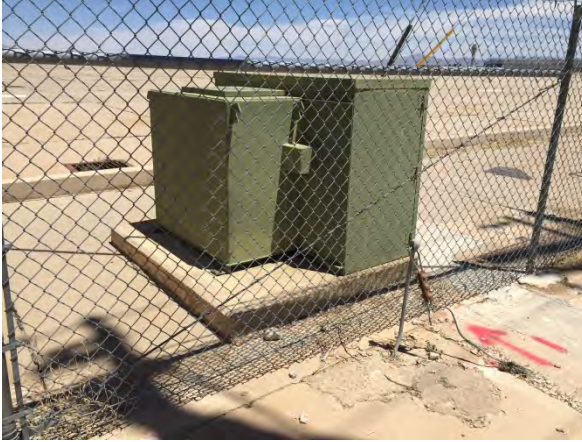
Photograph 55. Pad-mounted transformer at the southwest corner of the USFWS structure. View to the southeast.

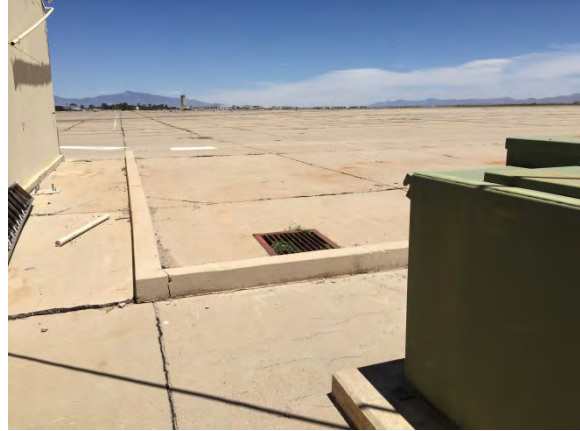
Photograph 56. Drain east of the transformer and south of the USFWS structure. View to the east.

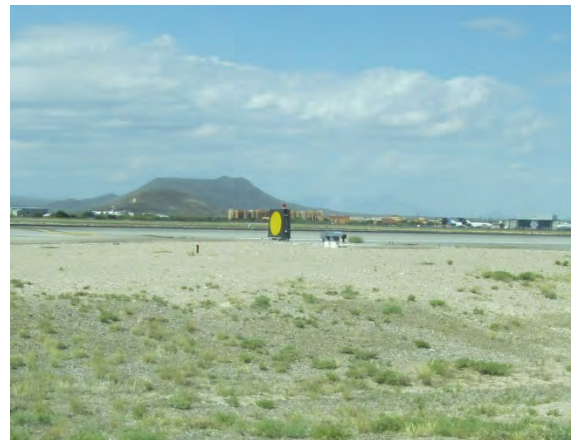
Photograph 77. AANG arrestor system north of Taxiway A5. View to the southwest.

- The fuel tanks and vaults associated with the four AANG arresting systems, the AANG hydrazine maintenance area, and the hazardous material storage area adjoining the former fire station should be investigated to determine whether the use and storage of fuel or chemicals in these areas has impacted Site soils.

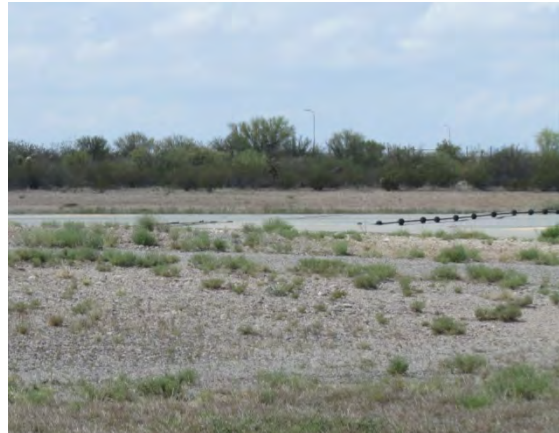
Photograph 91. Deployed AANG arrestor system near Taxiway A17. View to the southwest.

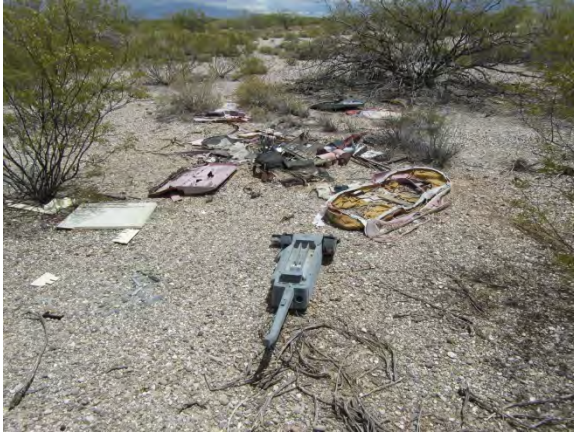
Photograph 102. Wildcat dumping in the south-central portion of the site in Section 32.

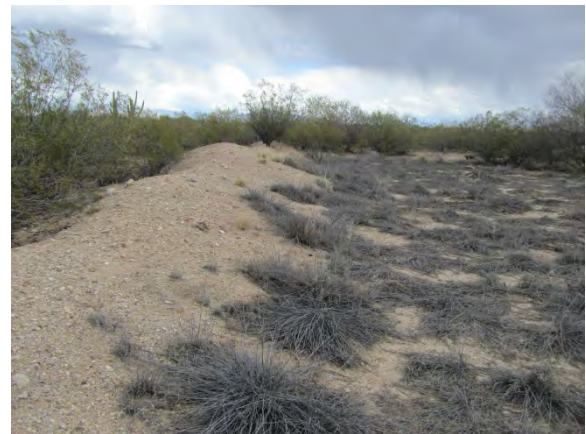
Photograph 105. Mounded soil in the south-central portion of Section 32.

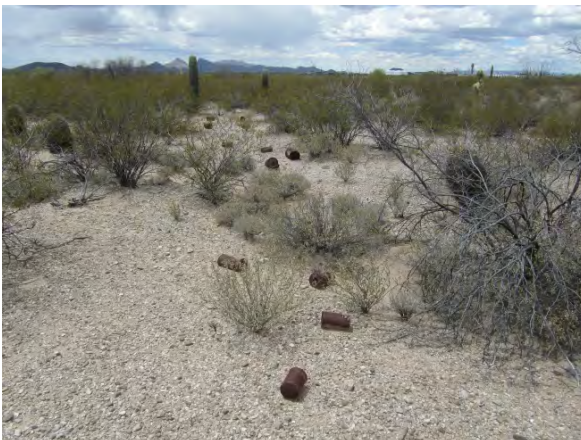
Photograph 106. Wildcat dumping in the south-central portion of the site in Section 32.

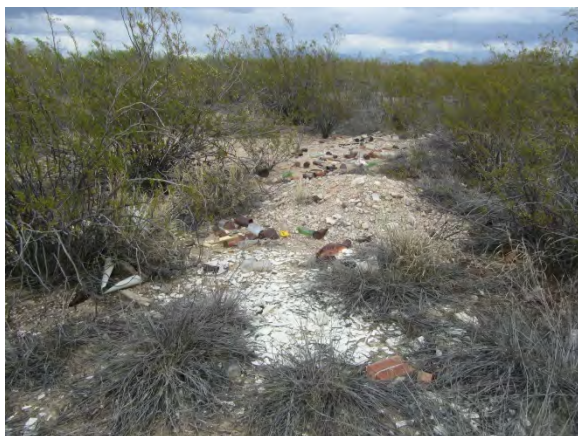
Photograph 113. Wildcat dumping in the southwest portion of the site in Section 32.

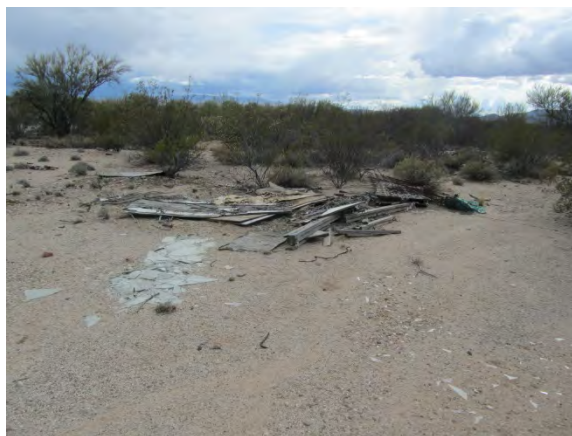
Photograph 114. Wildcat dumping in the southwest portion of the site in Section 32.

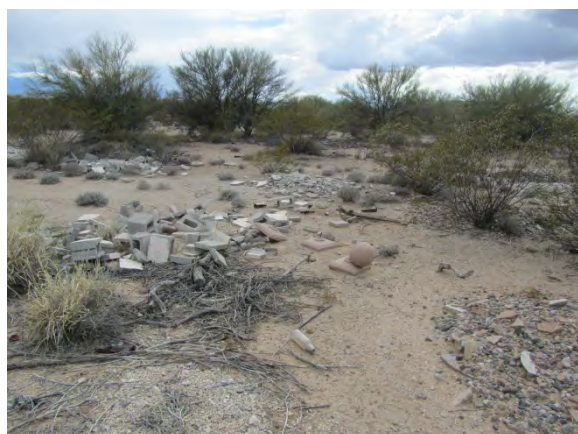
Photograph 115. Wildcat dumping in the southwest portion of the site in Section 32.

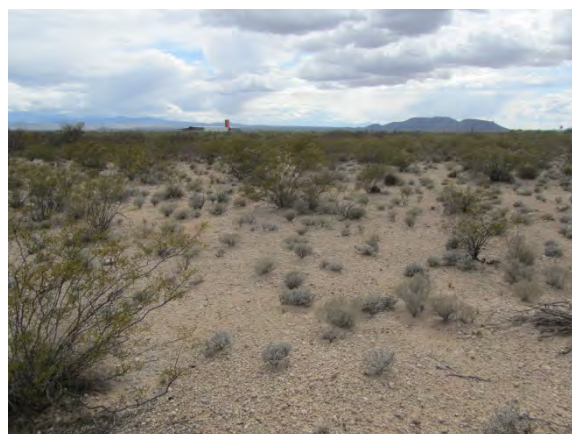
Photograph 116. Wildcat dumping in the southwest portion of the site in Section 32.
