Phase I Environmental Due Diligence Audit (EDDA)

Environmental Impact Statement for the Proposed Airfield Safety Enhancement Project and Land Transactions for the Tucson International Airport Tucson, Arizona

January 23, 2018
AAI Date: December 27, 2016
File No. 01216132.01

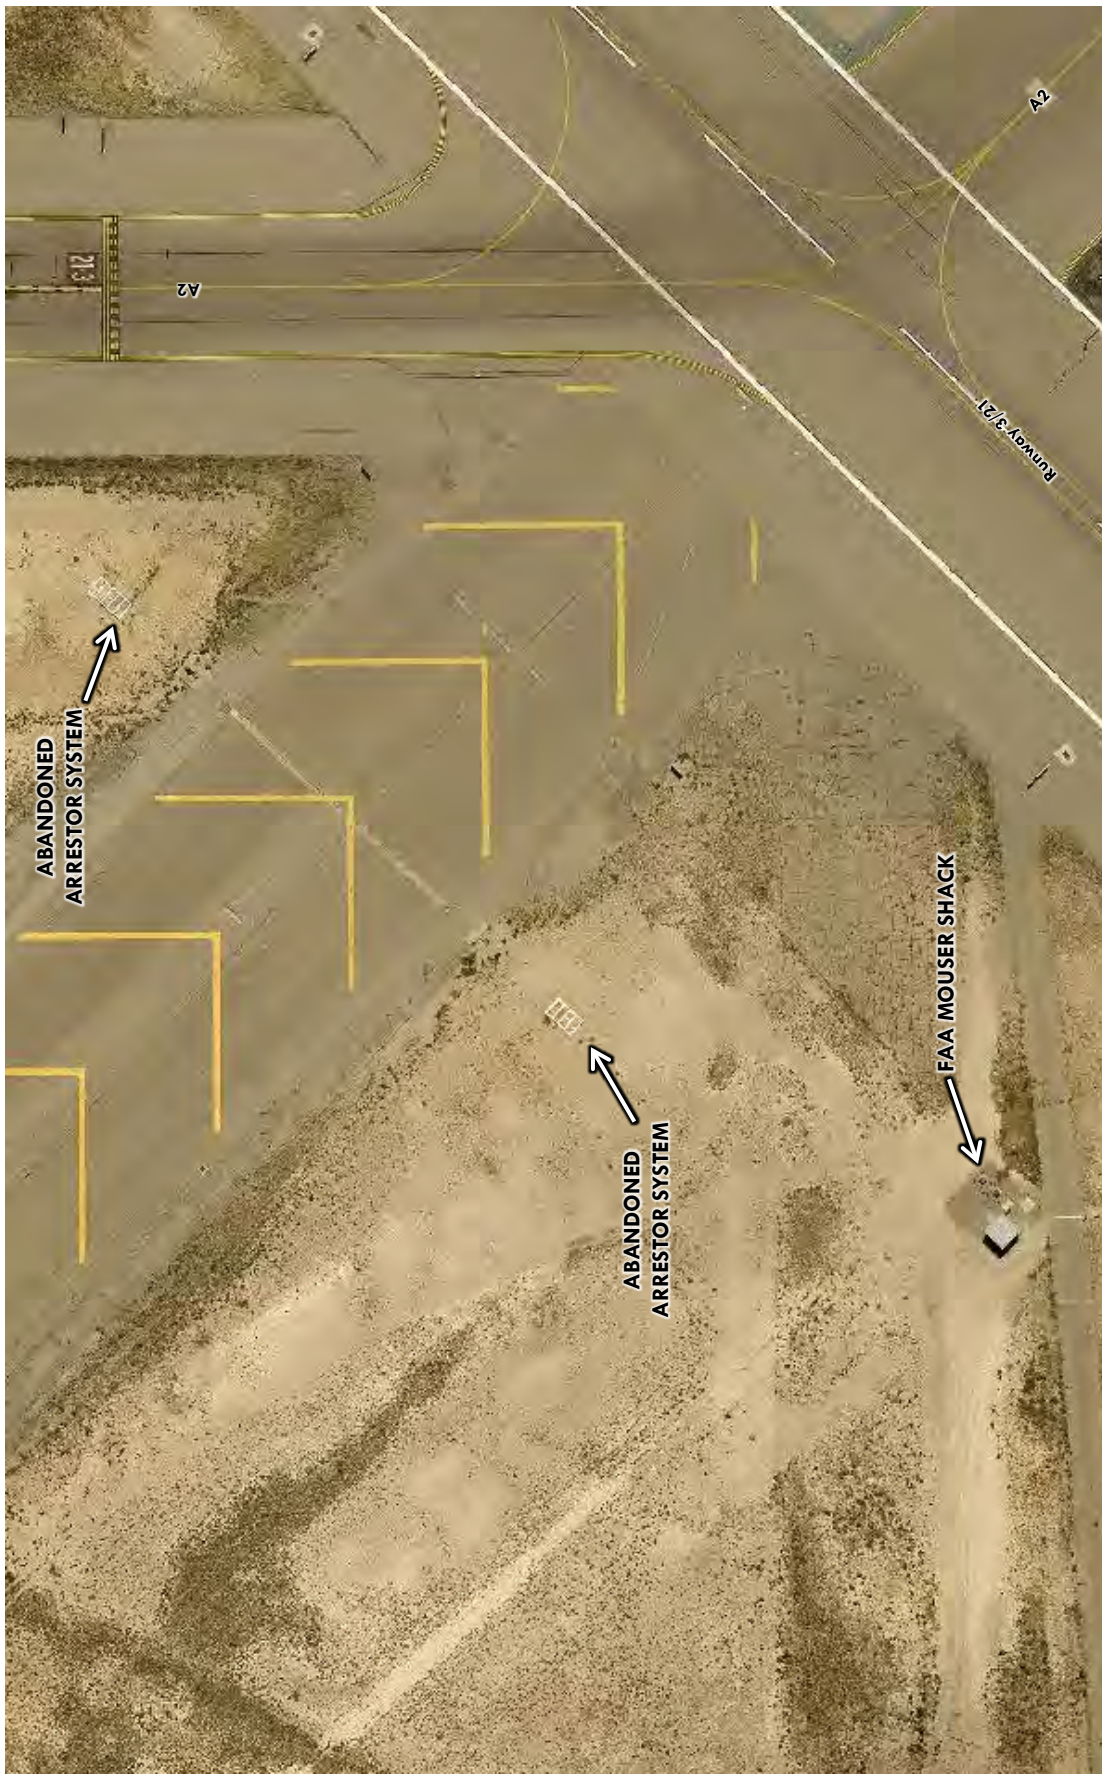
Figure 5E
Site Detail
Hydrazine Maintenance Area

- Several areas of the Site that have potential for contamination from fuel or chemicals used or stored in these areas include the fuel tanks and vaults associated with the four AANG arresting systems, the AANG hydrazine maintenance area, and the hazardous material storage area adjoining the former fire station. These are potential RECs for the Site.
- The A-Magazine ECMs at AFP-44 (the eastern six ECMs are within Parcel F) have been used to store explosives and other hazardous materials since 1954, which is considered a potential REC for the Site. SCS was not allowed to visually inspect the interiors of the ECMs or perform any destructive sampling because they were in use.
- Wildcat dumping of solid waste on the Site Parcels G and H in Section 32, and to a lesser extent along the roads in Section 33, is considered to be a REC for the Site.

- The fuel tanks and vaults associated with the four AANG arresting systems, the AANG hydrazine maintenance area, and the hazardous material storage area adjoining the former fire station should be investigated to determine whether the use and storage of fuel or chemicals in these areas has impacted Site soils.

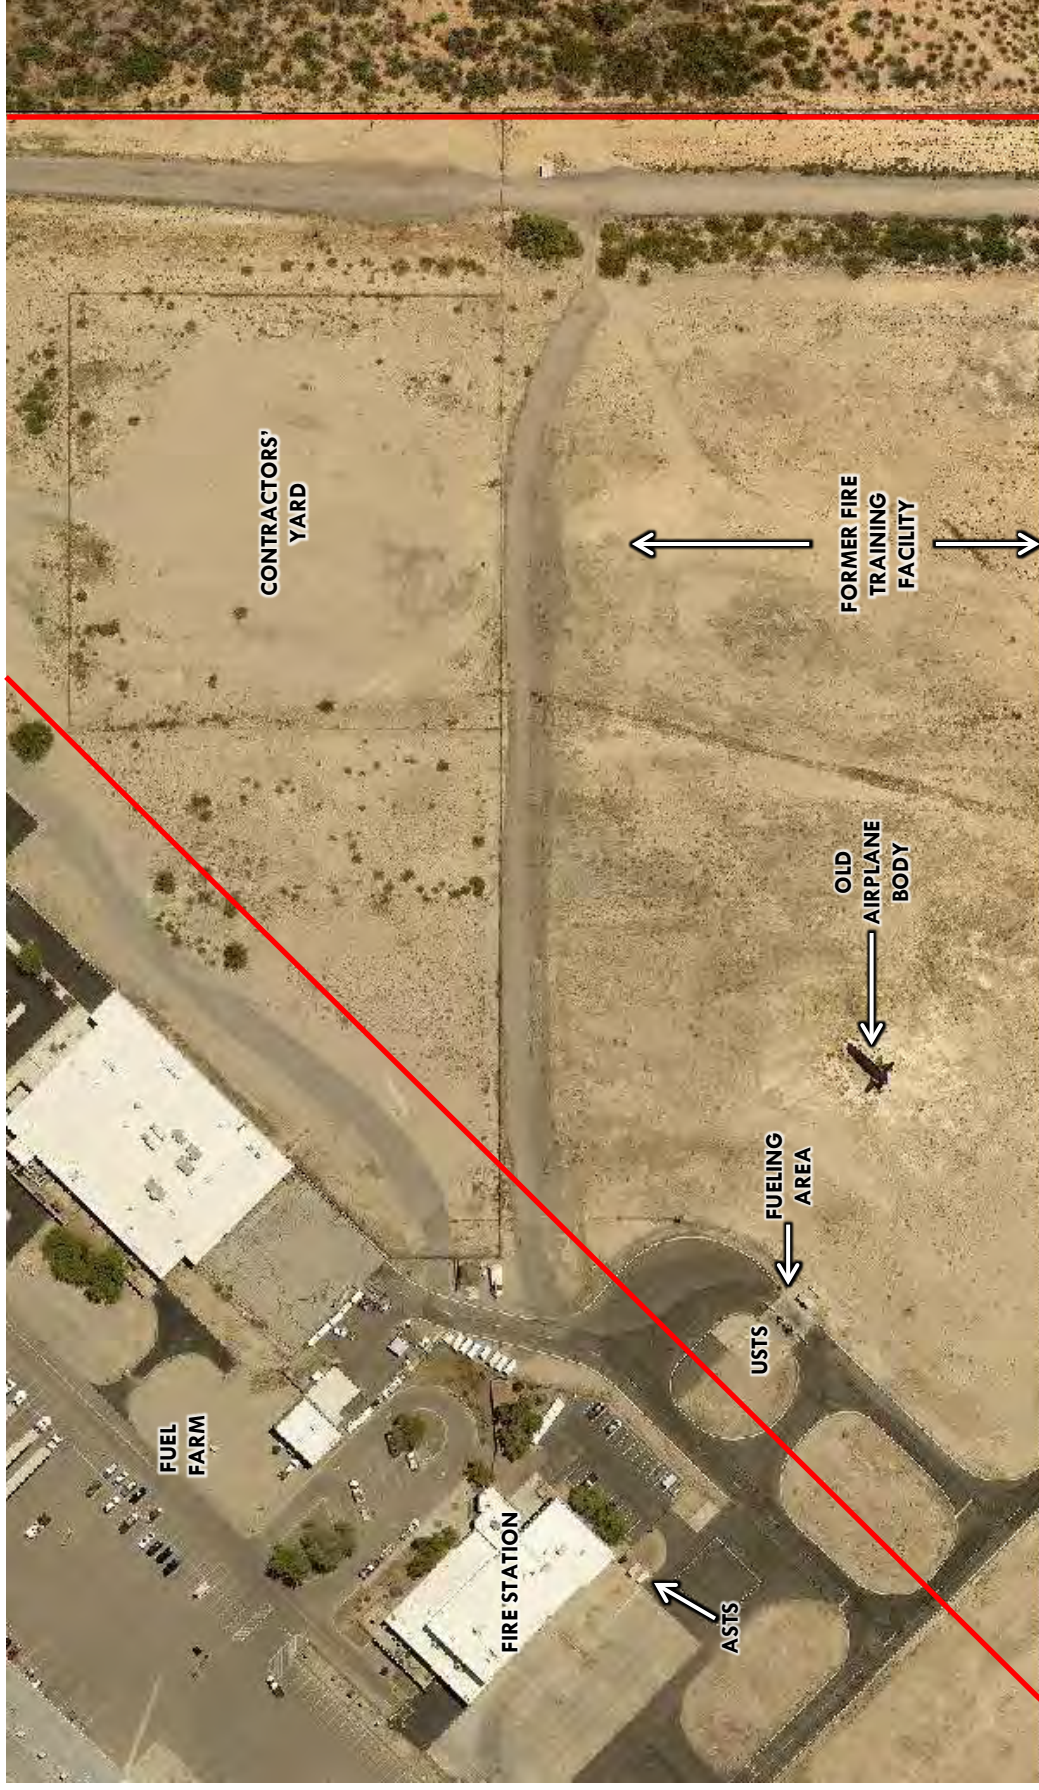
Figure 8A
Site Detail –Contractors' Yard
and Portion of Fire Training Area

<p>Contractors' Yard: Vacant area containing a secured fenced area located near the current fire station and used by various contractors doing work at the airport. A fire diamond was posted on the fence (flammability 2, health 3, and instability/reactivity 1). Observed in the fenced area were vehicles, equipment, a metal storage container, a portable toilet, cable spools, piping, and other supplies.</p>	No
<p>Fueling Facility: East of the current Fire Station is a fueling facility with underground storage tanks (USTs) that is shown to be located within the Site boundaries. However, SCS understands that this area is not included as part of the Site.</p>	No
AIR FORCE PLANT 44 SITE AREAS	
<p>A-Magazine: Twelve ECMs used for storage of explosives and other materials are located on the western portion of the Site. The ECMs are arranged in two rows of six and are known as the A-Magazine. Only the eastern six ECMs are located within Parcel F; however, all 12 ECMs are planned to be demolished during the proposed project. The structures were reportedly built in 1954. The ECMs consist of concrete structures overlain by soil and capped by asphalt that has degraded. Drain trenches along the sides of the floor divert water that leaks into the structures into pipes leading through the walls to the west exterior of the structures. Utilities include electricity and water. This is the best information that is obtainable at this time, given the lack of access due to the current continuous operation of the ECMs.</p>	Yes

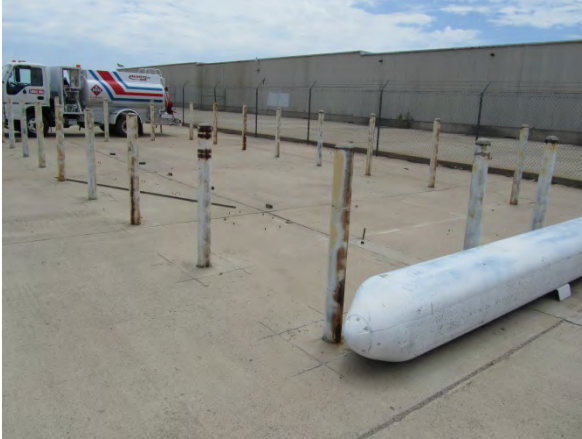
Photograph 13. Former location of aboveground storage tank (AST) for fuel east of the Double Eagle offices. View to the southeast.

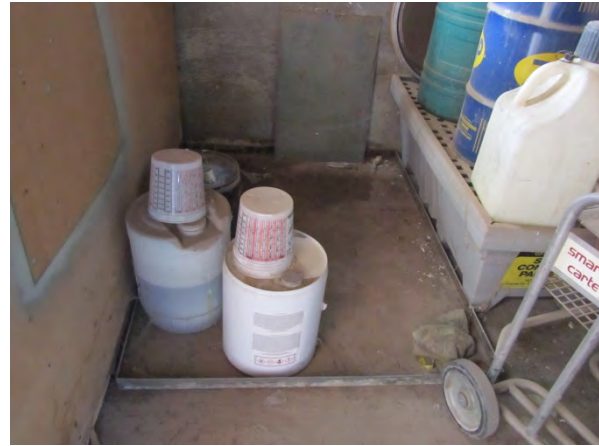
Photograph 20. Spill tray and pallet in the storage area. View to the south.

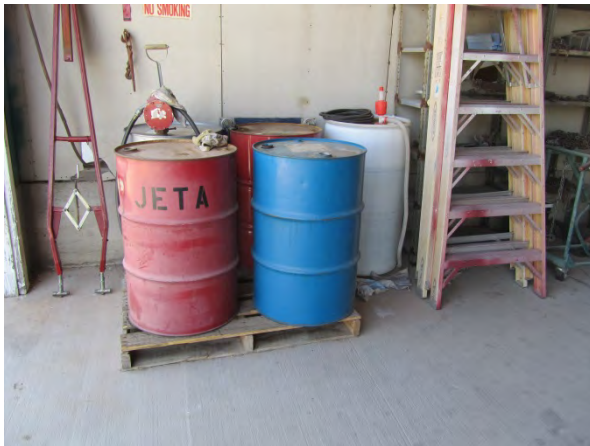
Photograph 21. Drums in the maintenance area in the west end of the Velocity Air south hangar. View to the east.

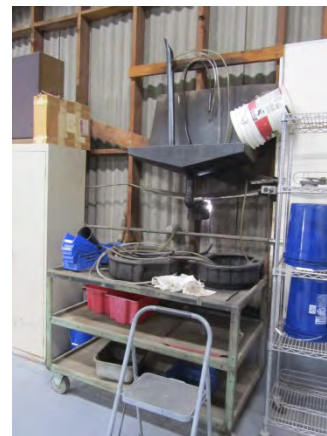
Photograph 24. Used oil collection area in the southwest portion of the shop. View to the southeast.

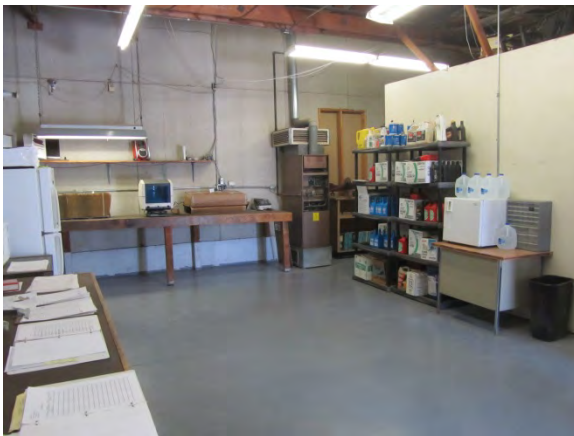
Photograph 27. Some oil containers stored on a shelf inside the office building.

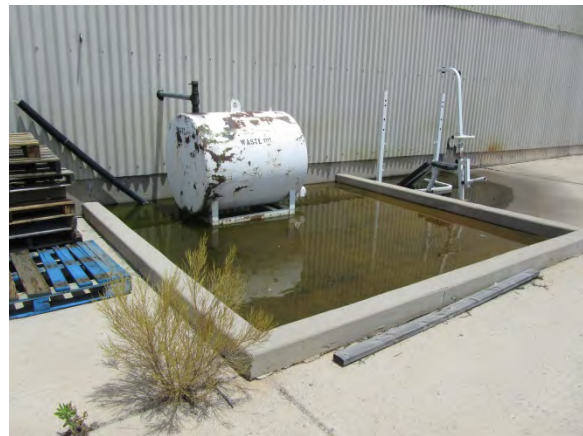
Photograph 28. Used oil AST in secondary containment outside the south wall of the Velocity Air south hangar. View to the northeast.

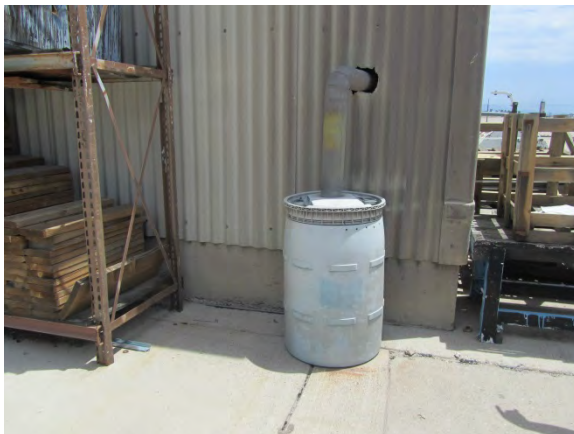
Photograph 29. Drum to capture sand blasting debris outside the west wall of the Velocity Air south hangar. View to the east.

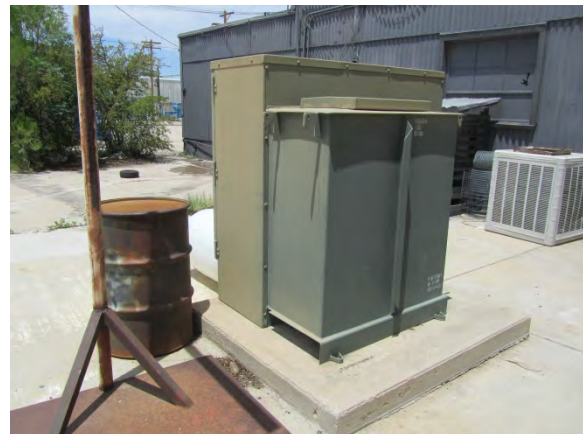
Photograph 30. Pad-mounted transformer and drum south of the Velocity Air offices. View to the northwest.

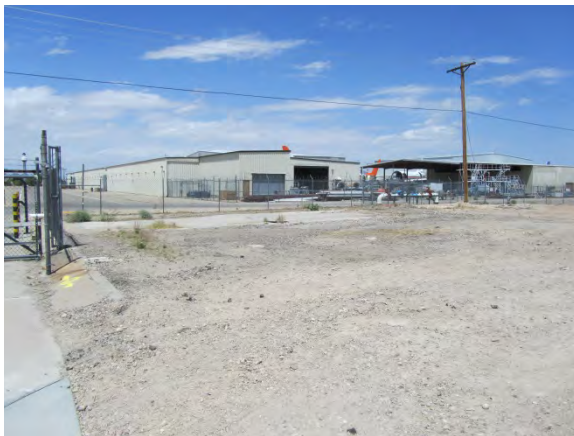
Photograph 33. Wash rack in the west portion of the former fire station area with Ascent Aviation to the rear. View to the northwest.

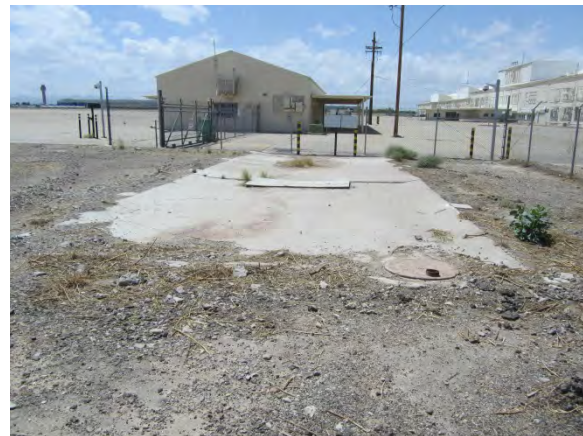
Photograph 34. Wash rack in the west portion of the former fire station area (USFWS building to rear). View to the south.

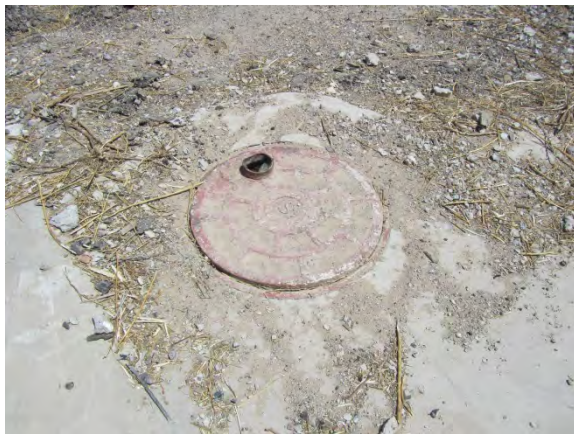
Photograph 35. Manhole in the wash rack pad.

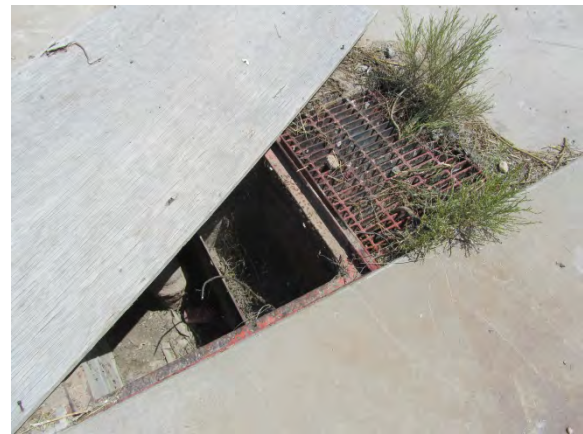
Photograph 36. Drain and separator in the wash rack pad.

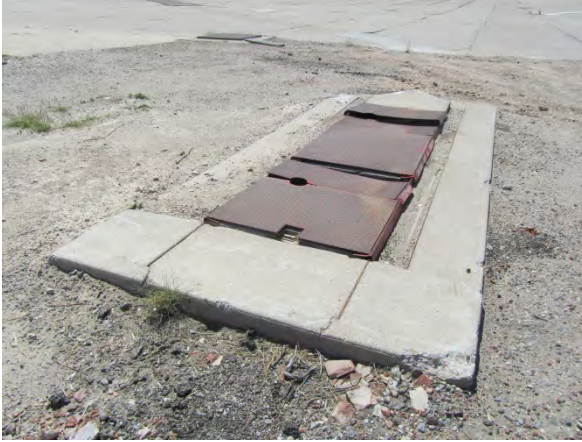
Photograph 37. Vault in the former fire station area.
View to the southeast.

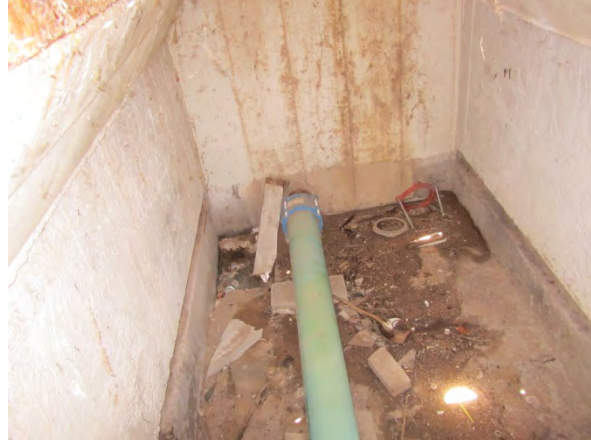
Photograph 38. Interior of vault.

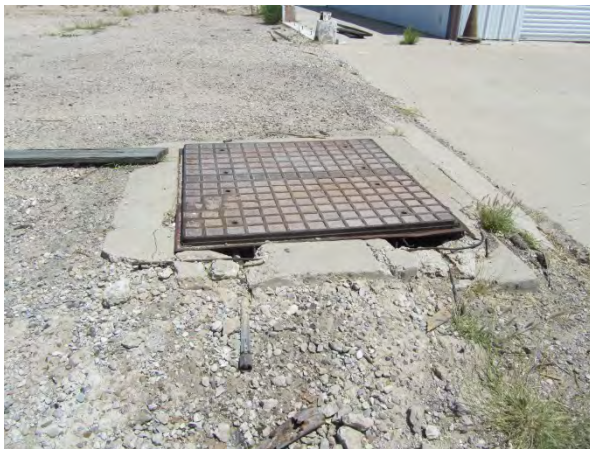
Photograph 39. Vault in the former fire station area.
View to the north

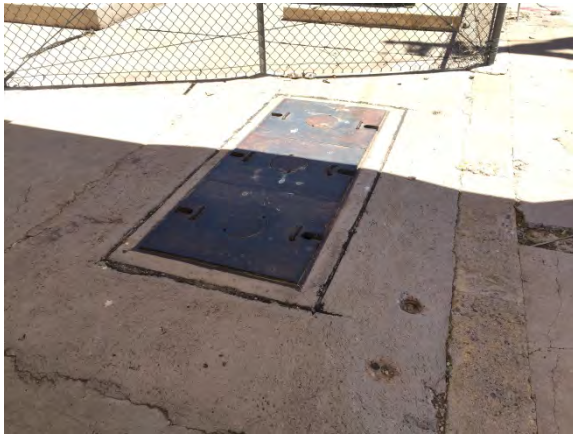
Photograph 58. Interior of the utility vault.

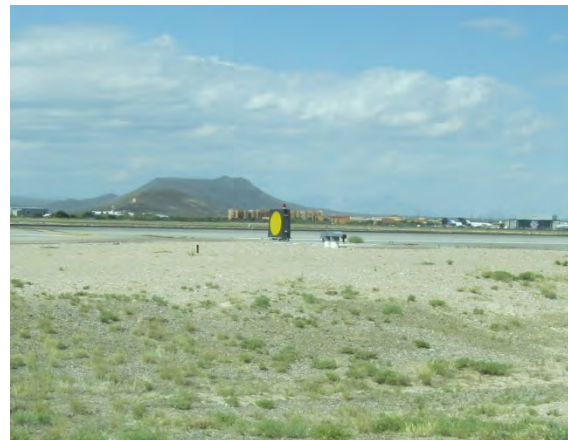
Photograph 77. AANG arrestor system north of Taxiway A5. View to the southwest.

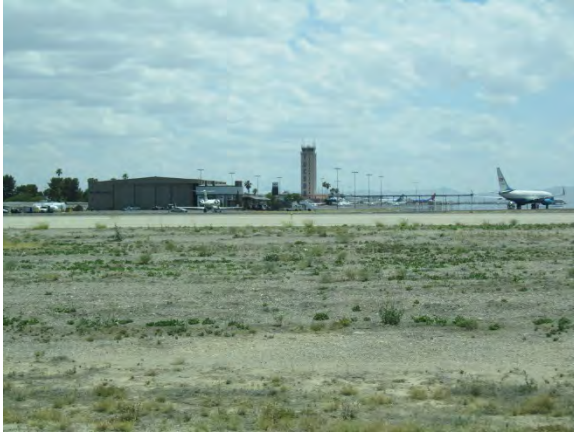
Photograph 78. Atlantic Aviation, old airport traffic control tower, and parked airplanes adjoining the site to the east. View to the southeast.

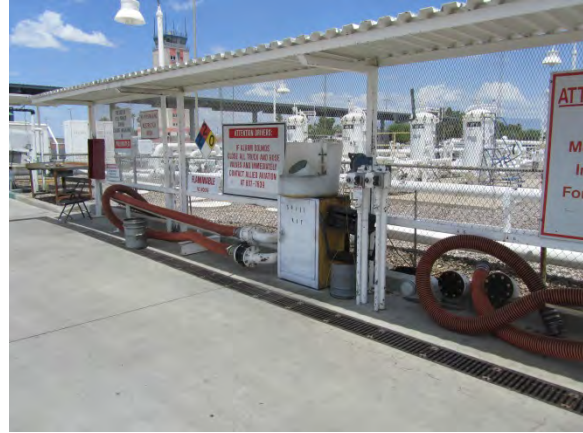
Photograph 79. Fuel farm northwest of the airport terminal, east of the site. View to the north.

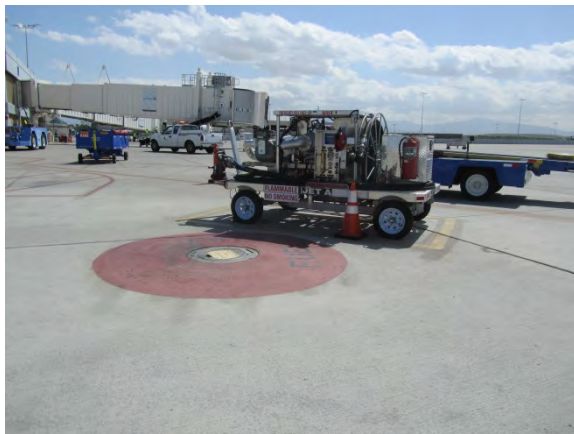
Photograph 80. Fuel pit area in the terminal ramp east of the site. View to the southeast.

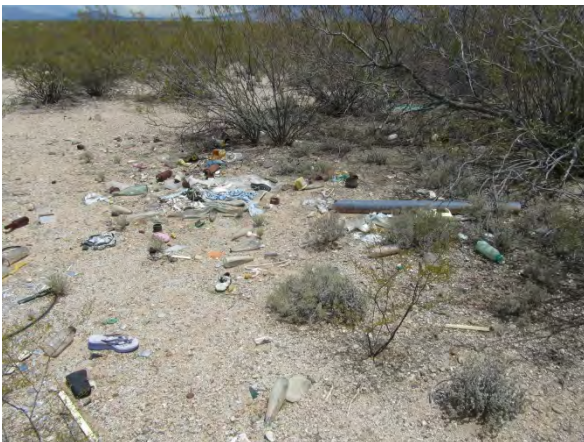
Photograph 100. Wildcat dumping in the south-central portion of the site in Section 32.

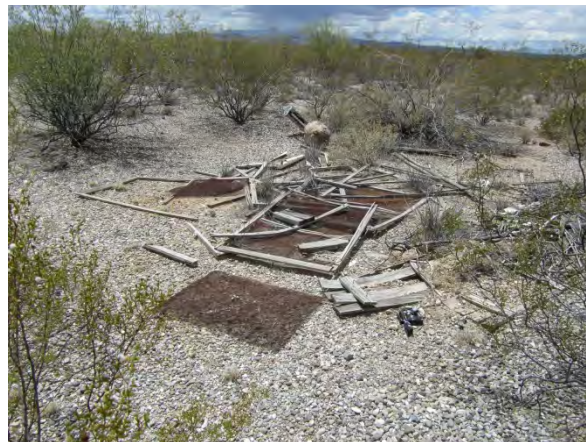
Photograph 101. Wildcat dumping in the south-central portion of the site in Section 32.

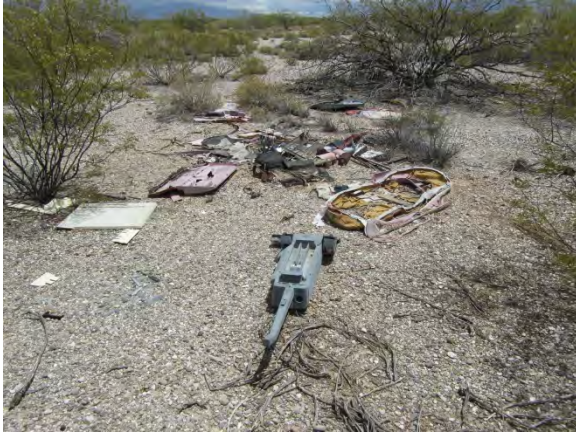
Photograph 102. Wildcat dumping in the south-central portion of the site in Section 32.

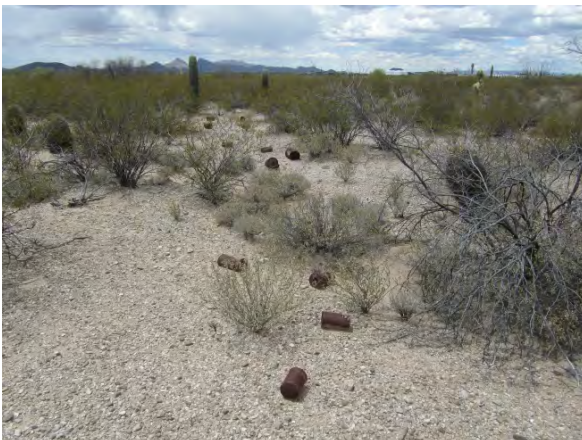
Photograph 106. Wildcat dumping in the south-central portion of the site in Section 32.

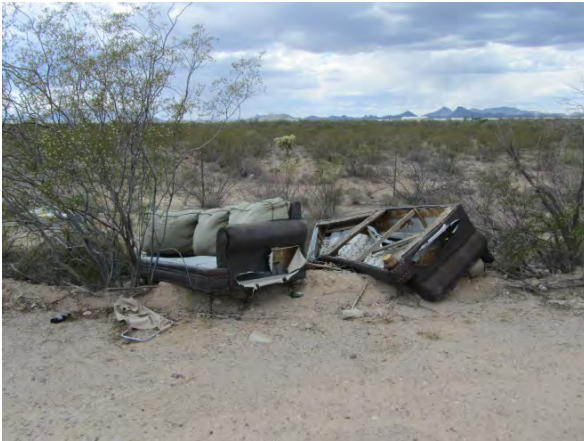
Photograph 110. Wildcat dumping along Country Club road on the site between Sections 32 and 33.

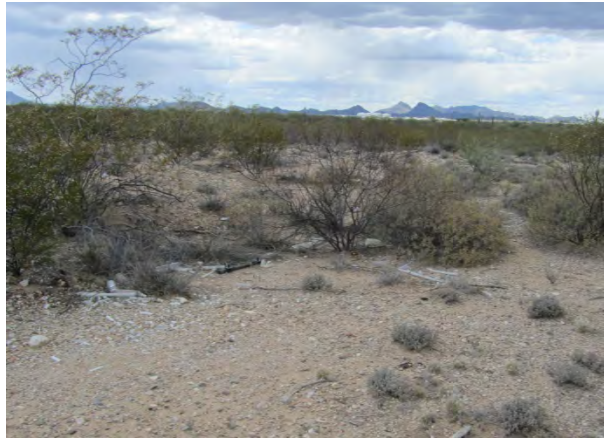
Photograph 111. A collection of fluorescent tube lightbulbs disposed on the site along Country Club Road.

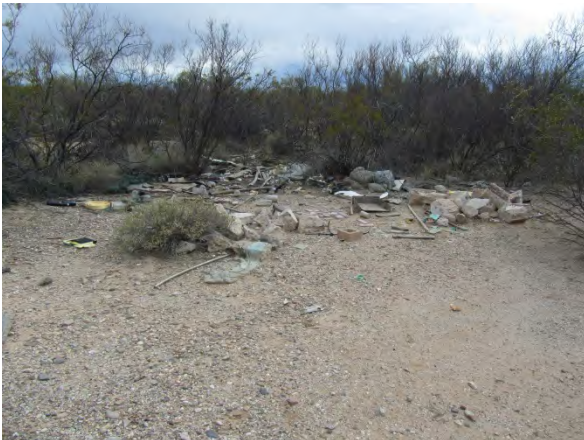
Photograph 112. Wildcat dumping in the southwest portion of the site in Section 32.

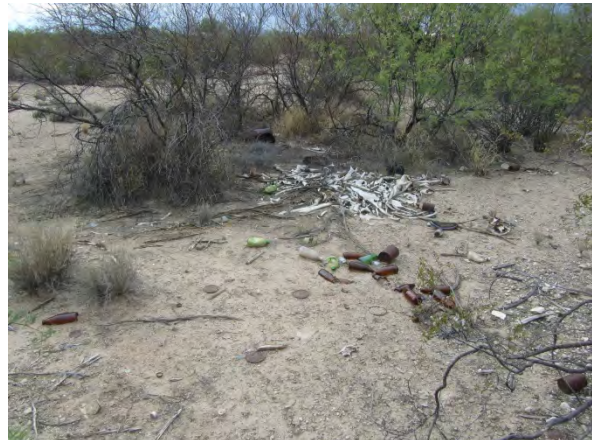
Photograph 113. Wildcat dumping in the southwest portion of the site in Section 32.

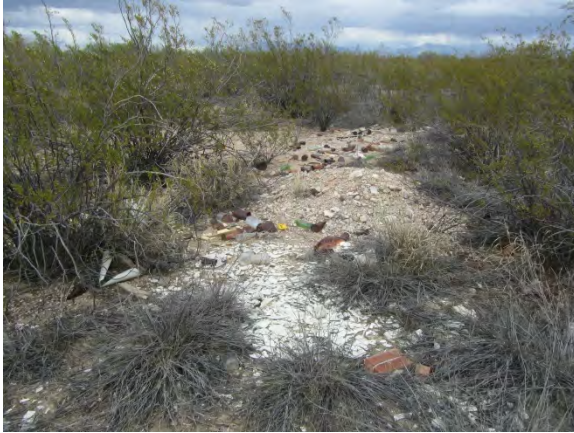
Photograph 114. Wildcat dumping in the southwest portion of the site in Section 32.

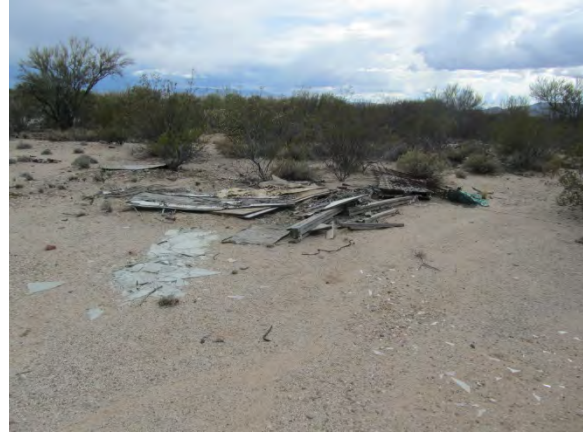
Photograph 115. Wildcat dumping in the southwest portion of the site in Section 32.

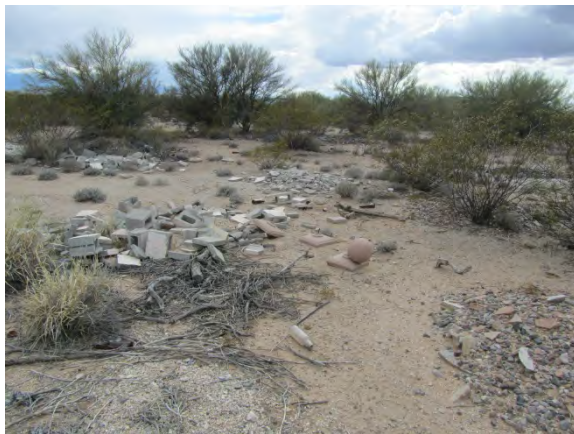
Photograph 116. Wildcat dumping in the southwest portion of the site in Section 32.

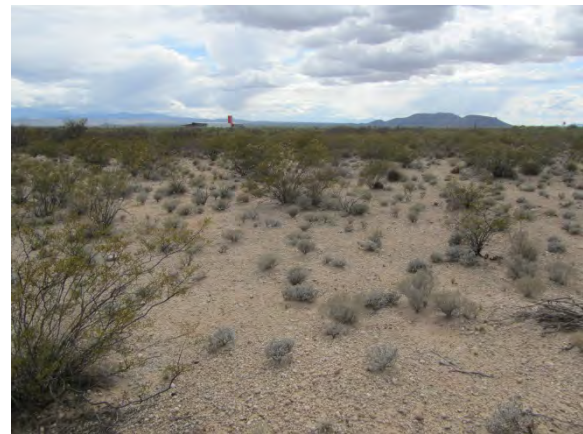
Photograph 117. View across the western portion of the site. View to the southwest.

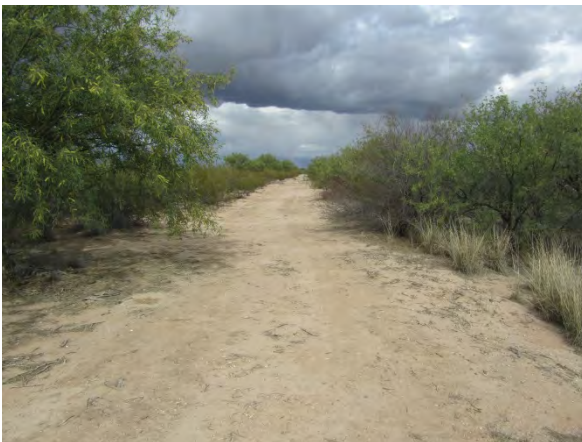
Photograph 118. Dirt road used for access for installation of chain-link fence on the north portion of the site in Section 32. View to the east.

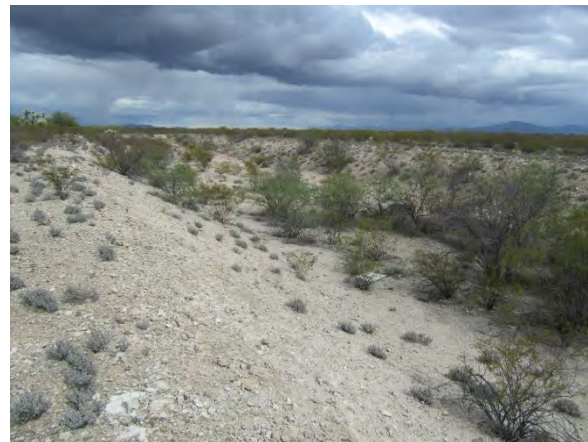
Photograph 119. Excavated area in the north portion of the site in Section 32. View to the southeast.

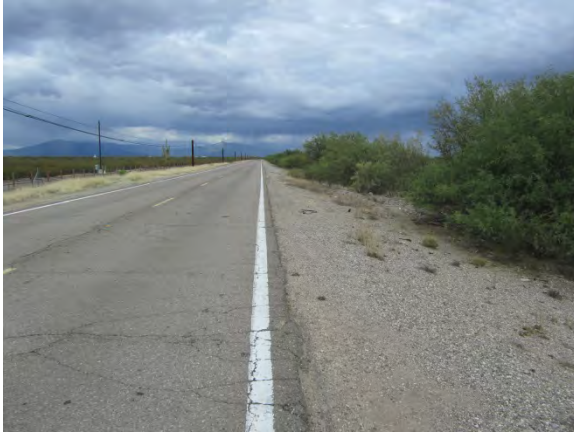
Photograph 120. Hughes Access Road closed to traffic, adjoining the site to the north in Sections 32 and 33. View to the east.

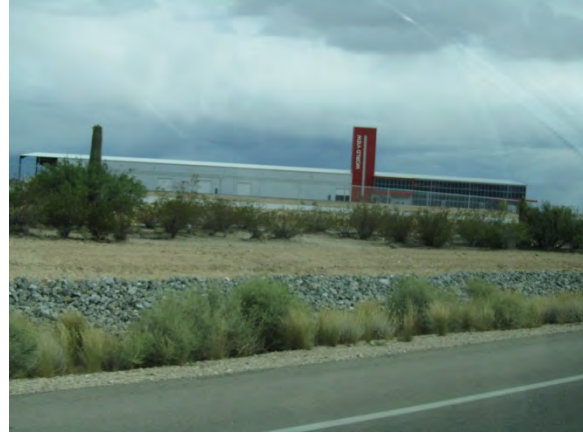
Photograph 121. World View adjoining the site in Section 33 to the west. View to the northeast.

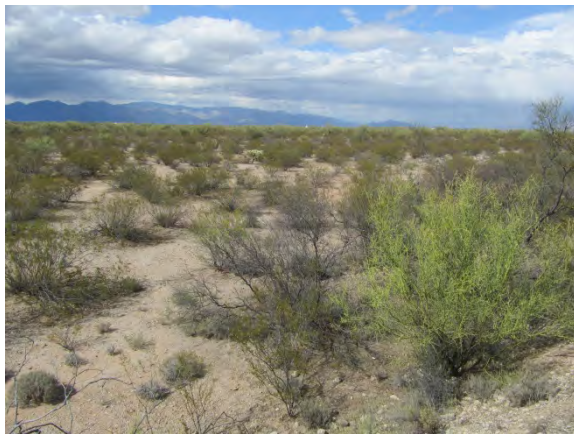
Photograph 122. Vacant land in the Section 33 portion of the site. View to the east.

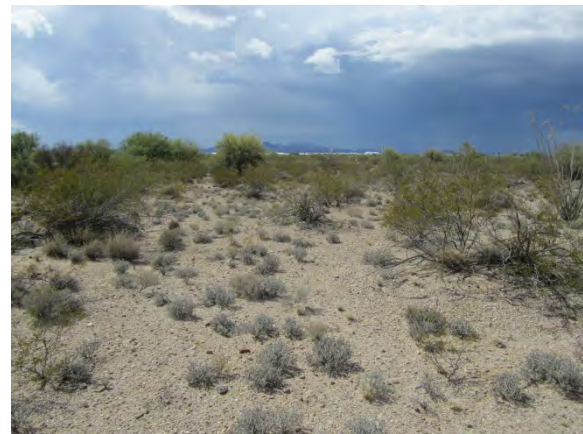
Photograph 123. Vacant land in the Section 33 portion of the site. View to the northwest.

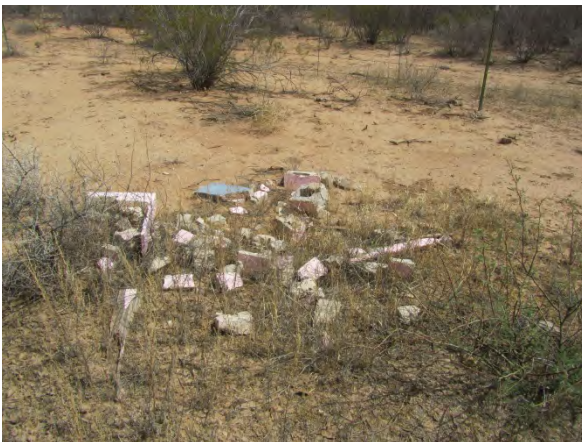
Photograph 124 Some wildcat dumping in the north portion of the site in Section 33.

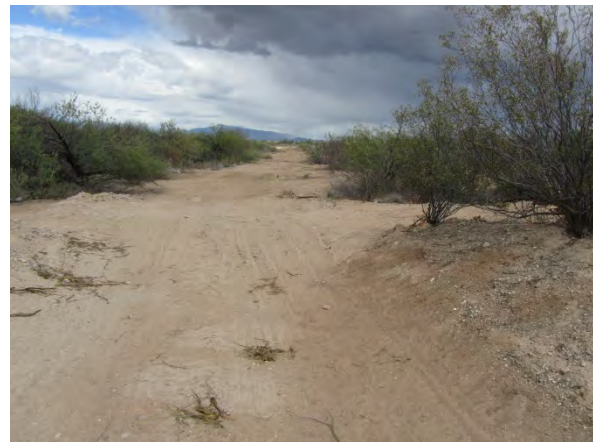
Photograph 125. Dirt road used for access for installation of chain-link fence on the north portion of the site in Section 33. View to the southeast.

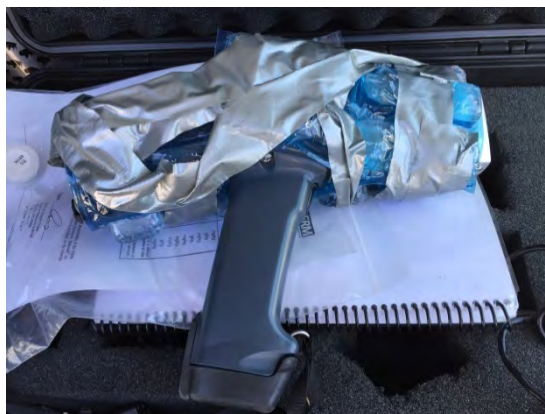
content of painted surfaces directly without the need to collect samples; it is a non-destructive method that will not damage the building materials/structures. Due to overheating of the XRF as a result of hot weather (temperatures exceeding 100 degrees Fahrenheit), Ms. Hartshorne returned to the site on June 6 and 15, 2017 to complete the sampling of the exterior of ECMs A-101 through A-106 (a.k.a. #871 through 876). The high temperatures caused repeated shut-down of the XRF, which was mitigated during the third event by wrapping with ice packs.

XRF wrapped in ice packs

- Prior to the demolition of the 12 ECM sites, a LBP survey should be performed for any painted or similarly coated surfaces inside each structure. It is recommended that this survey be performed during cooler weather in order to optimize the performance
